REPORT OF THE DIRECTOR OF THE BUREAU OF SAFETY IN RE
INVESTIGATION OF AN ACCIDENT WHICH OCCURRED ON
THE ATLANTIC COAST LINE RAILROAD AT HAINES CITY,
FLA., ON SEPTEMBER 25, 1931.

October 28, 1931.

Inv No 1724
 Atlantic Coast Line R R ,
 Haines City, Florida,
 Sept 25, 1931

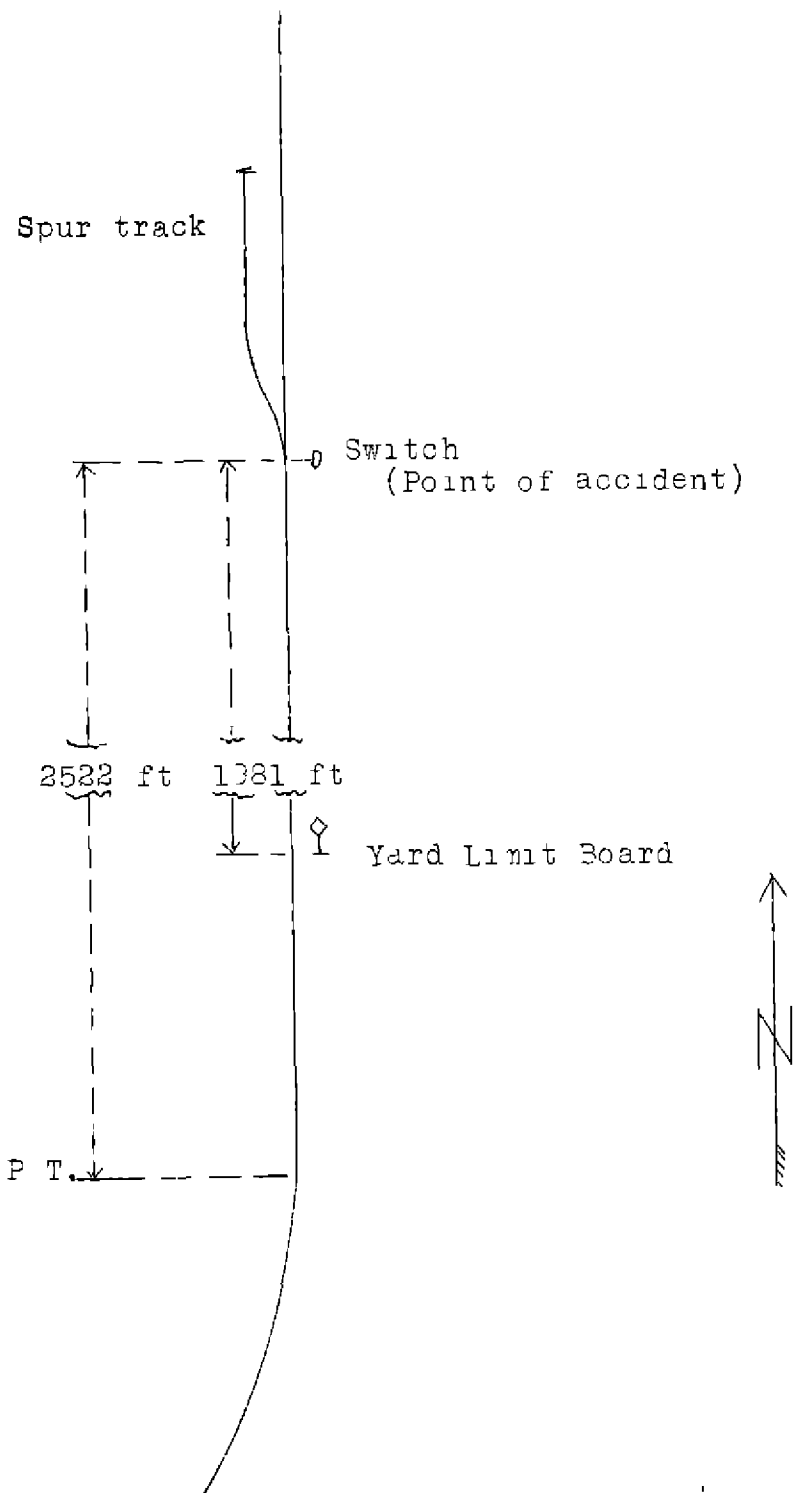
The switch involved is a facing-point switch for northbound trains, with a No. 10 turnout, and leads off the main track to the left or west to the spur track, which is 226 feet in length. The switch stand is located on the east side of the track, the centers of the targets are 5 feet above the head-block ties. When the switch is closed a green circular target is displayed, while a red arrow-shaped target is displayed when the switch is open. The switch stand is not equipped with a switch lamp.

This accident was caused by an open switch.

After the accident the switch was found to be lined and locked for the spur track, with the switch target displaying a red indication, although it had not been used by train or switch crews for several days. While the testimony was conflicting as to whether or not the switch was used by the section crew, or whether the motor car was lifted over both to and from the spur track without using the switch, yet the investigation established the fact that the switch was lined for the main track at the time southbound freight train No. 577 passed, a trailing-point movement, during the noon hour, at which time the motor car stood on the spur track. Therefore, the whole question hinges on whether or not the switch was opened to push out the motor car from the spur track after the noon hour, or whether it was lifted back to the main track; the weight of evidence in this respect is to the effect that the motor car was lifted back, the switch not being used, and that on departing the switch was observed to be properly lined for the main track and the switch target displaying a green indication. The switch was not damaged as a result of the accident and there was no indication of malicious tampering. It appears that the switch was inadvertently left open by some one in possession of a switch key; while there were circumstances to indicate that Section Foreman Lominack, or a member of his crew, might have left the switch open, yet the section foreman emphatically maintained that neither he nor any of his crew had handled the switch on the day in question and at the time of the investigation it could not be definitely determined exactly when or by whom the switch was opened.

There is a long tangent approaching the switch, and it is believed that the engineman would have seen the red indication of a lighted switch lamp, had the switch stand been equipped with one, in time to have averted the accident. This was a main-track switch, although located within yard limits, and the practice of not equipping main-track switches with lamps, especially in territory
