## INTERSTATE COMMERCE COMMISSION

REPORT OF THE DIRECTOR OF THE BUREAU OF SAFETY IN  
RE INVESTIGATION OF AN ACCIDENT WHICH OCCURRED  
ON THE BALTIMORE & OHIO RAILROAD NEAR ALTAMONT,  
MD., ON MARCH 2, 1930.

March 24, 1930.

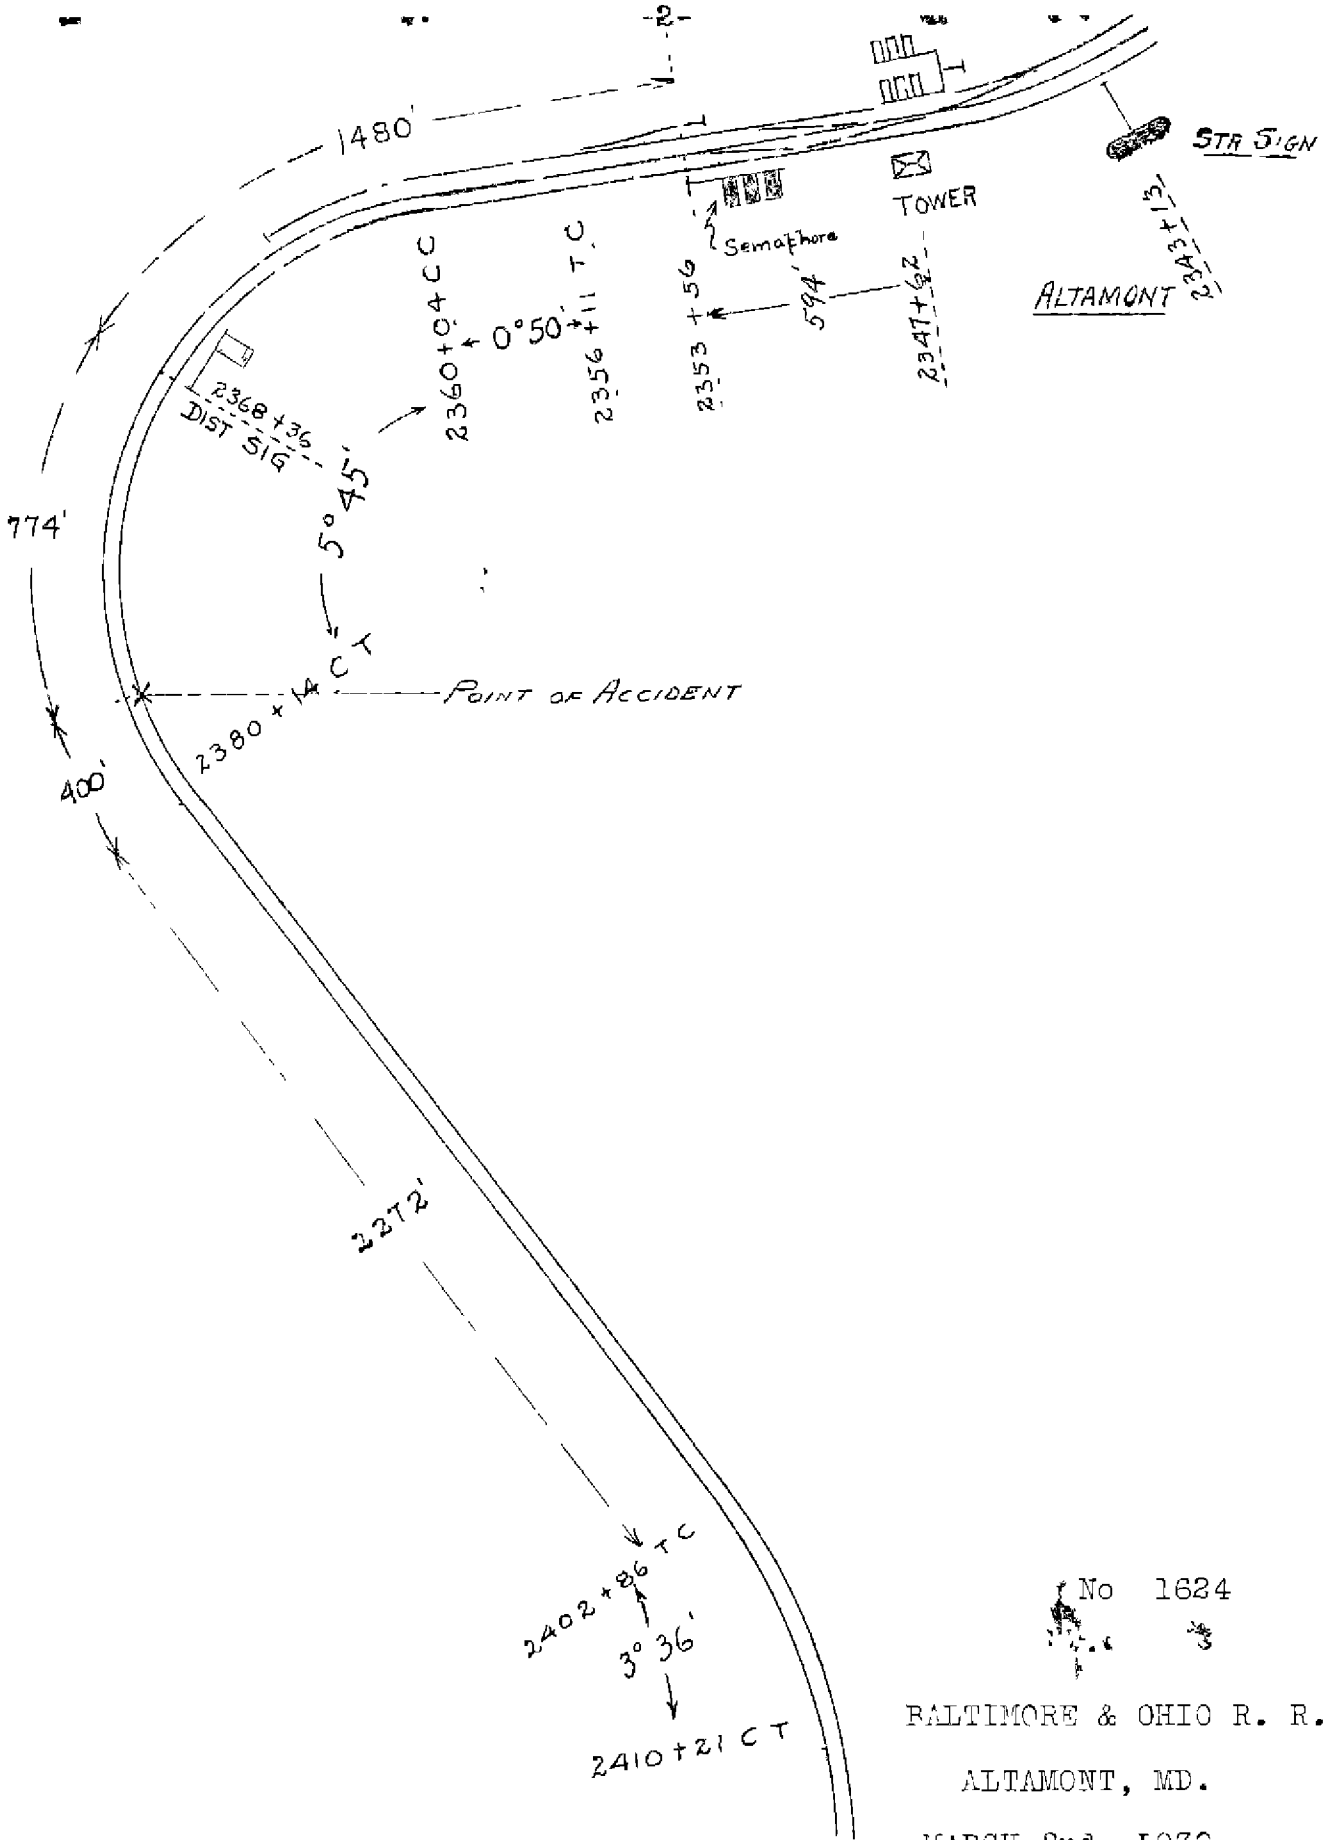
No 1624  
 BALTIMORE & OHIO R. R.  
 ALTAMONT, MD.  
 MARCH 2nd 1932.

The rear car in extra 7165 was derailed but remained upright, the caboose was overturned and destroyed by fire, and the helper engine was derailed and came to rest in an upright position, although its tender was overturned. Engine 4434, its tender, and the forward truck of the first car in the express train were also derailed, the engine coming to rest upright, the tender on its side, and the forward end of the first car mounted on the overturned tender. The employees injured were the engineman and fireman of helper engine 4407 and the fireman and flagman of extra 4434.
