INTERSTATE COMMERCE COMMISSION

REPORT OF THE DIRECTOR OF THE BUREAU OF SAFETY IN RE
INVESTIGATION OF AN ACCIDENT WHICH OCCURRED ON THE
BALTIMORE & OHIO RAILROAD AT BRUNSWICK, MD., ON
JANUARY 18, 1930.

March 29, 1930

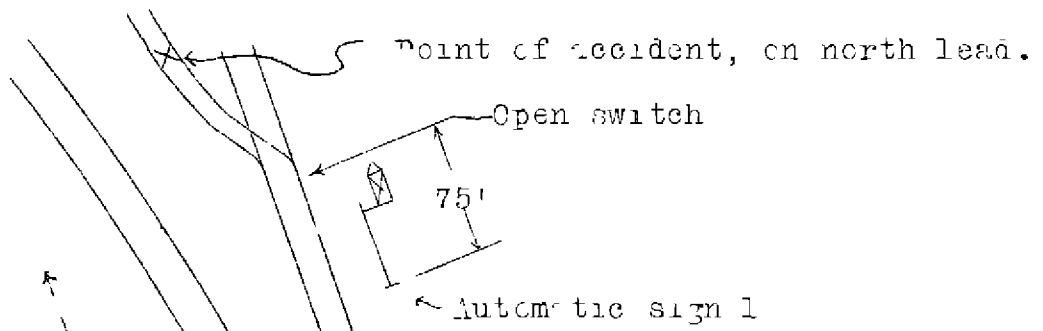
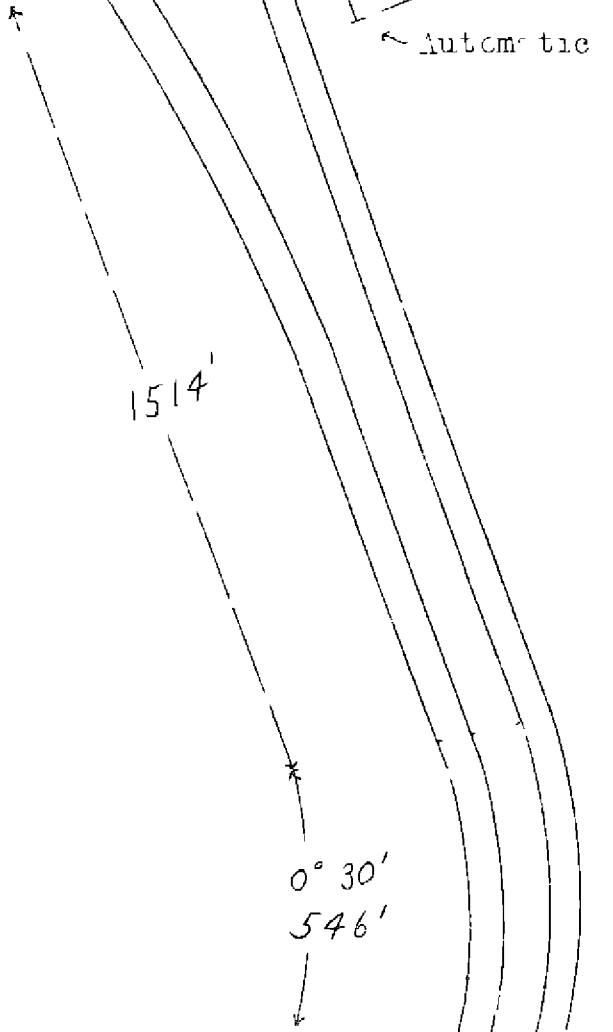
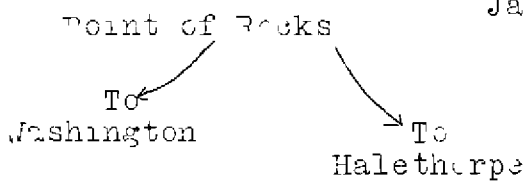
No. 1608
Baltimore & Ohio R.R.,
Brunswick, Md.
Jan. 18, 1930.

The only signal involved in this accident was an automatic block signal, of the three-position, upper-quadrant semaphore type, located 75 feet east of the switch at the entrance to the yard. The facing-point switch at the eastern entrance to Brunswick yard is equipped with a parallel ground-throw intermediate New Century switchstand, with an Anderson switch interlocker, and is pipe-connected to a Hayes derail, located on the north lead track near the clearance point thereof.

This accident was caused by an open switch, for which Conductor Baldwin, of extra 4601, was primarily responsible.
