INTERSTATE COMMERCE COMMISSION.

REPORT OF THE CHIEF OF THE DIVISION OF SAFETY COVERING THE INVESTIGATION OF AN ACCIDENT ON THE BALTIMORE & OHIO RAILROAD AT FELTON, PA., ON DECEMBER 17, 1915.

JANUARY 28, 1916.

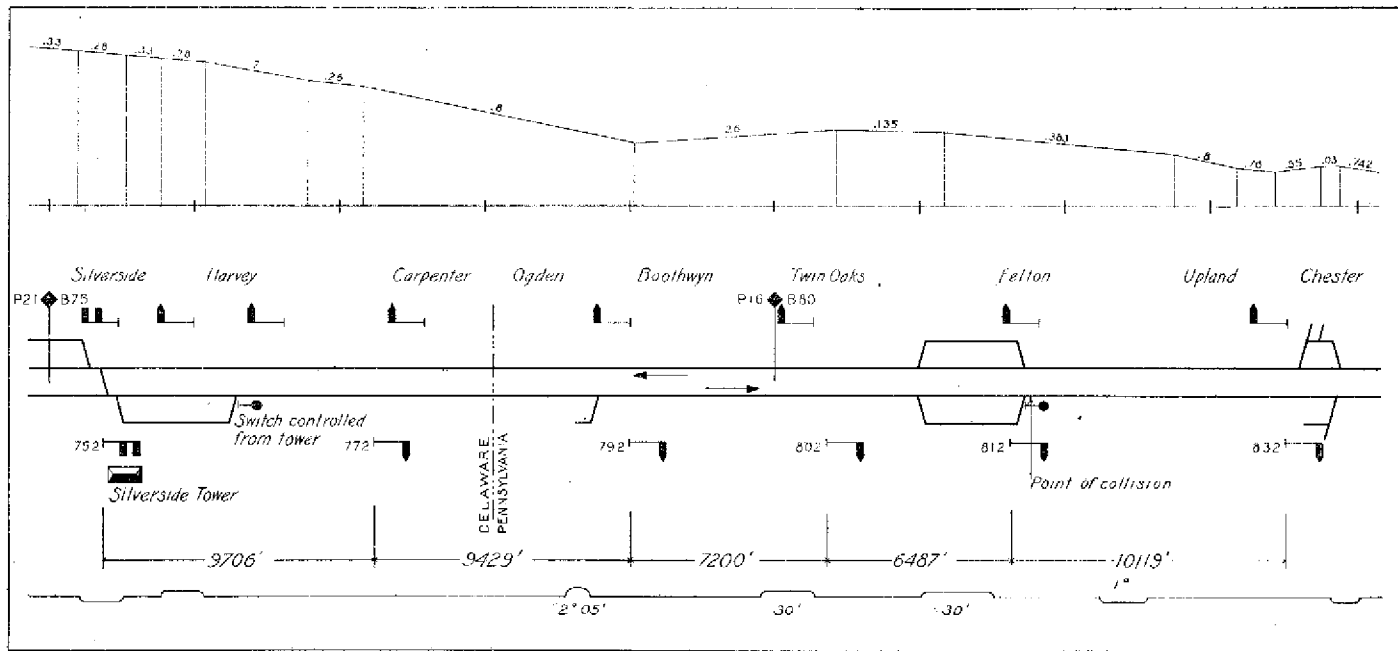
Block signal No. 812 at Felton is 545 feet in the rear of, or south of, the switch at the north end of the passing track, and signal No. 802, which gives the caution indication when the Felton signal is at stop, is at Twin Oaks, 6,487 feet farther south. The first signal north of Felton, No. 832, is located 10,119 feet from the Felton signal. The length of blocks in this vicinity varies considerably, but none is less than a mile long. The Felton signal is about 600 feet north of a curve, and the Twin Oaks signal is located at the north end of the curve; but as the curvature is only 30 minutes, a good view is had of both of these signals in ordinary weather.

Sketch showing profile and alignment of track between Silverside and Chester, with location of sidings, signals, and switch indicators.
