INTERSTATE COMMERCE COMMISSION

REPORT OF THE CHIEF OF THE BUREAU OF SAFETY COVERING INVESTIGATION OF AN ACCIDENT WHICH OCCURRED ON THE BALTIMORE & OHIO RAILROAD AT GLENWOOD, W VA, ON DE- CEMBER 11, 1919

JANUARY 14 1921

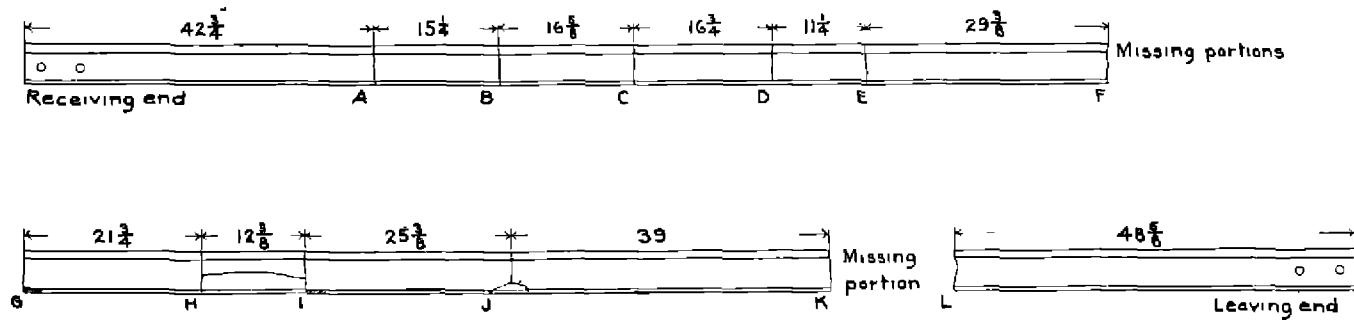
FIG 3—Diagram of broken rail Incipient cracks at fractures B C, I J, and K, top of head, near gauge side

Figure No 3 is a diagram showing fragments into which the rail was broken, some parts of the rail not having been recovered after the accident. The recovered fragments showed the several fractures had their origins at the upper surface of the head.

Five of the fractured surfaces exhibited dark colored areas, extending downward from the running surface of the head and located near the gauge side. Darkened areas were present at lines of rupture designated by the letters B, C, I, J, and K. Fracture C was incomplete at the time of derailment. An incipient fracture, at this place was completed after the rail had been removed from the track. Figure No 4 shows end views of three fractured surfaces on each of which dark areas were present.

These dark areas represent progressive cracks, the inception and extension of which led to the final failure of the rail and the derailment of the train.

Low rail of 3 degree curve Branded "Carnegie 1910 ET III 75 A" Heat number 1093
