INTERSTATE COMMERCE COMMISSION

REPORT OF THE DIRECTOR OF THE BUREAU OF SAFETY IN RE INVESTIGATION OF AN ACCIDENT WHICH OCCURRED ON THE BALTIMORE & OHIO RAILROAD AT KEARNEYSVILLE, W. VA., ON NOVEMBER 1, 1930.

November 18, 1930.

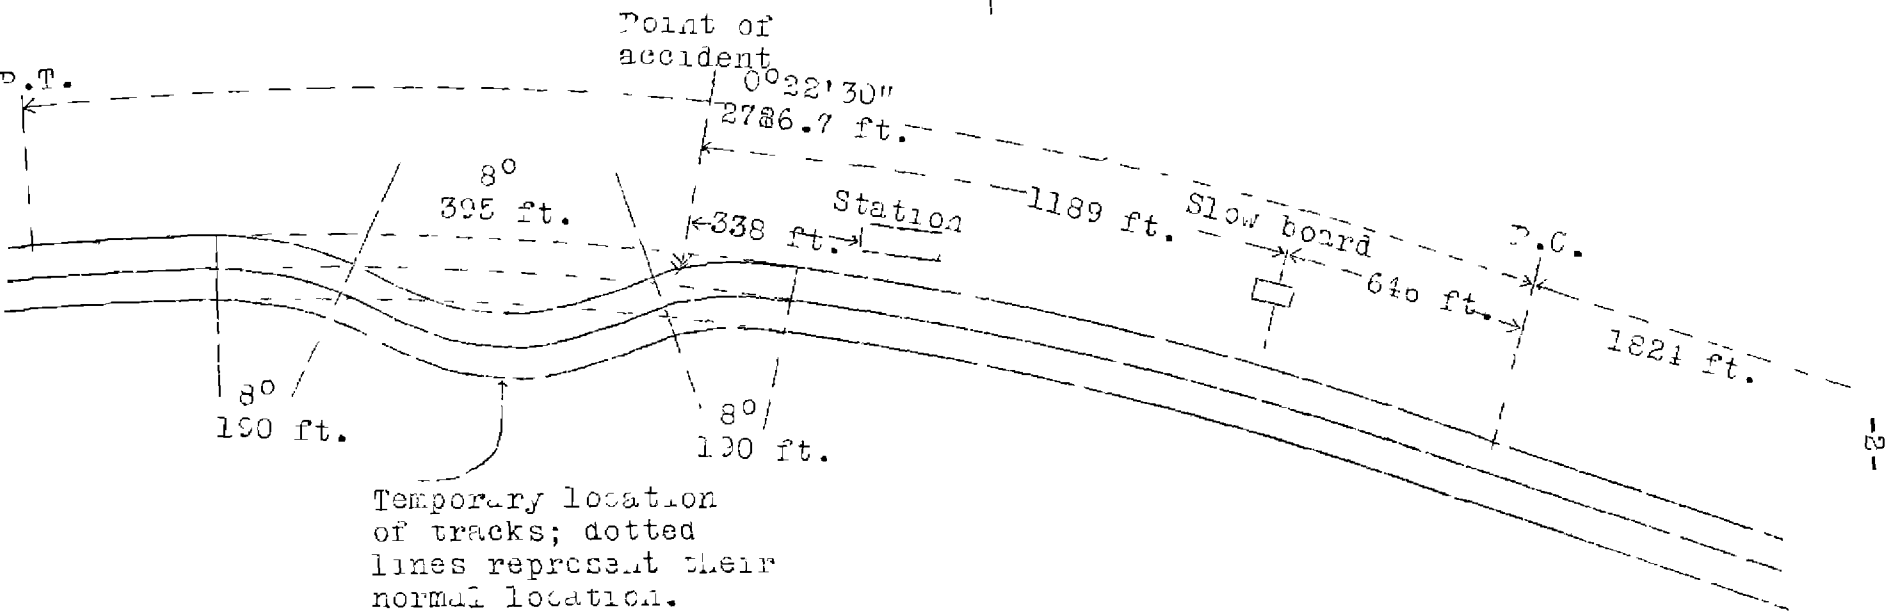
Env. No. 1675
Baltimore & Ohio Railroad
Kearneysville, W. Va.
November 1, 1930.

Temporary location of tracks; dotted lines represent their normal location.
