INTERSTATE COMMERCE COMMISSION.

**REPORT OF THE CHIEF OF THE BUREAU OF SAFETY COVERING
THE INVESTIGATION OF AN ACCIDENT WHICH OCCURRED ON
THE BALTIMORE & OHIO RAILROAD NEAR NORTH VERNON,
IND., ON DECEMBER 29, 1917.**

FEBRUARY 7, 1918

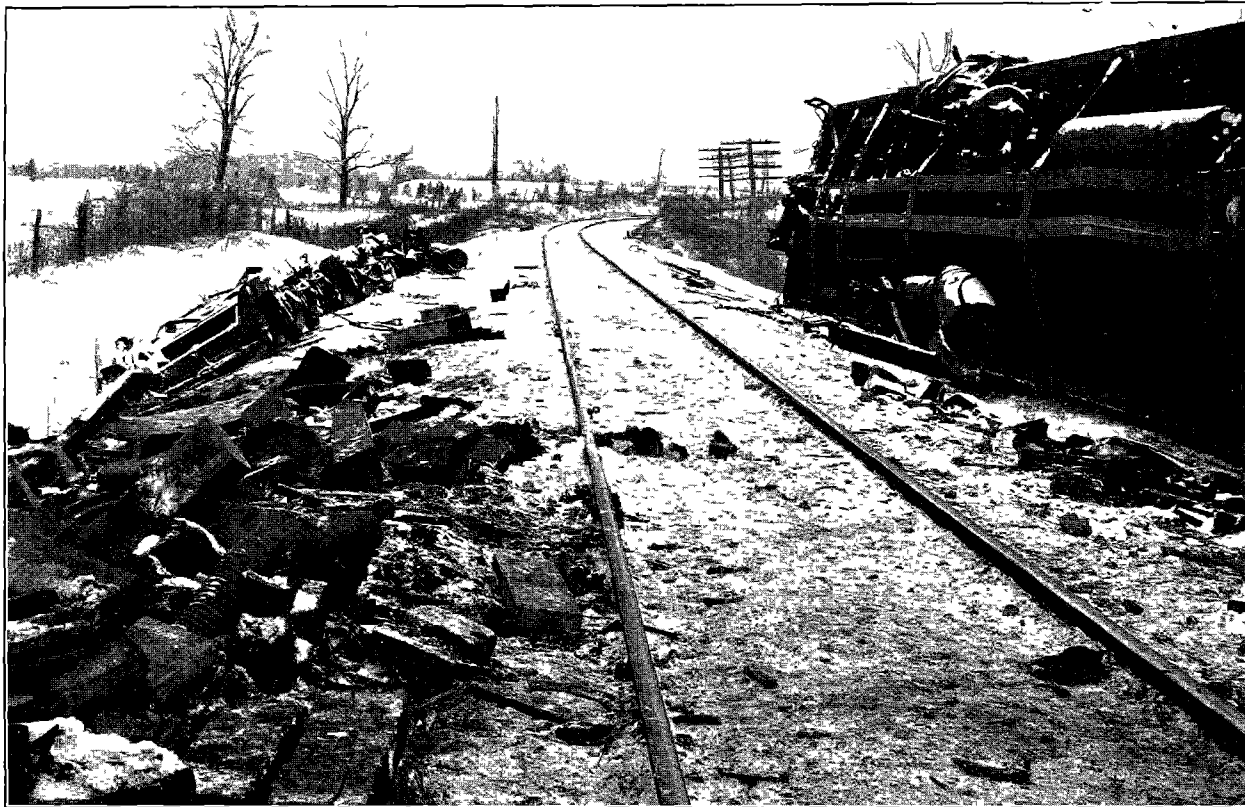
The accident occurred near the middle of a tangent 187 feet long connecting two curves. Beginning at the telegraph office at North Vernon and approaching this tangent from the west, the track is practically straight for 2,532 feet; there is then a 4-degree curve to the left 1,932 feet in length, including easement curves at each end; then a tangent 444 feet in length, and then a 2-degree curve to the left 783 feet in length, including easement curves at each end, the one on the east end reaching to the tangent on which the collision took place. Approaching the point of accident from the east beginning at a point about 1 mile therefrom, there is a 4-degree curve to the right 1,675 feet in length, including easements at each end; a compound curve to the left, 1,657 feet in length varying in curvature from 1 degree 9 minutes to 4 degrees; a tangent 1,127 feet in length, and then a 4-degree curve to the left 1,877 feet in length, including easement curves at each end, the one on the west end extending to the tangent on which the accident occurred. Approaching from both directions, the enginemen involved in this accident were on the outside of the curves described on each side of the point of accident, and when approximately 10 car lengths from the point of accident the westbound train came out of a deep cut which obstructed the view from the eastbound train. Illustration No 1 is a view eastward from the point of accident.

ILLUSTRATION NO 1—VIEW EASTWARD FROM POINT OF ACCIDENT

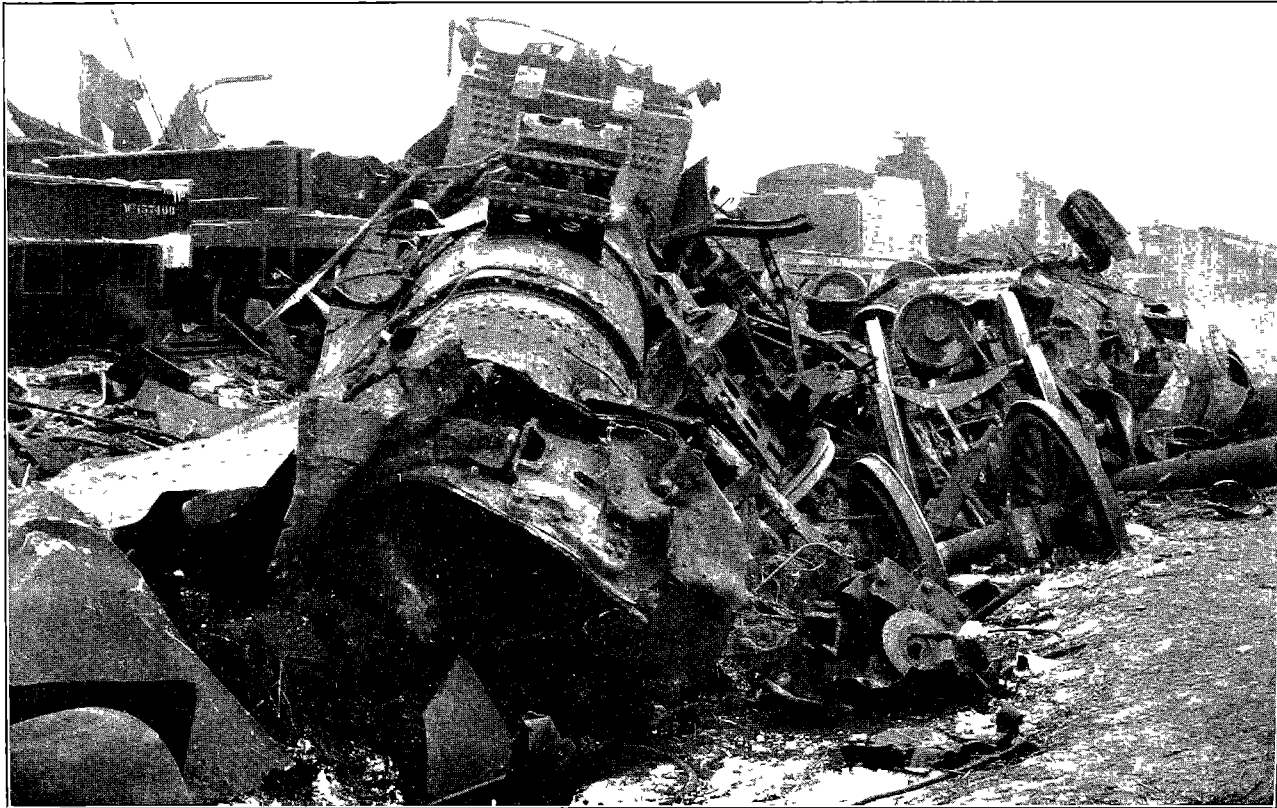
Both engines went off on the north side of the track, and were reversed in direction, they were entirely stripped of machinery, both boilers were torn loose and the frames and wheels were piled in a mass of wreckage. The tenders of both trains came to rest on the south side of the track, crushed between the mail car of train No 2 and the baggage car of train 2d No 23. Illustration No 2 is a view of the damaged locomotives. The baggage car of train 2d No. 23, which was an all-steel car, was telescoped by the tender for approximately a third of its length, but none of the other cars in this train was materially damaged and none of them was derailed. The combination mail and baggage car of train No 2, a steel car, was practically destroyed. The combination coach and baggage car, a wooden car with steel underframe, was telescoped under the all-steel mail car for approximately two-thirds of its length. The other cars in train No 2 were not seriously damaged and were not derailed. Illustration No 3 is a view of the wreckage on the south side of the track, while illustration No 4 shows a general view of the wreckage after the track had been cleared.

ILLUSTRATION NO 2—VIEW OF DAMAGED LOCOMOTIVES

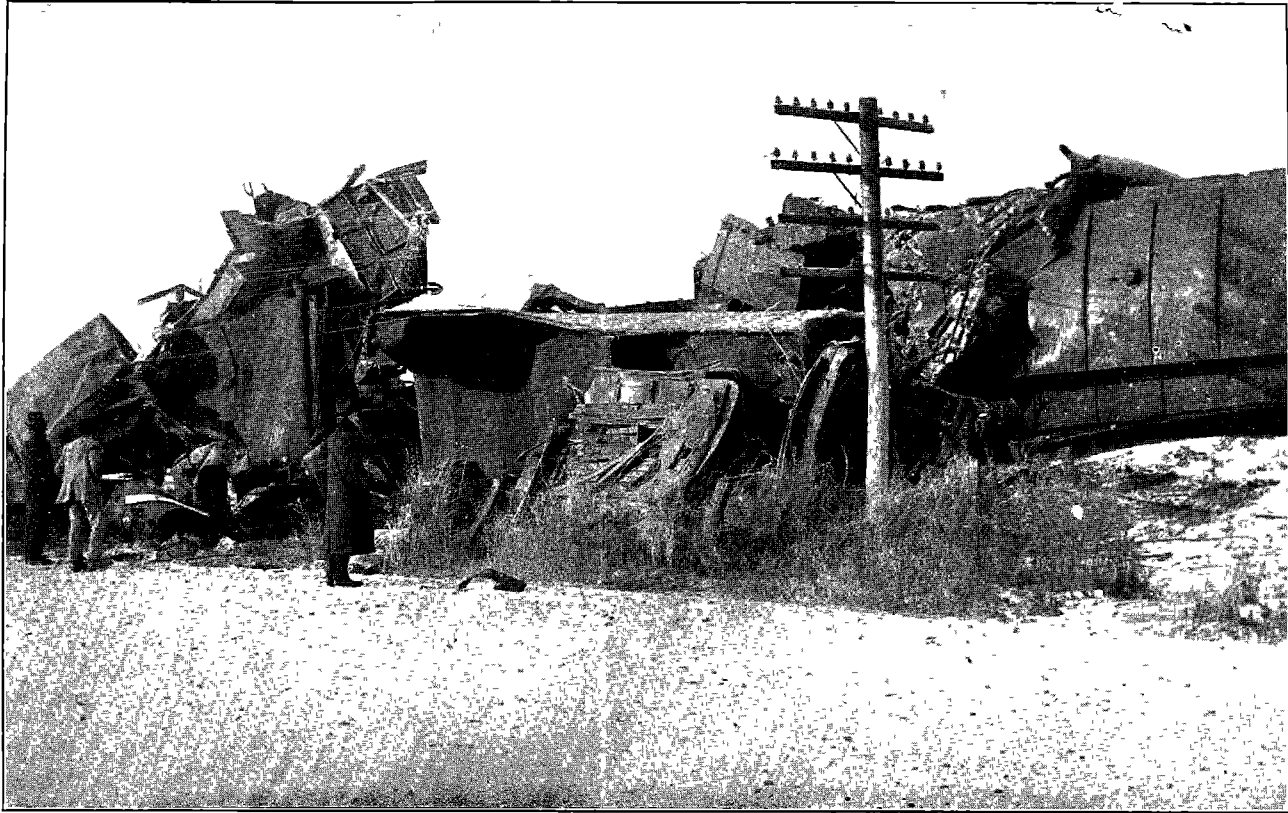
ILLUSTRATION NO 3—VIEW OF WRECKAGE ON SOUTH SIDE OF TRACK

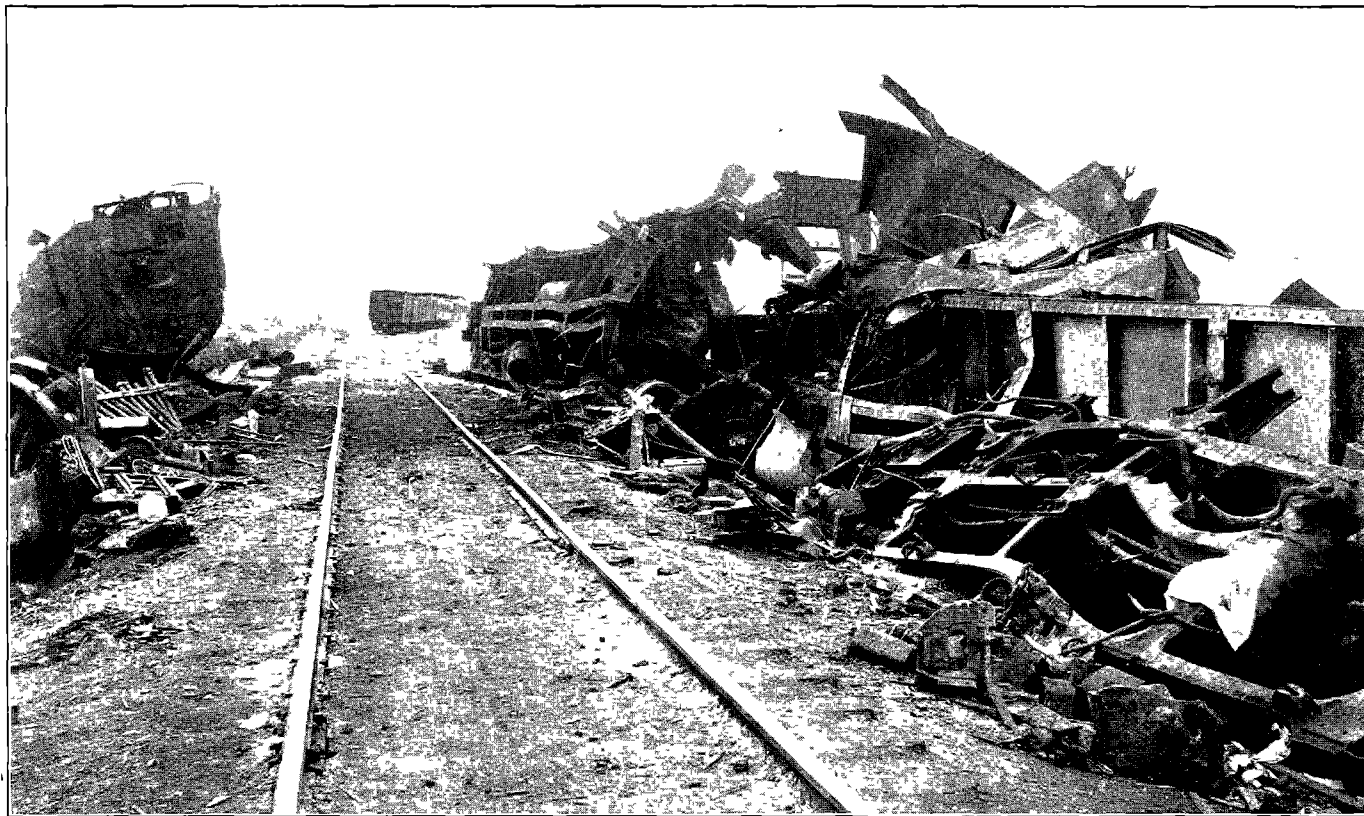
ILLUSTRATION NO 4—VIEW OF WRECKAGE AFTER TRACK WAS CLEARED
