INTERSTATE COMMERCE COMMISSION

REPORT OF THE CHIEF OF THE DIVISION OF SAFETY, COVERING THE INVESTIGATION OF AN ACCIDENT WHICH OCCURRED ON THE BALTIMORE & OHIO RAILROAD NEAR QUAKER CITY OHIO, ON FEBRUARY 20, 1917

AUGUST 20, 1917

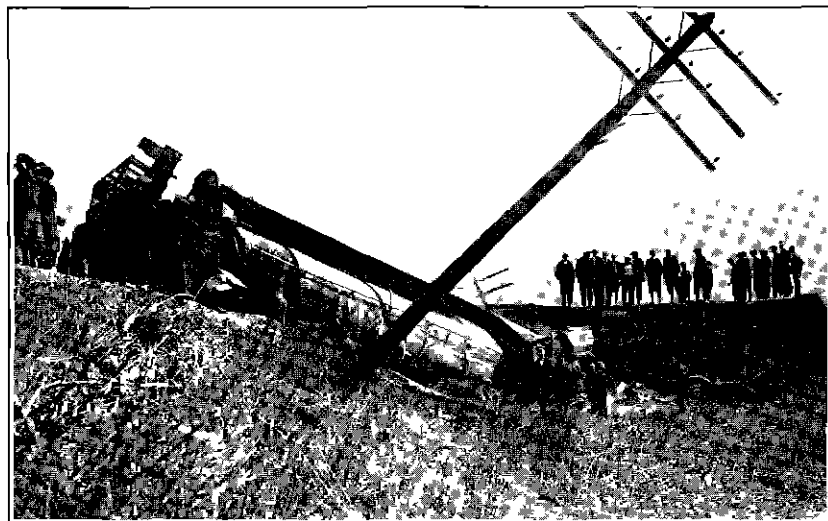
After derailment the engine ran on the roadbed about 100 feet, turned over to the south, and came to rest on its left side at an angle of about 45 degrees with the track, with its front end on the roadbed. The tender remained coupled to the engine and came to rest on its right side at right angles with the track, with the rear end farthest from the track. The combination mail and express car came to rest on its left side parallel with and about 50 feet from the track, the forward end being at the rear of the tender. The combination baggage car and coach remained on its trucks and came to rest with its front end about 45 feet from the track and against the preceding

A view of the derailed engine as it appeared from the foot of the embankment is shown by figure No. 1.

Figure No. 1 —View of derailed engine

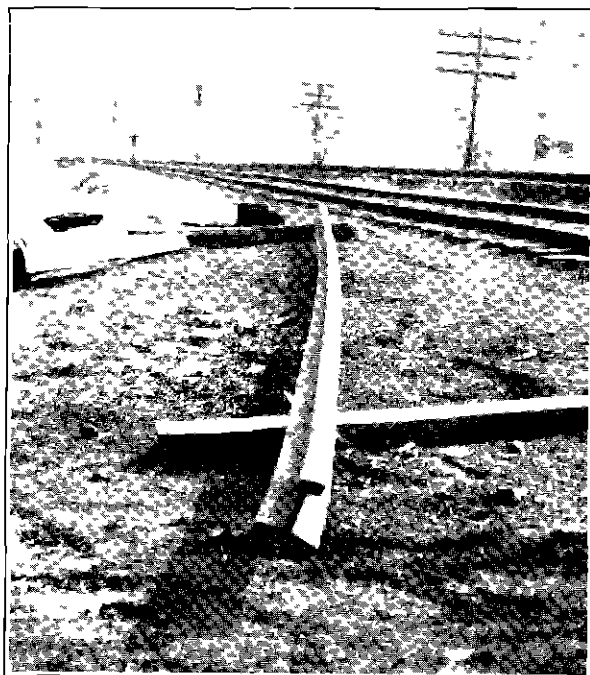
While the division engineer was of the opinion that the accident was caused by a broken rail, this investigation disclosed that the first marks of derailment were located on the third tie from the west or leaving end of a rail on the outside of the curve, which rail was the one preceding that which the division engineer mentioned as having developed a kink in the head, because of a defect in the web and having caused the derailment. The west end of the rail at the point of derailment was twisted outward at an angle of

about 30 degrees. Figure No. 2 shows a view of this rail the head of which was bent outward at the leaving end.

On account of the bad track conditions, low joints, loose spikes, sprung and badly flange-worn rails it is believed that the rails overturned by reason of there being insufficient security against flange pressures to prevent them doing so, and that the web fracture was a consequence of the derailment and not its cause. The second or westerly rail, in which this web fracture occurred, was an 80 pound Carnegie steel rail rolled in September, 1902 and laid in the track in the fall of that year. This rail was submitted for examination to Mr. James E. Howard, engineer-physicist, whose report upon it accompanied by data upon some additional rail sections follows.

Figure No. 2 —View of outer rail on curve. Head at end bent outward and rail twisted about 30 degrees

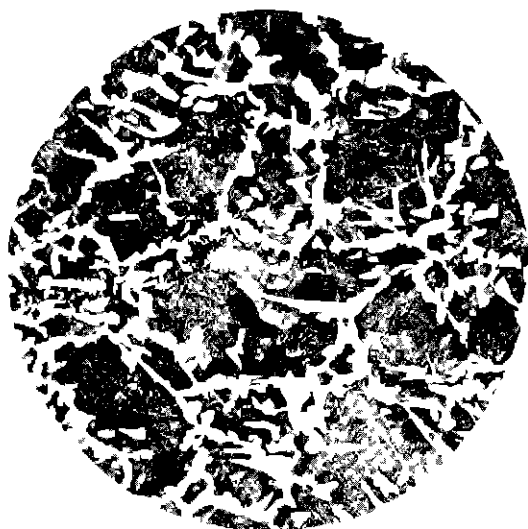
Photomicrographs were taken of the structure at different parts of the rail. Figure No. 4 shows the average structure, in cross section at the center of the head at a magnification of 100 diameters. Figure No. 5 represents the flattened grains of the metal next the running surface of the head the result of flow under the cold rolling action of the wheel pressures, under the same magnification as above stated and also shown in cross section. Impaired ductility under tensile stresses is characteristic of the metal thus affected. Early observations have shown a restoration in ductility is accomplished by annealing the steel. A restoration in the shape of the grains also attend exposure to annealing temperatures.

Figure No. 4 — Microstructure of rail shown in Figure No. 3 at center of head. Cross section magnification 100 diameters

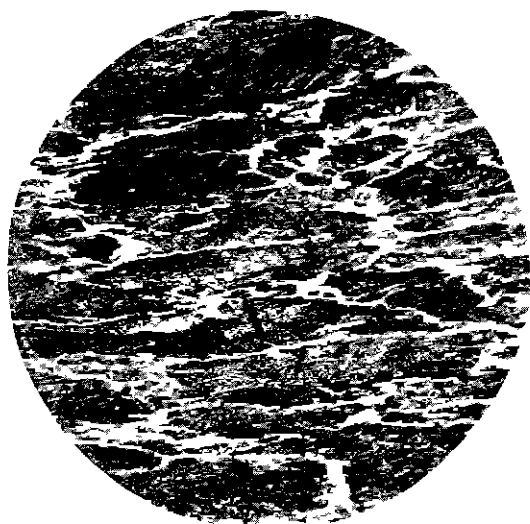
Figure No. 5 — Microstructure of rail shown in Figure No. 3, next running surface of head, showing flattening of the grains. Cross section magnification 100 diameters

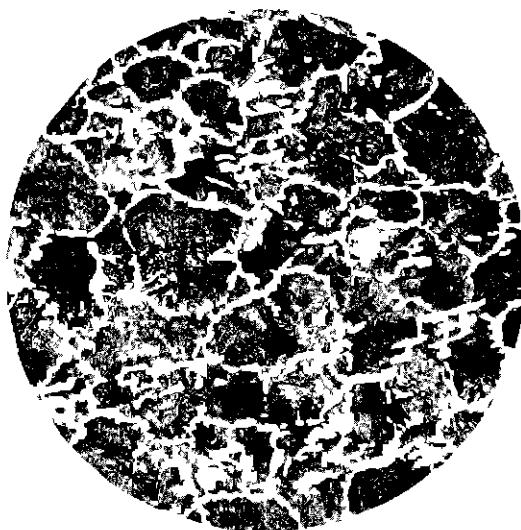
Figures Nos. 7 and 8 show the microstructure of the flanges of the present rail in longitudinal section. The internal strains in the flange represented by figure No. 7 were of compression, equivalent to a stress of 14,100 pounds per square inch, while those in the flange represented by figure No. 8 were of tension equivalent to 3,300 pounds per square inch. The determination of the presence of internal strains, their direction and magnitude, appears to be restricted to the method of strain gage measurements.

Figure No. 7 - Microstructure of rail shown on Figure No. 3. Longitudinal section of flange which was in a state of initial compression of 14 100 pounds per square inch. Magnification 100 diameters.

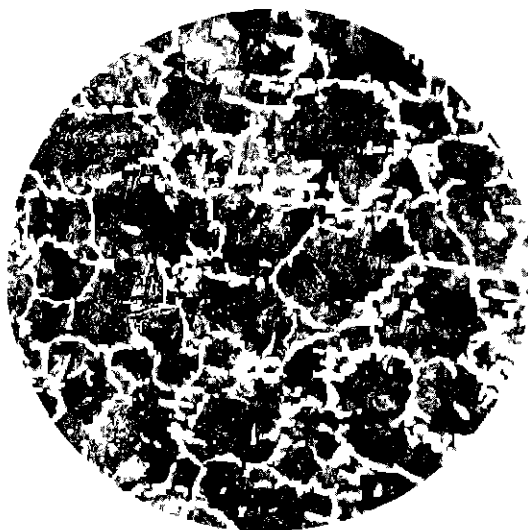
Figure No. 8 - Microstructure of rail shown on Figure No. 3. Longitudinal section of flange which was in a state of initial tension of 3 300 pounds per square inch. Magnification 100 diameters.

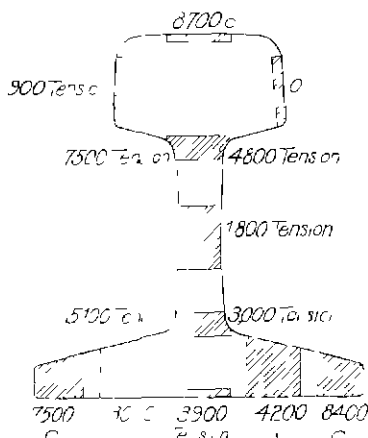
Figure No. 9 shows the stresses in a 100-pound rail, A. R. A. B. type, after accelerated cooling. The metal at the top of the head and in the flanges of the base was in a state of internal compression. There is a progressive change in the strains from the edges of the flanges to the middle of the base where they are commonly reversed and become strains of tension. Local strains of considerable intensity in tension are not uncommon at the junction of the web with both the head and the base, as illustrated in this rail.

FIGURE No. 9.—Cross section of new 100 pound rail. Internal stresses after cold rolling with an blast

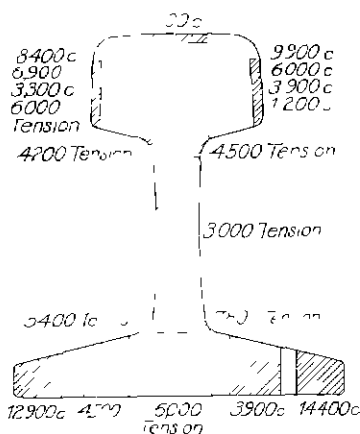
Figure No. 10 shows the stresses present in a rail of the same weight and type as above after accelerated cooling by means of an air blast. The results show most marked differences at the edges of the flanges. In the strips taken from the sides of the head there was a gradual reduction of the compressive stresses from the upper toward the lower edges, on one side of the head even reversing to a state of tension. Four gauged lengths were established on each of these strips at different distances from the plane of the neutral axis, furnishing the several values of the internal stresses here recorded.

FIGURE No. 10.—Cross section of new 100 pound rail. Internal stresses after cold rolling with an blast

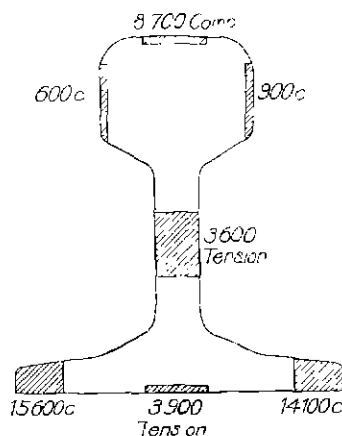
Figure No. 11 shows the internal stresses in a rail of 92.7 pounds weight per yard. This section was cooled at a normal rate in the air. The higher values of the compressive stresses in the flanges over the preceding section of corresponding treatment will be noted, a characteristic difference between thick and thin flanged rails.

FIGURE NO. 11—Cross section of a new 92.7 pound rail. Internal stresses after normal cooling in air.

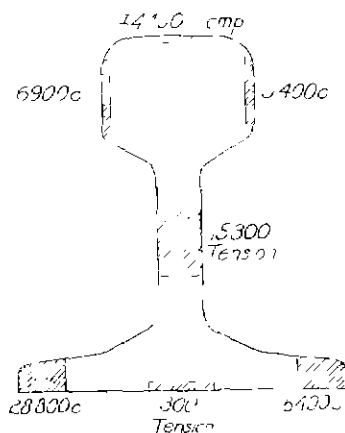
Figure No. 12 shows the state of internal stresses in the companion rail of No. 11 after accelerated cooling with an air blast. The stresses in this section are the highest that have yet been measured in air-cooled rails. The total range from tension to compression reached 59,400 pounds per square inch. The magnitude of these internal strains will be realized when compared with stresses usual in permanent engineering structures where the values commonly

FIGURE NO. 12—Cross section of a new 92.7 pound rail. Internal stresses after accelerated cooling with air blast.

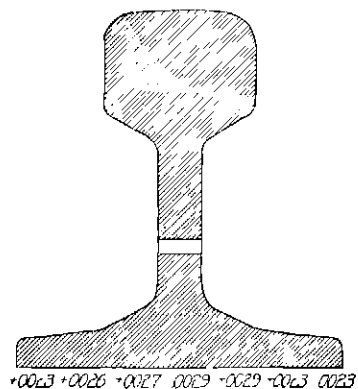
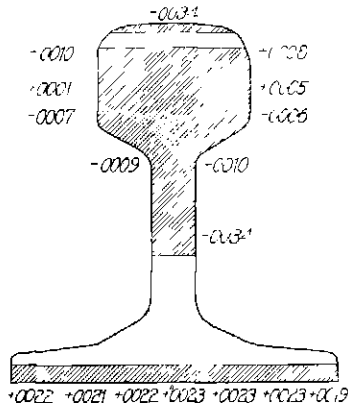
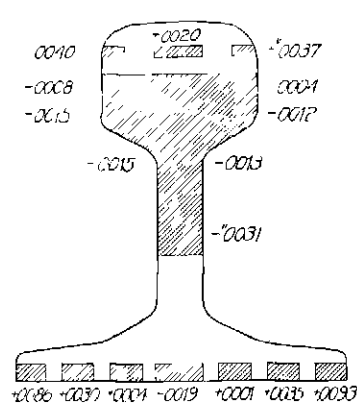
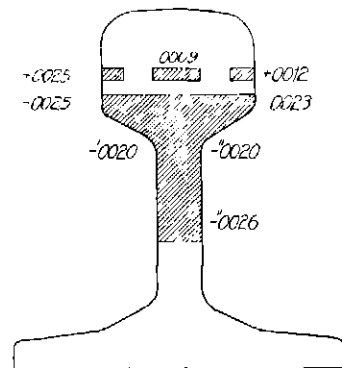
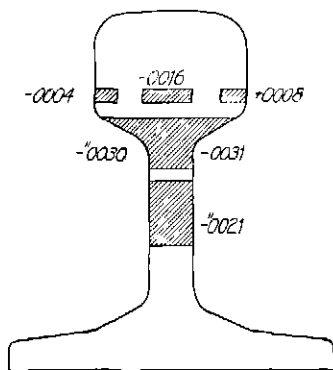
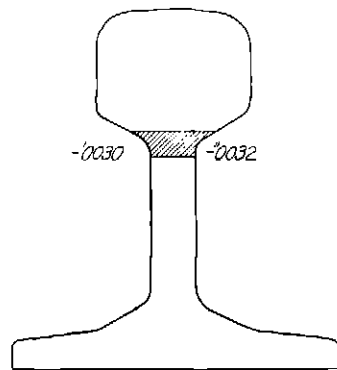
Diagram No. 14 shows the results of the examination of a companion rail of the same weight as before, after accelerated cooling, accomplished by means of an air blast directed upon the head. The cooling was done immediately after the last pass in the rail mill. The manner of dissection was nearly the same as in the previous example, measurements being taken at each stage. Accelerated cooling caused the introduction of higher strains throughout the cross section than witnessed in the section of normal rate of cooling. The

Diagram No. 14 —Cross section of a new 92.7 pound rail. Internal strains and stresses after accelerated cooling with air blast on head of rail was dissevered, with stresses corresponding to total strains released.

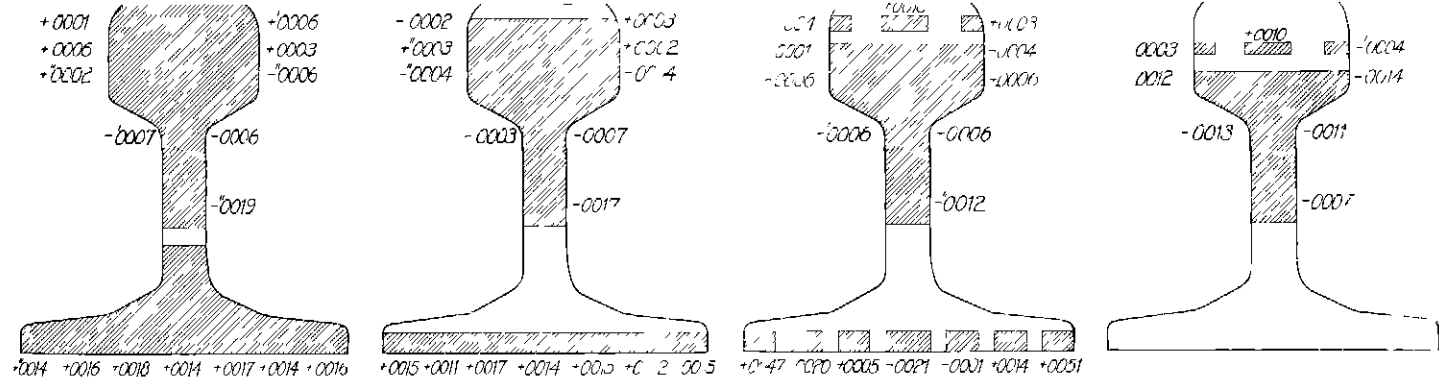
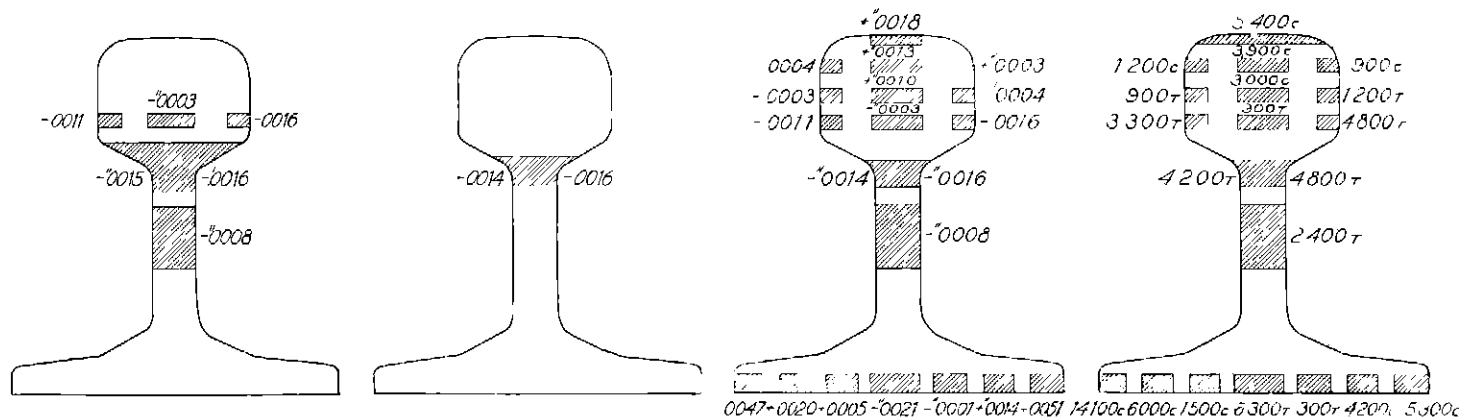
Diagram No. 13 shows the successive stages passed through by a rail of 92.7 pounds weight which cooled normally. The first machine cut which was made detached the head and the upper part of the web from the base. A general expansion occurred on each reference length on the underside of the base. In the upper portion of the rail the top of the head expanded while the web contracted in length. The readjustments which subsequently took place as the machine cuts were made for detaching the strips may be followed on the diagram. The shaded areas represent the state of the rail at each stage of its dissection. The final results showed the rail to have been in an initial state of compression at the top of the head and immediate vicinity. The flanges were also in a state of compression but merging into tension at the middle of the base. The sides and the lower part of the interior of the head was in tension and likewise the metal of the web at the middle of its depth and at its junction with the head. The results on this rail are fairly representative of the strains which are present in new rails of similar dimensions.

Diagram No. 13 —Cross section of a new 92.7 pound rail. Internal stresses and strains after normal cooling in air. Strains progressively displayed as section of rail was disassembled. Vertical stresses corresponding to total strains released.
