# INTERSTATE COMMERCE COMMISSION

## REPORT OF THE CHIEF OF THE BUREAU OF SAFETY COVERING INVESTIGATION OF AN ACCIDENT WHICH OCCURRED ON THE BALTIMORE & OHIO RAILROAD NEAR WOLF LAKE YARD OFFICE, SOUTH CHICAGO, ILL., ON JUNE 14, 1920

JULY 20, 1920

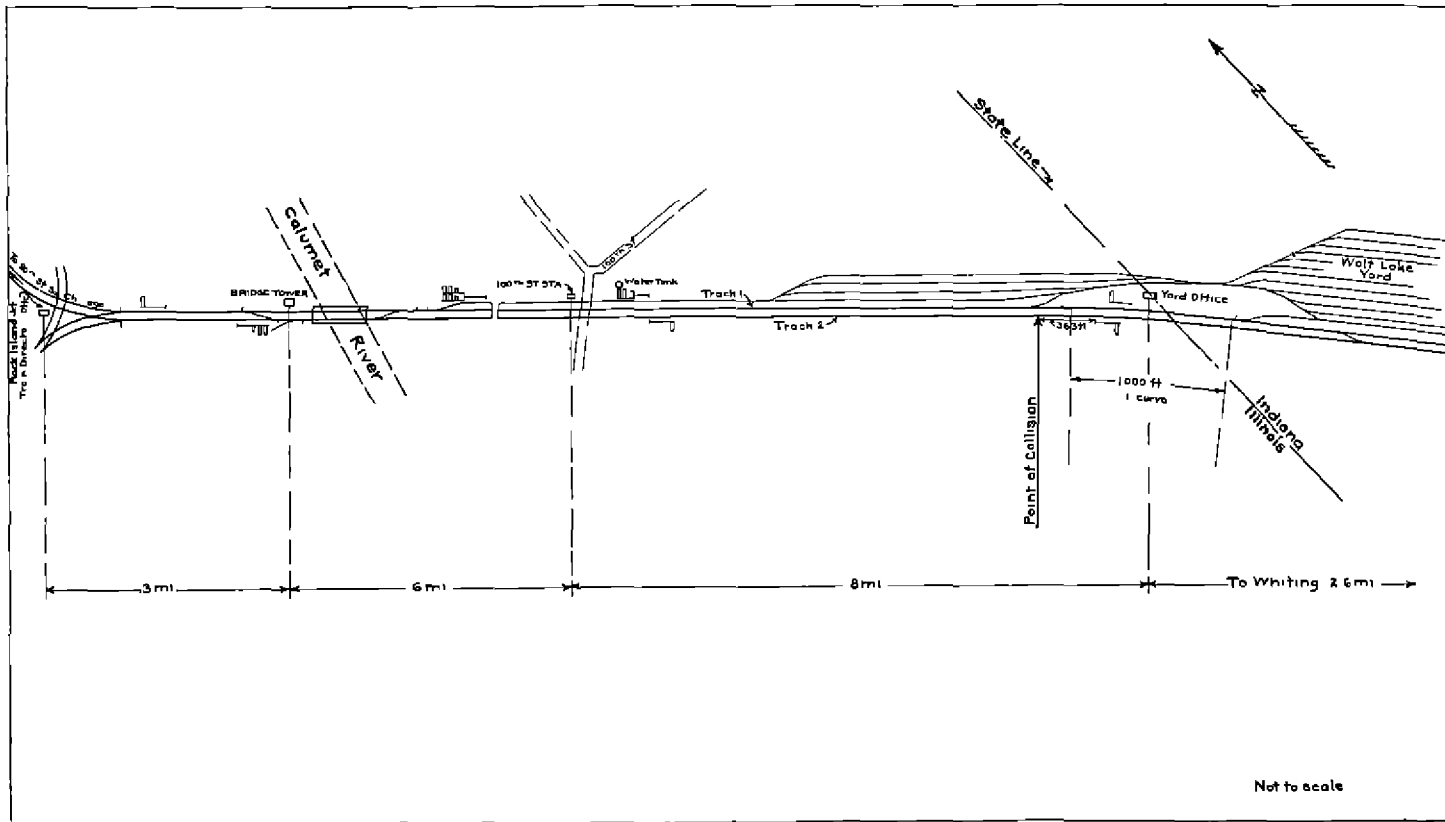
FIG 1—Diagram showing track layout in vicinity of point of accident.

approaching this signal the engineman applied the brakes. The employees on the engine saw the passenger train approaching but did not know that it was on the eastbound track until it came around the curve and was only a short distance away. The engineman then applied the brakes in emergency, and all of them jumped off the engine before the trains collided. The point of accident was 363 feet west of the block signal.
