REPORT OF THE DIRECTOR OF THE BUREAU OF SAFETY IN RE
INVESTIGATION OF AN ACCIDENT WHICH OCCURRED ON THE
BALTIMORE & OHIO RAILROAD AT WILSMERE, DEL., ON
AUGUST 11, 1929.

November 22, 1929.

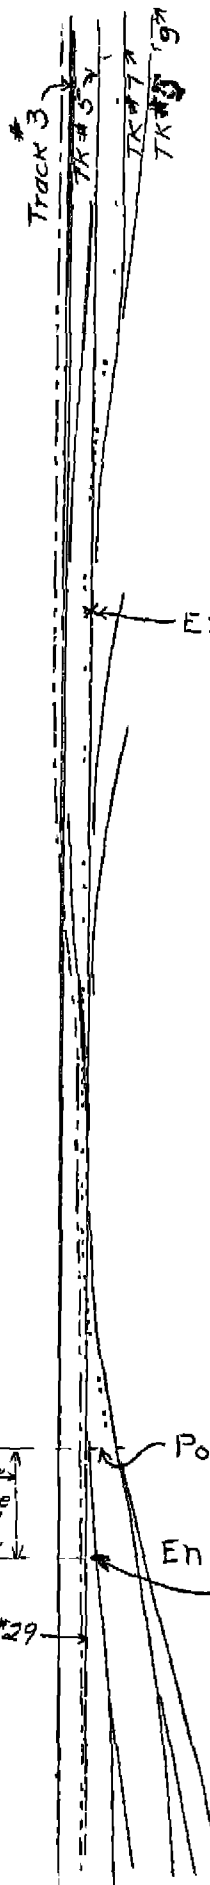
No 1582
Baltimore & Ohio R R
Wilmere, Del.
Aug. 11, 1929.

..... Indicates Movement
of Engine #4623

- - - - - Indicates Movement
of Engine #1039

← Engine #4623 Moving Backwards

1 1/2 Car lengths - 23'
between Clearance
Point & West End
of Cars Handled by
Engine #1039

← Point of Accident

← End of Cars Handled by
Engine #1039

The leading car struck the engine on its left side at the gangway between the engine and tender, crushing the side of the engine cab. The forward truck of the leading car was derailed and the car damaged to some extent. The employee killed was the fireman of the light engine.
