INTERSTATE COMMERCE COMMISSION

REPORT OF THE CHIEF OF THE DIVISION OF SAFETY COVERING THE INVESTIGATION OF AN ACCIDENT ON THE BALTIMORE & OHIO SOUTHWESTERN RAILROAD AT ORIENT, OHIO, ON AU- GUST 12, 1915

OCTOBER 12, 1915

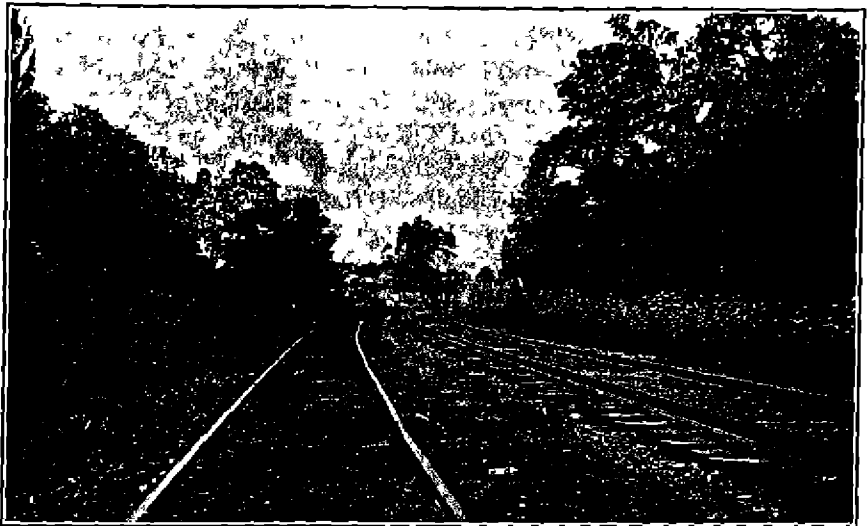
Beginning at a point about 0.7 of a mile east of Orient station and proceeding westward the track is tangent for about 850 feet. This is followed by a 2° curve to the right 2,700 feet in length, followed in turn by a $1^\circ 14'$ curve to the right 1,200 feet in length. It was 2,300 feet west of the east end of the first mentioned curve that the accident occurred. A view of about 750 feet may be ob

tained from the engine of an approaching west bound train At this point there is a grade of 0.5 per cent descending westward Illustration No 3 shows the view approaching the point of accident from the east

No 3—View approaching point of accident from the east
