INTERSTATE COMMERCE COMMISSION

REPORT OF THE DIRECTOR OF THE BUREAU OF SAFETY IN RE INVESTIGATION OF AN ACCIDENT WHICH OCCURRED ON THE BOSTON & MAINE RAILROAD AT BALLOCH, N H, ON FEBRUARY 13, 1928

JUNE 22, 1928

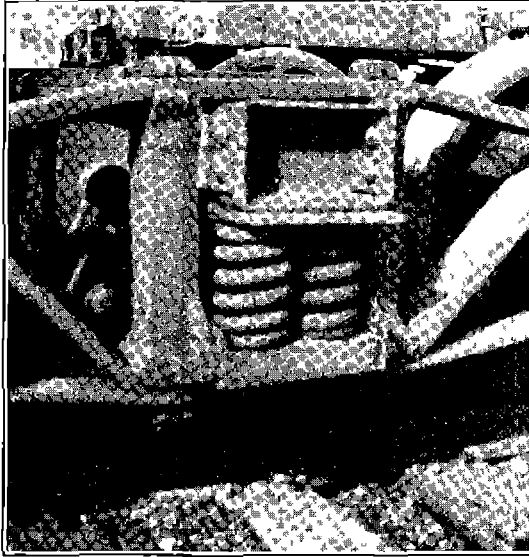
Figure 1 is a partial view of the type of arch-bar frame which fractured. It consisted of an upper and a lower arch bar, a tie strap, two column castings, and through bolts.

FIG 1—Partial view of arch bar frame in forward truck of derailed car

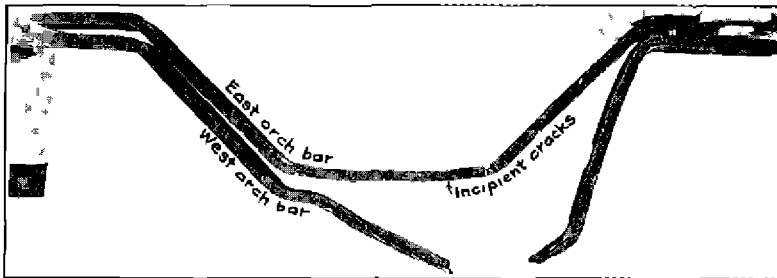
Figure 2 shows side views of the two lower arch bars of the rear truck, the shape of the west arch bar after fracture, and the location of incipient cracks in the east arch bar.

FIG 2—Lower arch bars from rear truck of derailed car. Arch bar from west frame fractured. Incipient cracks in arch bar from opposite side of truck. Bars made of wrought iron.

The points of origins of the incipient cracks in the east arch bar will be noted. They also were located directly under the rear edge of the spring plank. They extended from the under edges of the bar obliquely toward the bolt hole of the column casting. These cracks were in process of extension when the accident occurred. A

derailment from the rupture of the east arch bar of this truck was in prospect

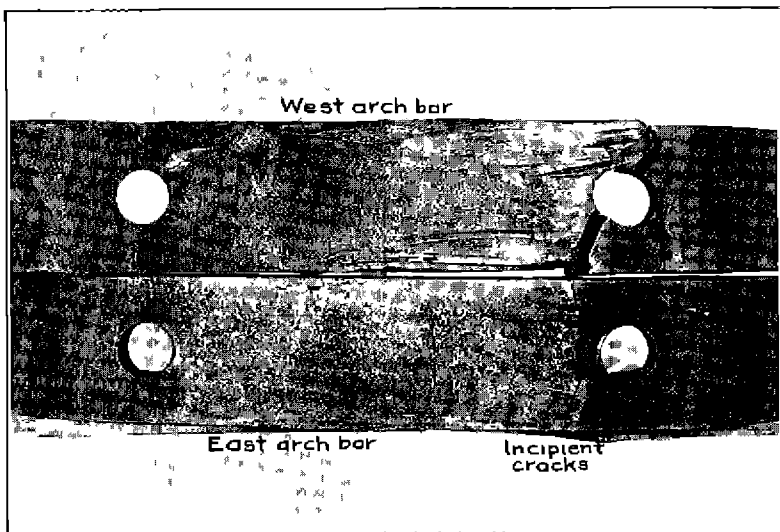
Figure 3 is a detailed view of each arch bar, from their under sides, comprising sections which include the bolt holes of the column castings. The fracture of the west arch bar originated at its inner lower corner, directly below the rear edge of the spring plank. It extended thence in an oblique direction to the bolt hole of the column casting, completing the rupture of the bar by the fracture of the

section between the bolt hole and the outer edge of the bar. The presence of the column casting bolt hole offered a path for the extension of the line of rupture, but was not primarily a vital factor in originating the fracture.

The seats of the spring plank and column castings of the fractured truck were much worn. At each edge of the spring plank seat of the east arch bar the metal was worn to a depth of a sixteenth of an

FIG. 3.—View of fracture of west arch bar and incipient cracks in east arch bar

inch. Under the middle of the width of the plank there was no loss of metal by abrasion. The arch bar itself was bent concave, in downward direction, clearing the plank at the middle of its width. The seats of the column castings were worn to a depth of an eighth of an inch. Similar conditions were displayed by the fractured bar.

Prior to the accident fractures were in progress in each of the lower arch bars of the rear truck of this coal car. Their origins were at the lower corners of the bars. Each lower corner of the east bar had an incipient crack. The fracture of the west bar started at the lower inner corner.

They were progressive fractures of unknown date of inception, and difficult of detection in the truck frame under service conditions. It is recognized that this type of truck frame is being superseded by others of unit or different construction. Nevertheless a large number of arch bar frames are still in current service. The manner of failure of this bar shows where attention should center in the inspection of trucks of this type.

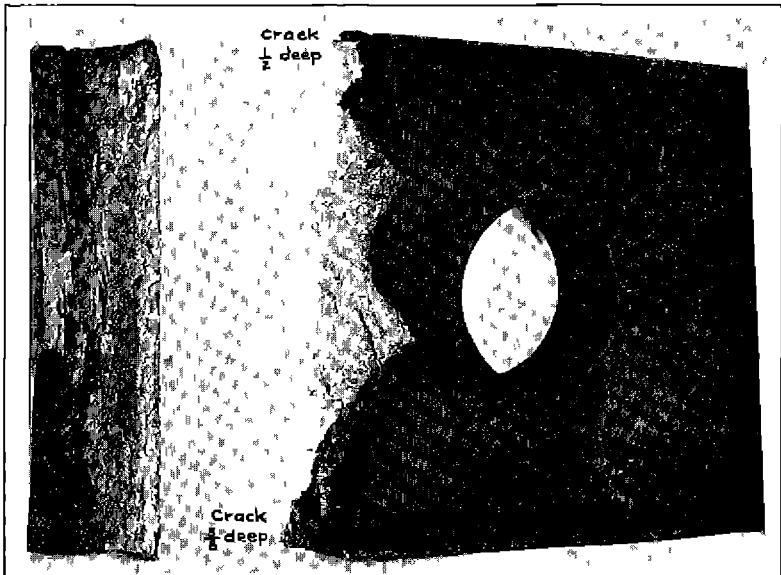
Figure 5 illustrates the appearance of the east arch bar after fracture by bending test. The incipient cracks shown on Figure 3

FIG 5.—Fractured surface of east arch bar under bending test. Dark colored parts of fracture represent incipient cracks which were formed in the bar during its period in service.

are here shown as the edges of the dark-colored areas on the fractured ends of the bar. In this cut the bar is viewed from the underside. Fractures began at each of the lower corners, and extended progressively upward and obliquely toward the bolt hole.

The metal of the bar beyond the incipient cracks retained its toughness, a feature to be borne in mind, which distinguishes wrought or puddled iron from the behavior of carbon steels of any grade. This peculiarity of retention of toughness, notwithstanding the presence of an incipient crack, gives special value to wrought iron in many situations. Other features of value will be mentioned.

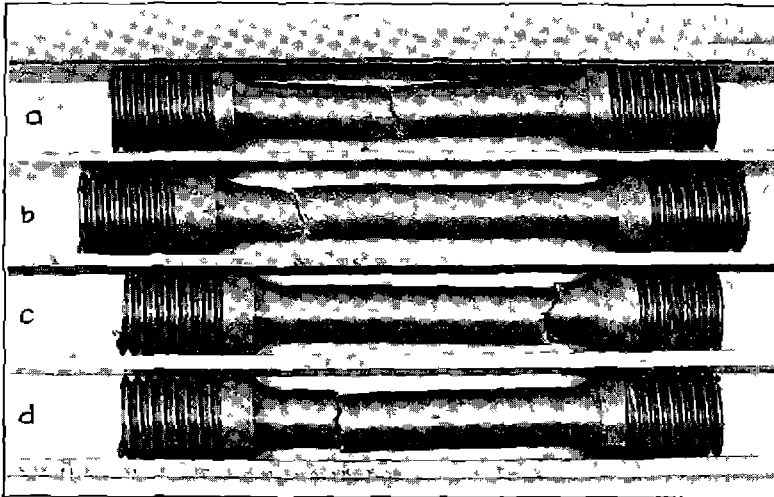
FIG. 6—Fractured tensile specimens from east and west arch bars, natural state of the metal

a, east arch bar longitudinal specimen, b, west arch bar longitudinal specimen, c, east arch bar crosswise specimen, d, west arch bar crosswise specimen

the natural state of the metal, that is, the test pieces were taken from the ends of the arch bars and tested without treatment of any kind. One specimen from each bar was tested in longitudinal direction, and one from each in crosswise direction. It is well known that the strength of wrought iron is greater in lengthwise

These tests show the metal of which the arch bars were made to have been of inferior grade, unsuitable for the important place which they occupied. Responsibility for the accident presumptively attaches to the use of a poor grade of wrought iron in these arch bars.

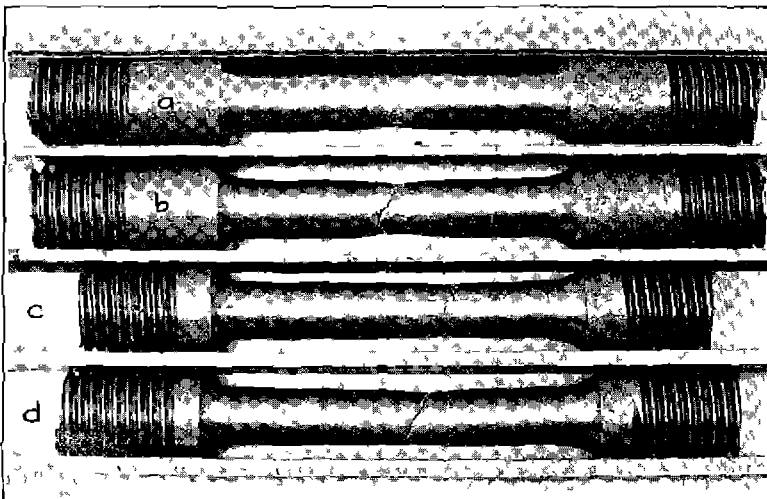
FIG. 7—Fractured tensile specimens from east and west arch bars after treatment

a, east arch bar longitudinal specimen, cold swaged, b, west arch bar longitudinal specimen, cold swaged, c, east arch bar, longitudinal specimen, heated to 1,400° F and quenched in water, d, west arch bar longitudinal specimen, heated to 1,400° F and quenched in water

Figure 7 illustrates the appearance of test pieces from each arch bar after special treatment of the metal. A longitudinal specimen from each bar was cold swaged. The metal was extended under the hammer 20 per cent, after which the tensile specimens were prepared. A longitudinal specimen from each bar was quenched in water from a temperature of 1,400° F.

The gain in tensile strength of the swaged specimens will be noted. Swaging and cold rolling have the same effect in kind on the tensile strength of the iron. General elongation was practically destroyed, but contraction of area not apparently disturbed.

Quenching from a high temperature had a profound effect on the tensile strength of the iron. Each of the four features of the tests showed substantial gains. Unlike carbides of iron, no hardening or embrittlement of the metal attended sudden quenching.

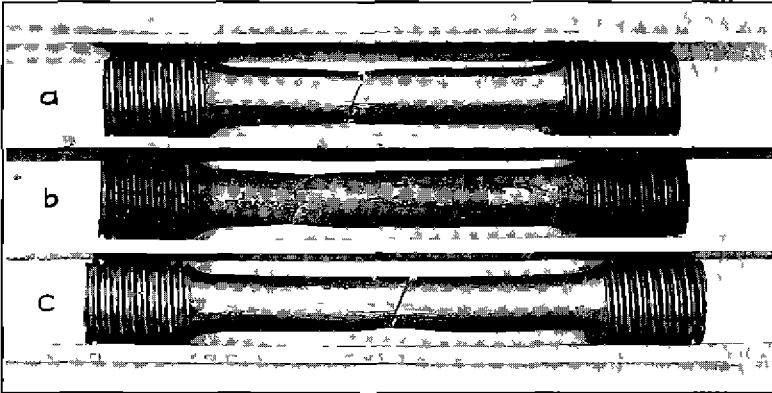
Figure 8 shows the appearance of tensile specimens after fracture, which were taken from this bar of wrought iron, originally tested in 1882. Figure 8 *a* represents the test piece in the natural state of the iron, figures 8 *b* and 8 *c* after the metal had been annealed at 900° and 1,400° F, respectively.

It will be seen that annealing at 900° F lowered the tensile strength which it had acquired by overstraining, in amount nearly 12,000 pounds per square inch and exposure to the higher annealing temperature of 1400° F lowered it another 12,000 pounds per square inch, the latter value being below the primitive test. Finishing

FIG. 8—Specimens from bar of double refined wrought iron. Original test made in 1882.

a, tested in natural state after 46 years rest; b, annealed at 900° F; c, annealed at 1400° F.

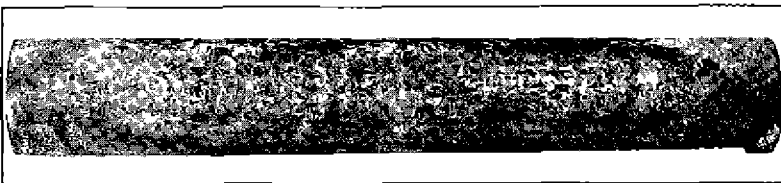
FIG. 9—From bar of double refined wrought iron tested in 1882. Strain gauge measurements made after different treatments.

Figure 9 represents a section 12 inches long, 1.85 inches diameter, from the bar of double-refined iron, from which this and the several test pieces were taken. Strain gauge measurements were made on this section, three gauged lengths 10 inches long each, spaced circumferentially 120° apart, and designated by the letters *a*, *b*, and *c*.

After the several annealings were completed the bar was suddenly heated in an open fire to approximately 1,700° F and cooled in lime. This treatment caused an average shortening of 0.0027 inch, equivalent to a compressive stress of 7,300 pounds per square inch, based on a modulus of elasticity of 27,000,000 pounds per square inch.

The bar was next heated along elements *b* and *c*, about 8 inches each, with an oxy-acetylene torch, and cooled in the air. Element *b* was first heated. When cold it was found shortened 0.0122 inch, equivalent to 32,900 pounds per square inch compressive stress. Element *c* was shortened 0.0057 inch. Element *a* was increased in length 0.0023 inch. That is, the two elements heated and overcompressed at the time, when cold, were shorter than originally, while the element not heated was longer finally.
