INTERSTATE COMMERCE COMMISSION

REPORT OF THE DIRECTOR OF THE BUREAU OF SAFETY IN RE
INVESTIGATION OF AN ACCIDENT WHICH OCCURRED ON THE
BOSTON AND MAINE RAILROAD AT NORTH CHELMSFORD,
MASS., ON MAY 9, 1930.

June 24, 1930.

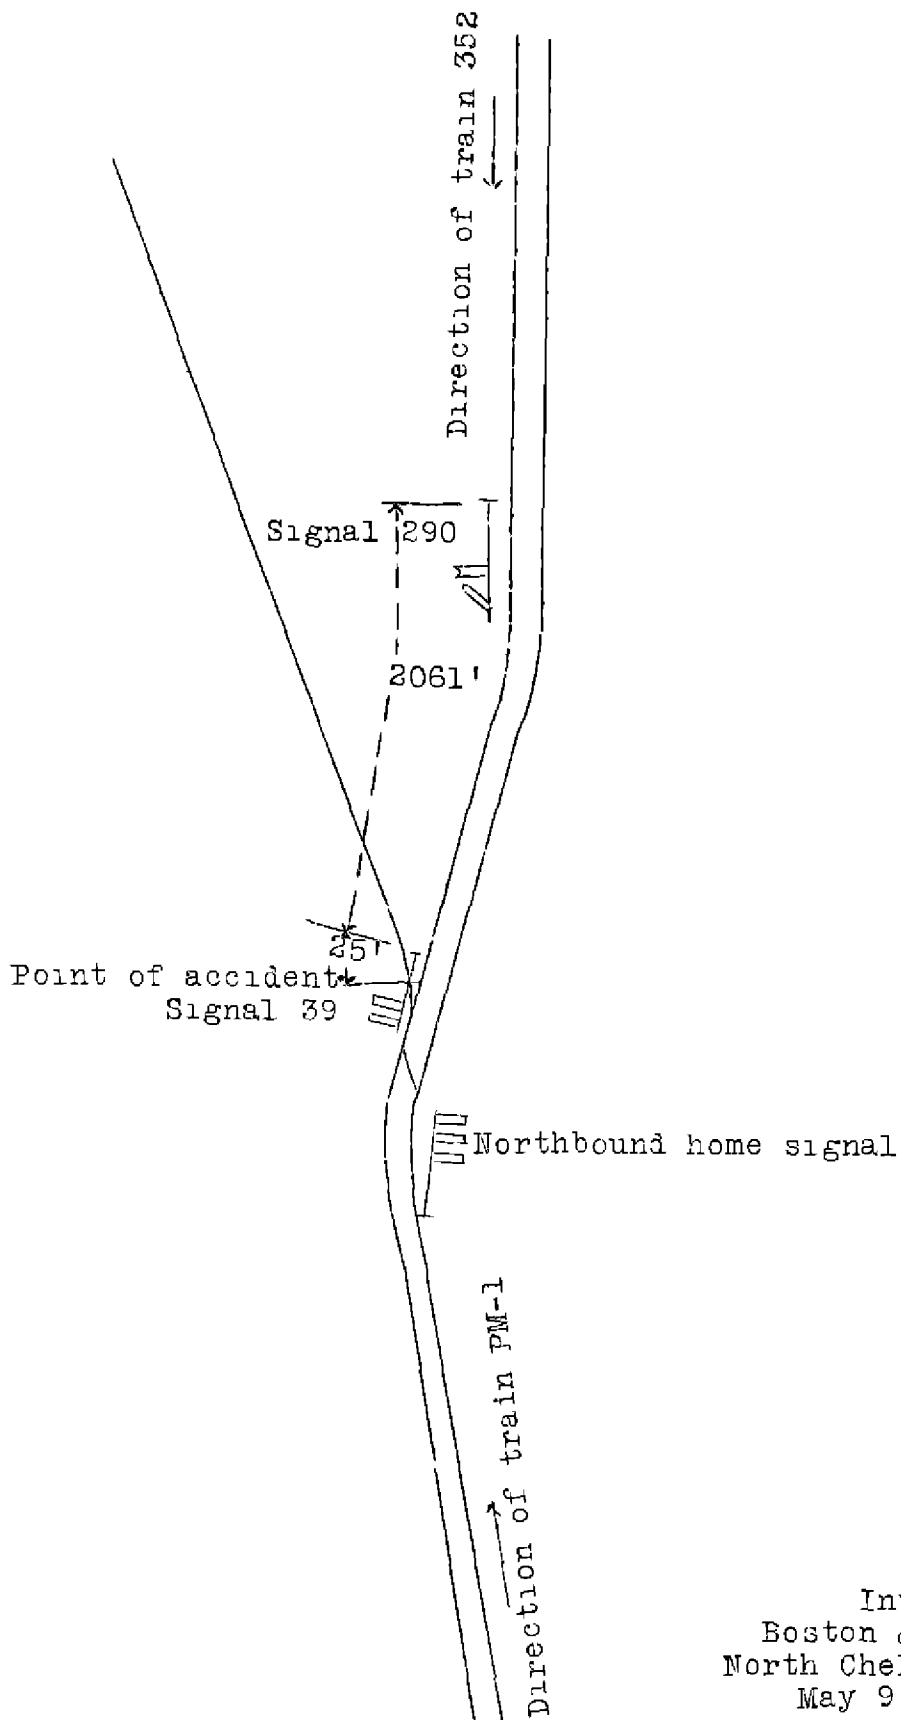
Inv. 1636
Boston & Maine R.R.
North Chelmsford, Mass.
May 9, 1930.

circuit for the southbound annunciator begins at a point approximately 6,600 feet north, and the circuit for the northbound annunciator begins about 7,500 feet south of the switch leading to the Stony Brook Branch. The signals involved are home interlocking signal No. 39, located approximately 150 feet north of the Stony Brook Branch switch and distant semi-automatic signal No. 290, located 2,061 feet north of signal No. 39. The point of accident was about 25 feet south of signal No. 39.
