INTERSTATE COMMERCE COMMISSION

REPORT OF THE DIRECTOR OF THE BUREAU OF SAFETY IN RE
INVESTIGATION OF AN ACCIDENT WHICH OCCURRED ON THE
BUFFALO, ROCHESTER AND PITTSBURGH RAILWAY NEAR
WEST FALLS, N.Y., ON APRIL 22, 1929.

September 19, 1929.

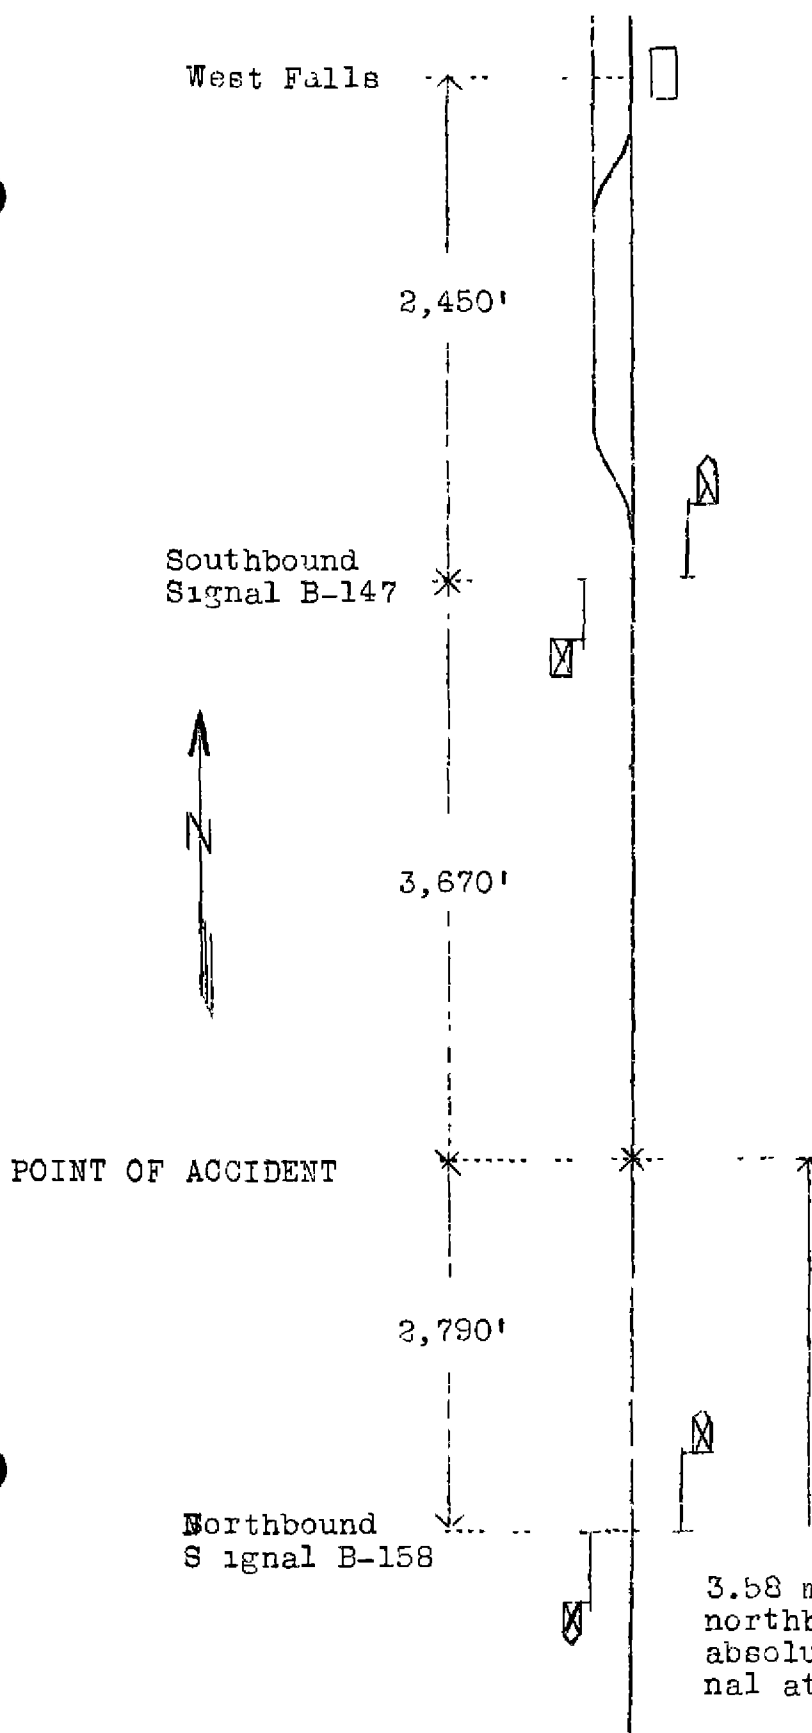
No. 1520
B. R. & P. Ry.
WEST FALLS, N.Y.
April 22, 1929

Yates
1.49
Loveland
1.2
Jewettville
0.94
West Falls
5.04
Colden
2.26
Glenwood
4.61
E. Concord
3.43
Springville

3.58 miles to
northbound
absolute sig-
nal at Colden
