INTERSTATE COMMERCE COMMISSION.

REPORT OF THE CHIEF OF THE BUREAU OF SAFETY COVERING THE INVESTIGATION OF AN ACCIDENT WHICH OCCURRED ON THE CENTRAL OF GEORGIA RAILWAY, NEAR JUNIPER, GA., ON OCTOBER 30, 1917.

MAY 2, 1918.

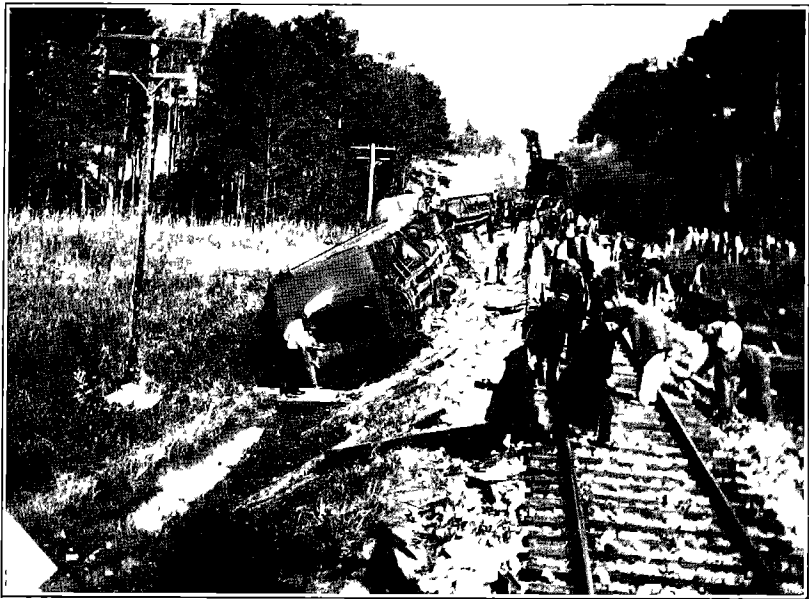
The rear trucks of the tender and the combination car were derailed and ran along close to the rail for a distance of 528 feet. The three rear cars became detached from the remainder of the train, were torn from their trucks and rolled down the embankment to the left of the track, remained coupled together, and lay on their left sides. The forward end of the first coach was 294 feet east of point of derailment and 30 feet from the track, and the rear end of the sleeping car was 30 feet from point of derailment and 35 feet from the track.

On account of the cars being of all-steel construction they were not seriously damaged. The track was torn up for a distance of about 200 feet, making it necessary to use 14 new rails and 150 new ties in making repairs. Figure No. 1 is a general view of the derailed train, looking east.

FIG 1 —General view of the derailment

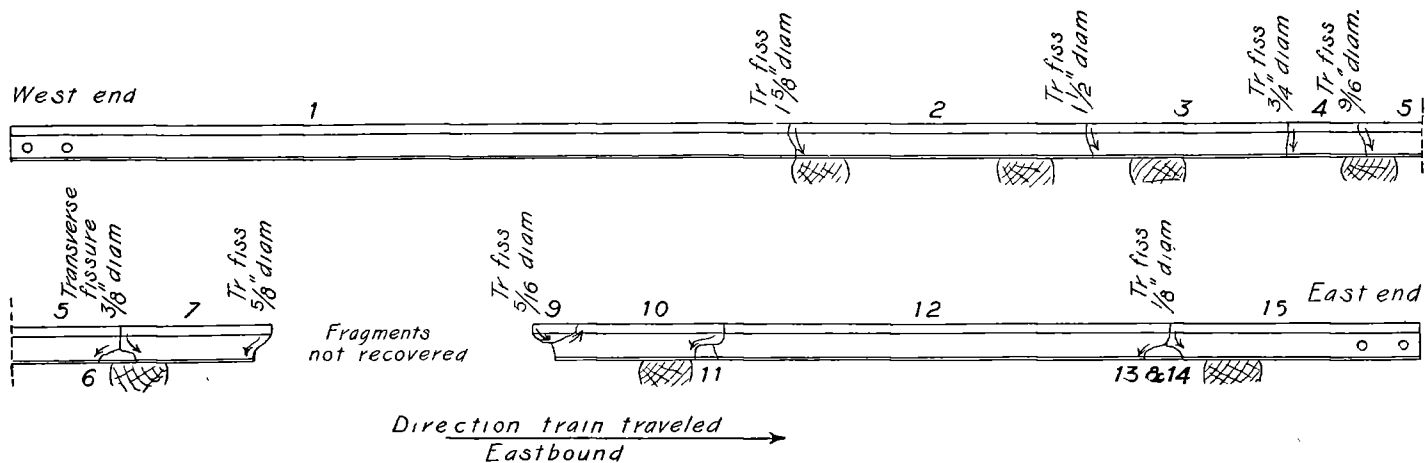
The failure of the rail was due to the presence of transverse fissures, eight being displayed in the different fragments of the head. The fissures were in different stages of development, ranging in size from one-eighth inch diameter to 1½ inches diameter. They progressively increased in size from the easterly end to the westerly end of the rail. Two of the fissures had enlarged from their interior nuclei and reached the side of the head on the gauge side of the rail. The surfaces of these fissures were dark colored. The other fissures had not reached the periphery of the rail and therefore presented bright surfaces, having a silvery luster, when exposed to view following the derailment. All were located on the gauge side of the head or over the web.

Referring to the present rail, figure No. 2 is a diagram of the rail viewed from the gauge side, showing the lines of rupture developed at the time of the derailment, the direction in which they traversed the rail, the places at which transverse fissures were displayed and their dimensions, also the location of ties which were adjacent to the transverse fissures.

FIG 2 —Diagram of the fractured rail, showing lines of rupture, and directions in which they traversed the rail, indicated by arrows. Eight transverse fissures displayed. Positions of ties in the vicinity of the transverse fissures sketched in.

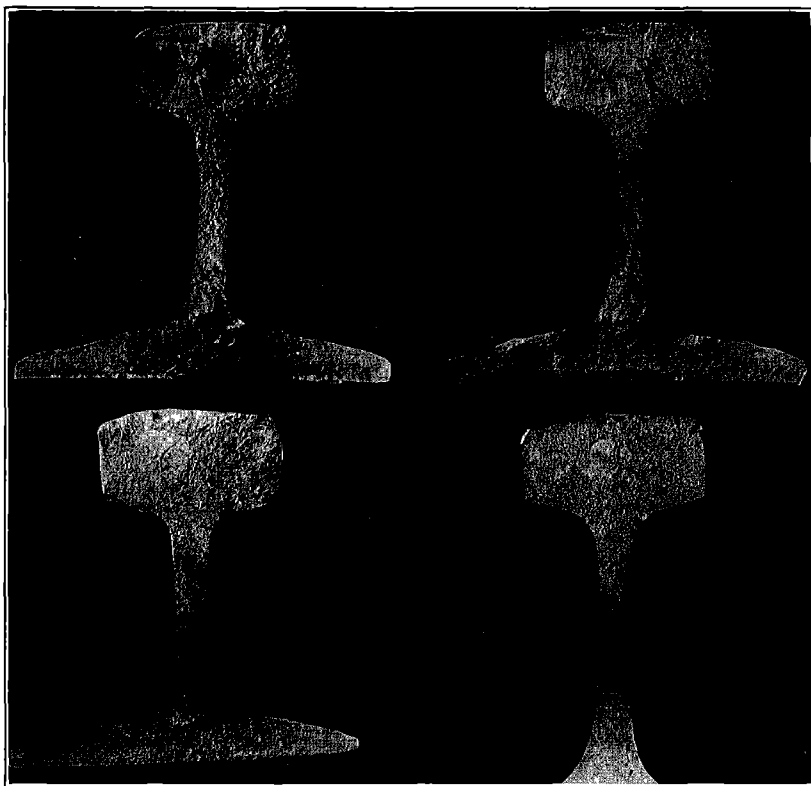
Photographs of the leaving ends of fragments Nos. 1, 2, 3, and 4, showing the transverse fissures which were displayed on each, appear in figure No. 3. These represent the largest two fissures, and two of intermediate size.

FIG. 3—Transverse fissures displayed on the leaving ends of fragments Nos 1, 2, 3, and 4, respectively

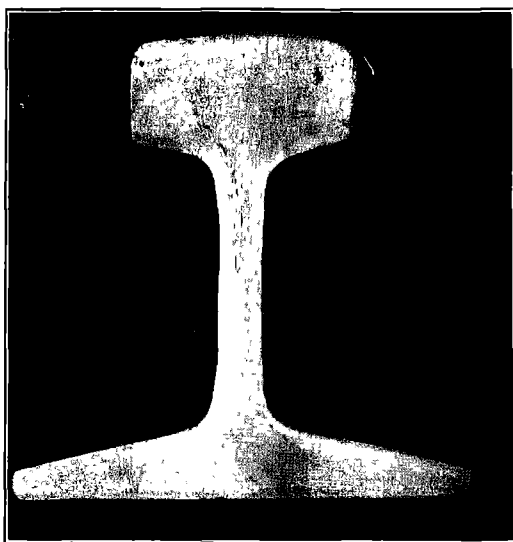
Figure No. 4 represents the cross section of the rail near the leaving end of fragment No. 3, after having been polished and etched with tincture of iodine. A group consisting of a large number of dark colored dots and short lines appears in the lower middle part of the head, which extend down the web into the base. Markings of this kind appear on sections iodine etched and on sulphur prints, those on the present rail being somewhat less pronounced than frequently displayed by rails when inspected in this manner.

FIG 4 --Cross section of rail, near leaving end of fragment No 3,
polished and etched with tincture of iodine

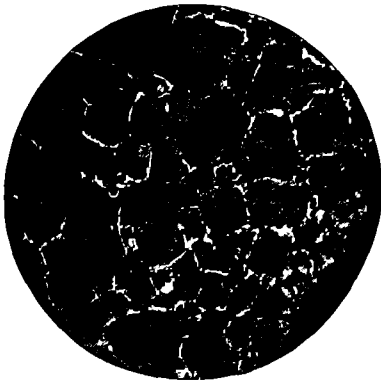
The group of four photomicrographs shown on figure No. 5 represent, in cross section, the structure of the rail in the vicinity of the transverse fissure which was developed at the leaving end of fragment No. 3. Figure A of this group shows the distortion of the microstructure next the running surface of the head. Lateral flow of the surface metal took place toward the gauge side. Figure B represents the microstructure at the upper corner of the head on the gauge side of the rail. The flattening of the structure here was very pronounced. Figure C shows the structure at the periphery on the gauge side of the head, near the lower corner, where no abrasive action nor contact with the wheels had taken place. An undisturbed grain structure is here exhibited. Figure D represents the microstructure at the middle and lower part of the head. There was no

characteristic difference in the microstructure of the head in the vicinity of the nucleus of the transverse fissure and other parts of the middle of the head.

FIG 5—Microstructure of the head of the rail, near the leaving end of fragment No 3, cross section, magnification 100 diameters. A At running surface near middle of top of head, showing lateral flow of surface metal toward gauge side of head. B. At upper corner of the head gauge side. Most pronounced effect of wheels in distorting the grain of the steel. C Near lower corner of the head gauge side. Slightly decarburized edge. Beyond the reach of the wheels and no distortion to the grain of the steel. D Structure of the rail near the center of the head.

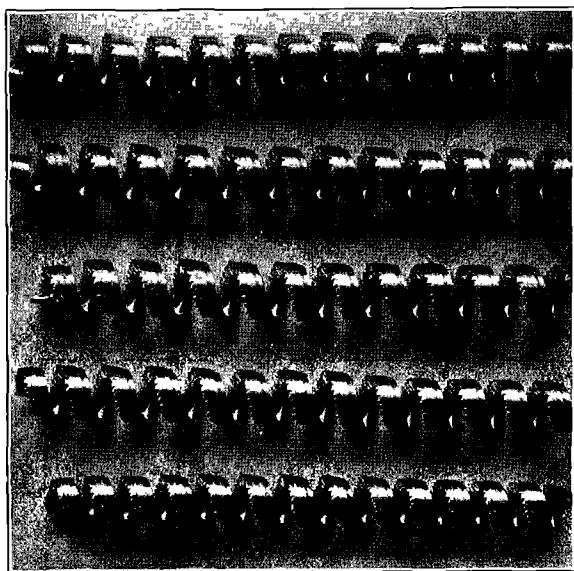
Figure No. 9 shows the appearance of some planer chips taken from the interior of the head of fragment No. 3. A heavy cut and feed were taken in removing these blue chips for the purpose of showing the quality of the steel.

FIG 9 —Appearance of planer chips taken from the middle of the head,
fragment No 3

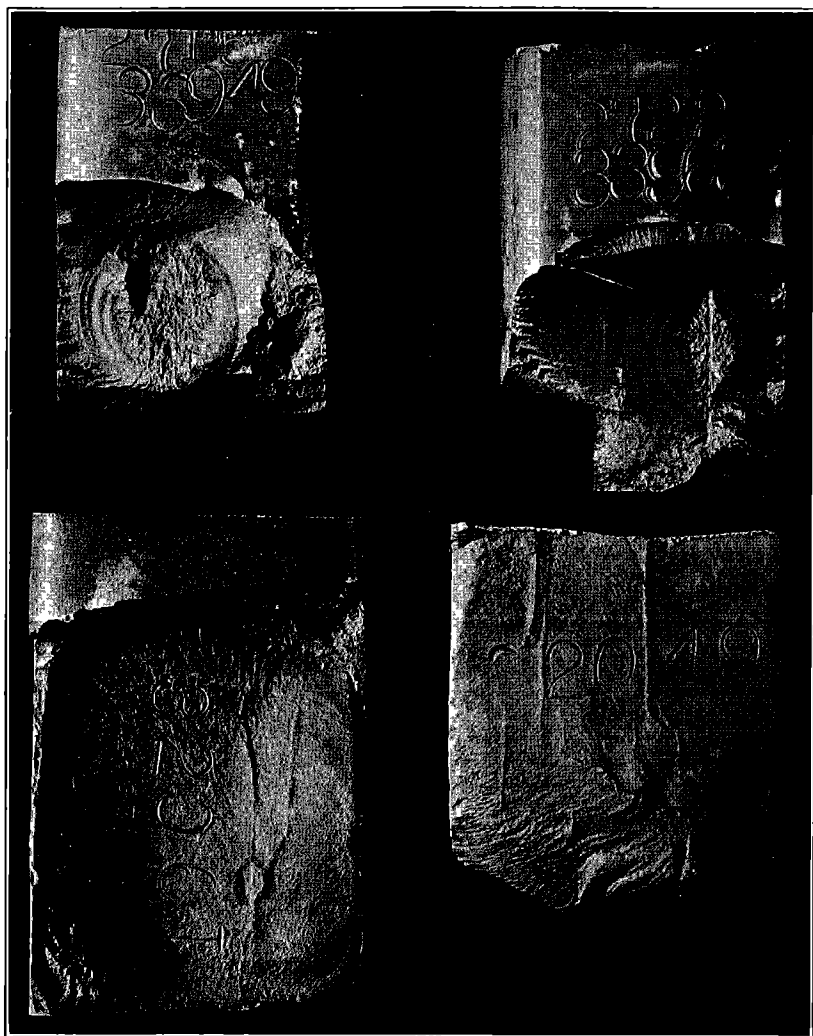
FIG. 10 —Group of shearing fractures in heads of other rails not involved in present derailment. Progressive shearing fractures in horizontal longitudinal planes, origins at longitudinal streaks in the steel

Figure No. 10 shows a group of four rail heads in each of which progressive shearing fractures developed, the origins of which were at longitudinal streaks in the steel. Fractures of this kind in the head, and similar ones in the base, follow the longitudinal streaks for a distance, then turn in their course and terminate at the surface or edge of the rail section. In the base they form crescent-shaped fractures. Those in the head, as here witnessed, generally change their courses in opposite directions, at one end curving upward and terminating at the running surface of the head, at the other end taking a downward course into the web and thence through the base. The difference in the manner of their development is attributed to the influence of the combined longitudinal bending and shearing stresses in the head on the one hand, and to the crosswise bending stresses received by the base on the other hand. The resemblance of these fractures to the ruptured surfaces of transverse fissures has led to their being mistaken for a modified form of transverse fissure.

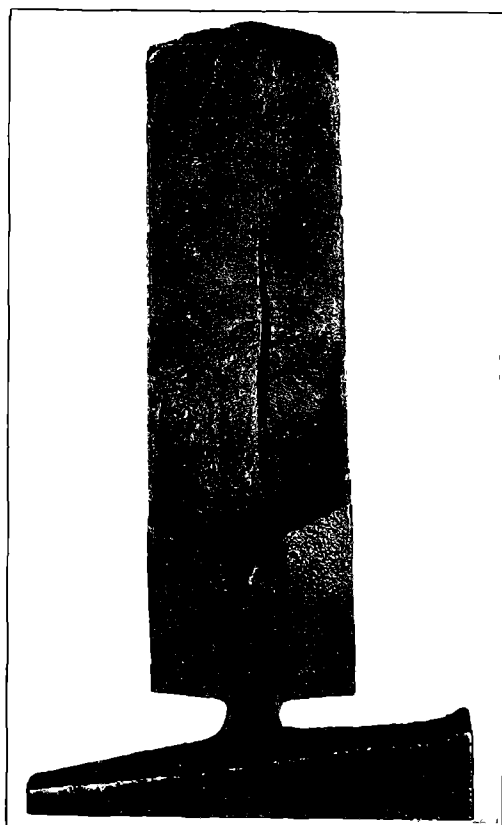
FIG 11 —Showing fracture in head of rail, progressive fracture starting at split in head View from the under side

Figure No. 11 shows a combined split head and horizontal shearing fracture. Each were progressive fractures. The split-head fracture had its origin in the upper part of the head, extending downward into the web. The split-head fracture was doubtless the primary one, the shearing fracture secondary, the latter having its origin at the edges of the former. Eventually the shearing fracture changed its course, at one extremity curving upward and completing the rupture in the head, at the other end curving downward and separating the web and the base. An end view of the rail is shown on figure No. 12, where the fracture appears as a split head only.

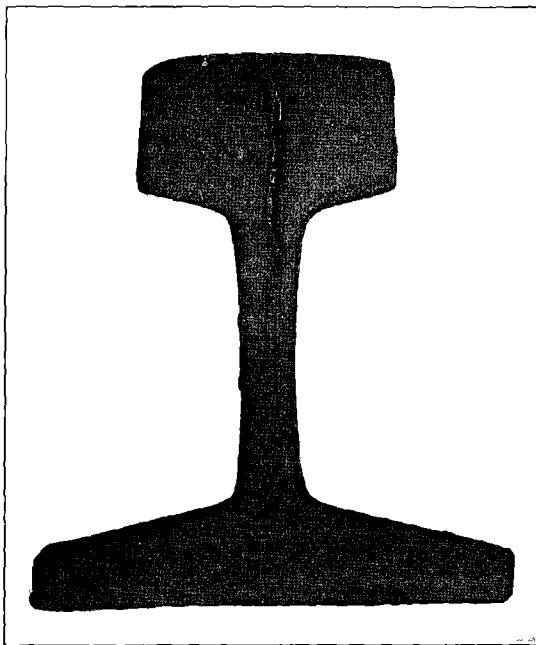
FIG. 12—Cross section of rail shown in Fig. No. 11. Split head from which a horizontal shearing fracture started detaching the upper portion of the head.
