INTERSTATE ~~COMMERCE~~ COMMISSION

REPORT OF THE DIRECTOR OF THE BUREAU OF SAFETY IN RE
INVESTIGATION OF AN ACCIDENT WHICH OCCURRED ON
THE CENTRAL OF GEORGIA RAILWAY NEAR ZELLOBEE,
GA , ON MARCH 7, 1930

March 28, 1930

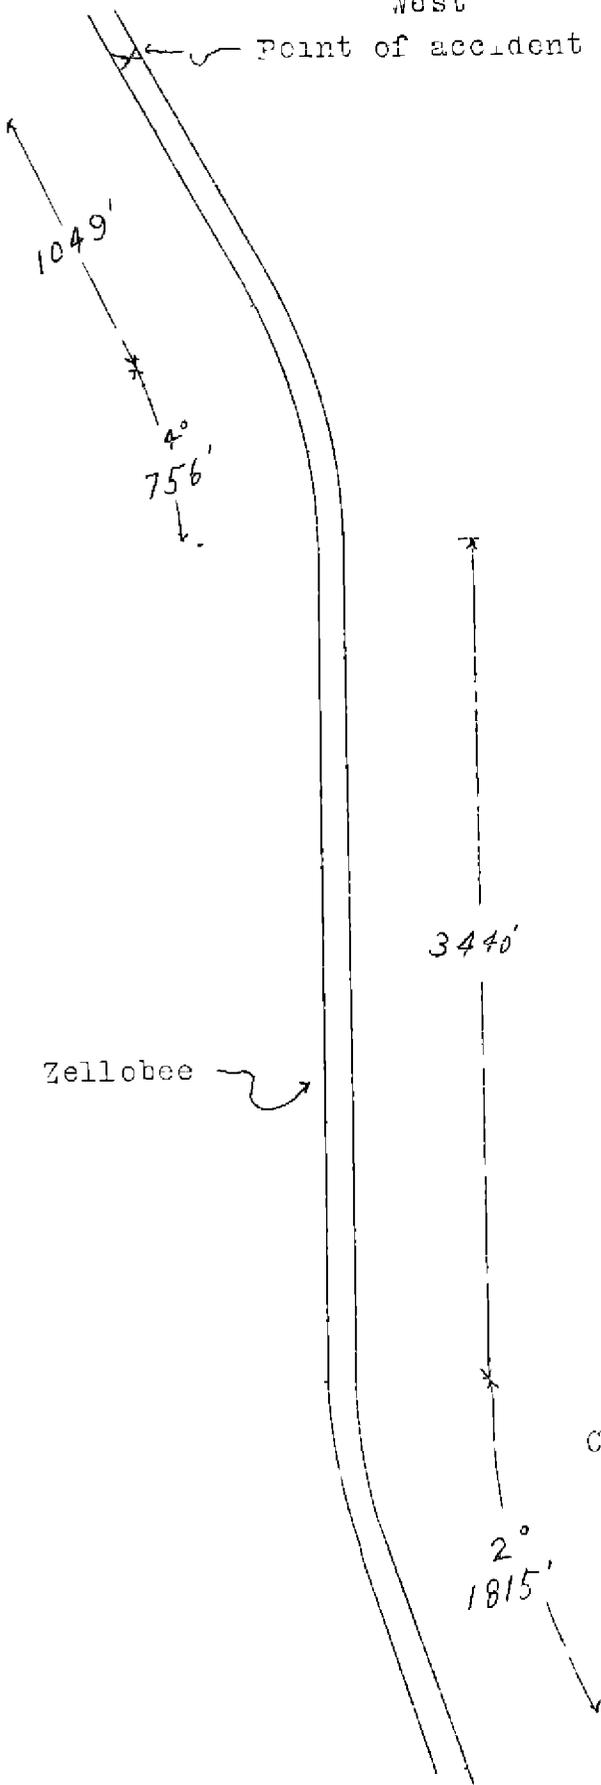
No. 1626
Central of Georgia Ry.,
Zellobee, Ga.
March 7, 1930

Point of accident
