INTERSTATE COMMERCE COMMISSION

REPORT OF THE CHIEF OF THE BUREAU OF SAFETY COVERING INVESTIGATION OF AN ACCIDENT WHICH OCCURRED ON THE CENTRAL RAILROAD OF NEW JERSEY AT ELIZABETHPORT, N J, ON MARCH 3, 1920

APRIL 8, 1920

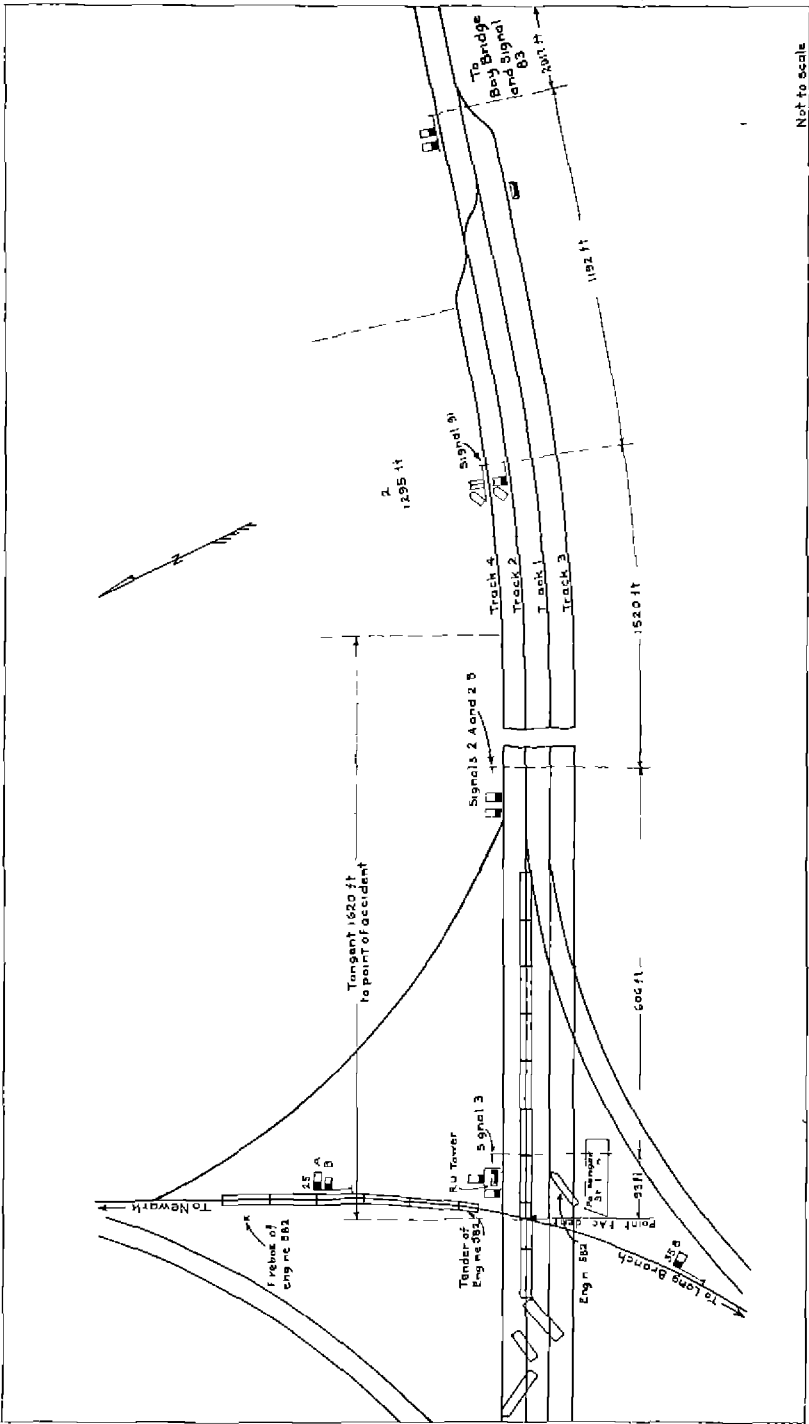
Diagram showing relative location of tracks and signals involved in accident

branch runs approximately north and south, and eastbound trains on the branch approach the station running in a southerly direction. The Elizabethport passenger station is located at the intersection south of the main line and east of the branch line. The accompanying diagram shows the relative location of the tracks and signals involved in this accident.

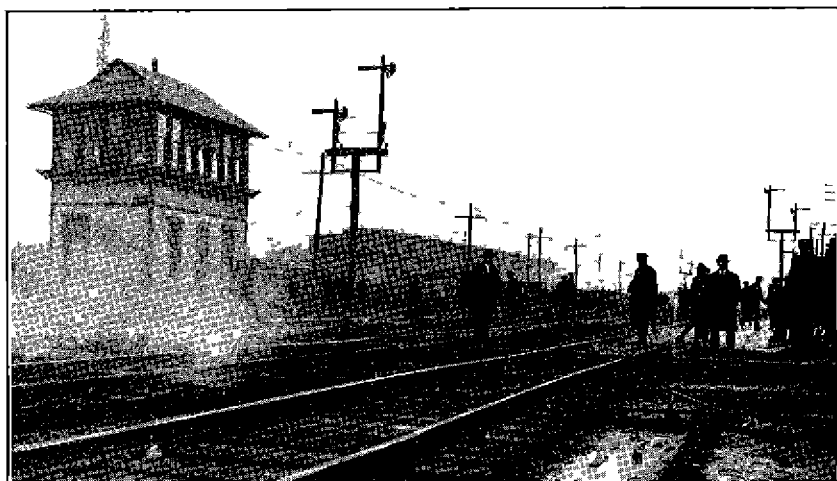
FIG. 1—Crossing on which accident occurred. RU tower, and semiautomatic signals 3 and 5.

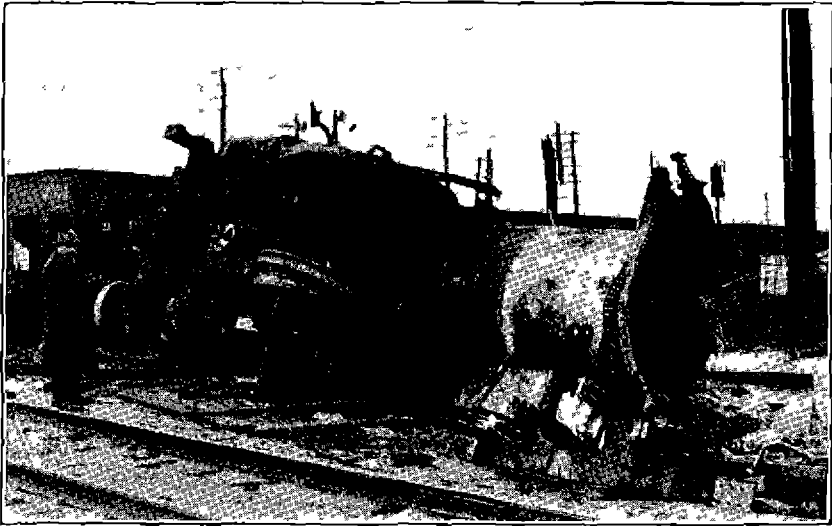
The impact of the collision resulted in the overturning of engine 582, of train No 499, the engine coming to rest, nearly reversed, across tracks 1 and 3. The boiler of this engine exploded, tearing the crown, stay, and flue sheets loose, and carrying the fire box, which was of the Wootten type, approximately 400 feet north of the point of collision. Illustration No 2 shows the condition of this engine after it had been removed from the track, illustration No 3 shows the fire box. With the exception of broken windows, no damage was sustained by the cars in this train. Engine 162, of train No 123, came to rest across track 4, about 150 feet west of the crossing, in a badly damaged condition, as shown in illustration No 4. The first car of train No 123 was derailed to the left, obstructing tracks 1 and 3, while the other cars remained on the rails. The employees

FIG. 2 — Engine 582, after having been removed from the track

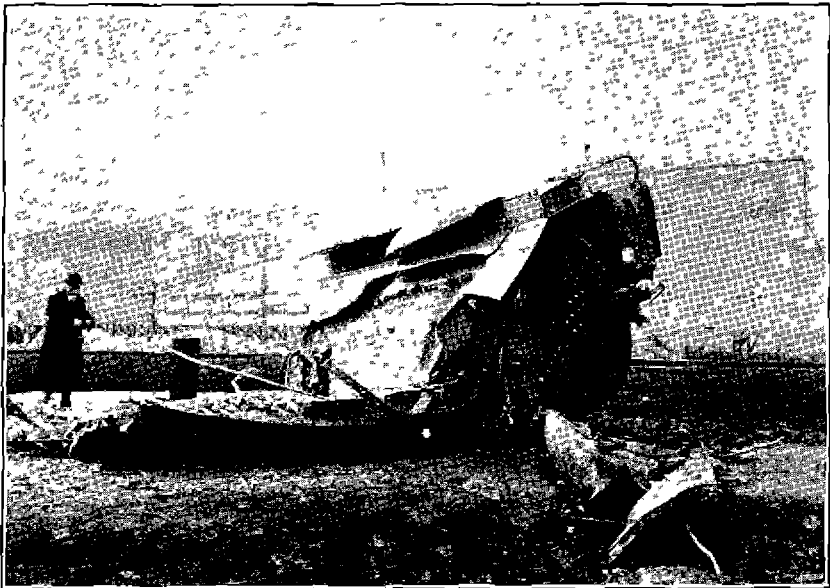
FIG 3 — Fire box of engine 582

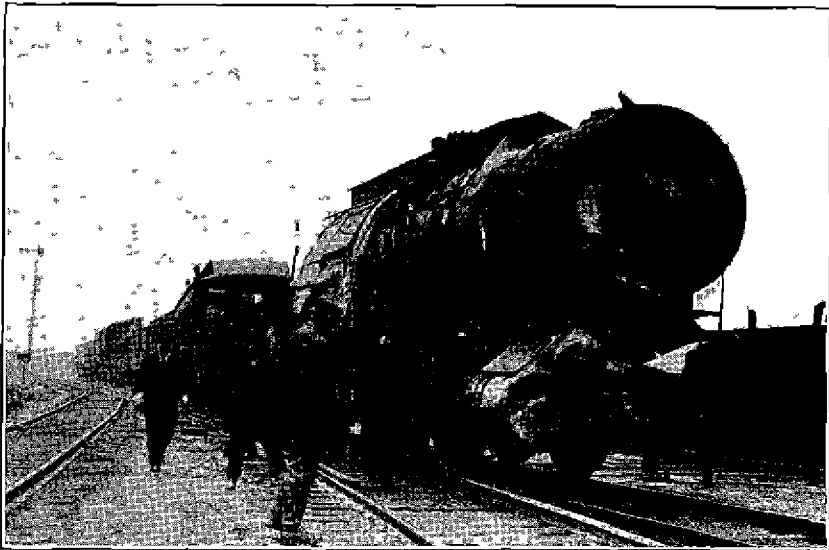
FIG. 4.—Engine 162 being removed from scene of accident
