INTERSTATE COMMERCE COMMISSION.

REPORT OF THE CHIEF OF THE BUREAU OF SAFETY COVERING THE INVESTIGATION OF AN ACCIDENT WHICH OCCURRED ON THE CHESAPEAKE & OHIO RAILWAY NEAR HARDWARE, VA., ON JANUARY 7, 1919.

FEBRUARY 21, 1920.

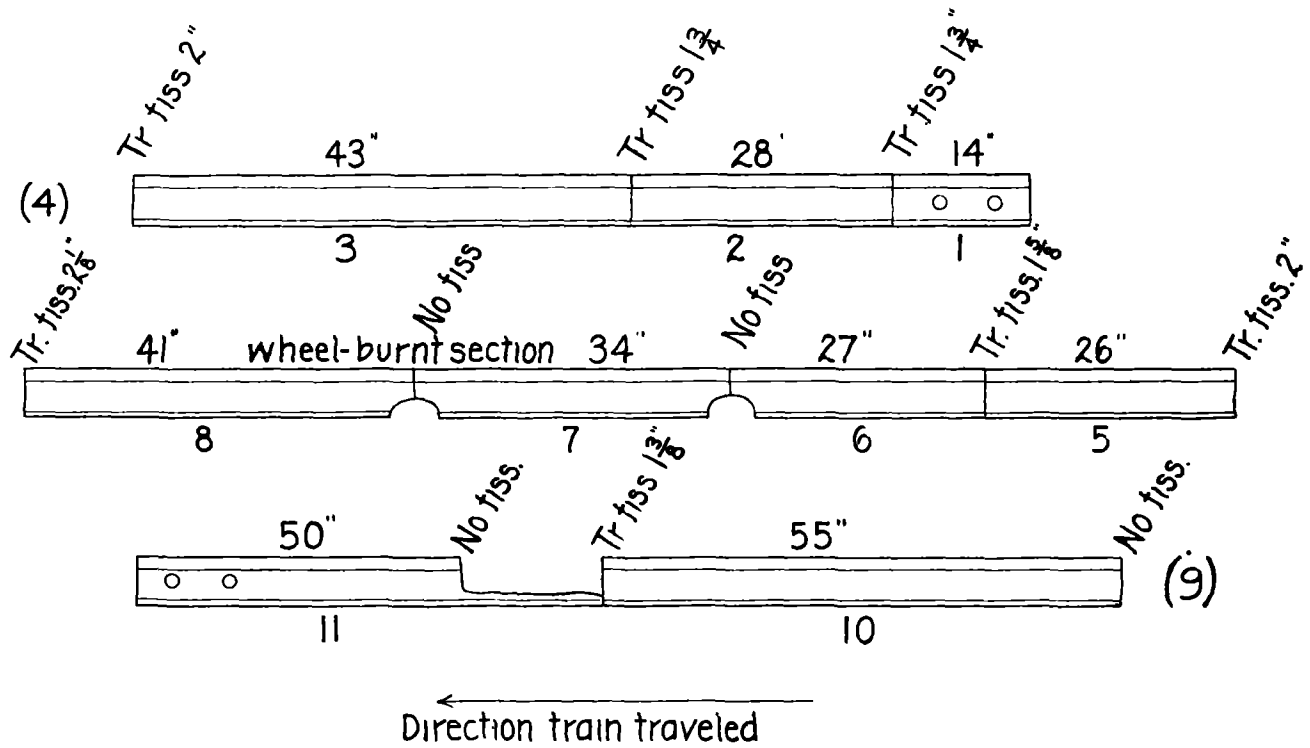
Figure 1 is a diagram showing the manner in which the rail was broken. Nine principal fragments were recovered, in length aggregating 26 feet 6 inches. Missing parts represented 6 feet 6 inches in length. The transverse fissures were located in different parts of the length of the rail, ranging in diameter from $1\frac{3}{8}$ inches to $2\frac{1}{8}$ inches. The line of rupture believed to have been the initial break was 14 inches from the receiving end. At this place there was a transverse fissure $1\frac{3}{4}$ inches in diameter. The seventh and last fissure in the order of their alignment was located 50 inches from the leaving end of the rail. This fissure had a diameter of $1\frac{3}{8}$ inches. The rail was broken at four other places which did not show fissures.

These transverse fissures presented the usual appearance of such fractures, each a progressive one from a well-defined nucleus. The nuclei were located about five-eighths inch below the running surface and all were on the gauge side of the head.

FIG 1 —Diagram showing the manner in which the rail causing the derailment was broken, with the location and diameters of the transverse fissures displayed

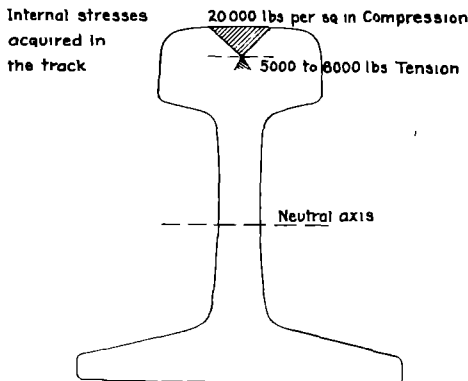
FIG 3—Cross section of rail showing relations of internal stresses in heads of rails which lead to fractures with interior origins, i e, transverse fissures

Figure 3 represents, in outline, the cross section of a rail, on the head of which are two shaded areas representing the state of internal strains which have been found in rails taken from the track. Along the upper part of the head stresses corresponding to the measured strains not infrequently exceed 20,000 pounds per square inch. In the interior of the head tensile stresses range from 5,000 to 8,000 pounds per square inch. This state of the steel is due chiefly to the cold rolling action of the wheels, a limited portion representing cooling strains of fabrication. The assumed conditions of the hypothetical beam are produced in the rail head, tending to cause the result there mentioned.

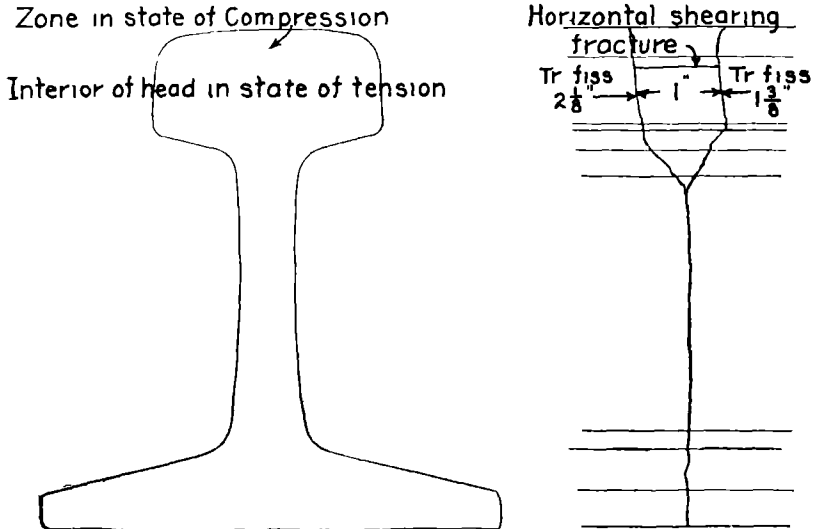
Figure 4 illustrates lines of rupture which were displayed by a 100-pound rail in service. A fragment 1 inch long was detached from the head, on each end of which was located a transverse fissure, one having a diameter of $2\frac{1}{8}$ inches and the other $1\frac{3}{8}$ inches. The wedge action of the surface metal was essential to cause this result, without which it would not appear feasible to accomplish. There was also a horizontal shearing fracture between these two transverse fissures, located by a seam in the metal. Figures 4a and 4b show the appearance of the transverse fissures.

FIG 4 —Lines of rupture in 100-pound rail, made by transverse fissures, result of conditions illustrated by figures 2 and 3
