INTERSTATE COMMERCE COMMISSION

REPORT OF THE DIRECTOR OF THE BUREAU OF SAFETY IN RE
INVESTIGATION OF AN ACCIDENT WHICH OCCURRED ON THE
CHESAPEAKE & OHIO RAILWAY AT HARVEY, W. VA., ON
JULY 11, 1929.

November 6, 1929.

No 1540
Chesapeake & Ohio.
Harvey, W Va
July 11, 1929.

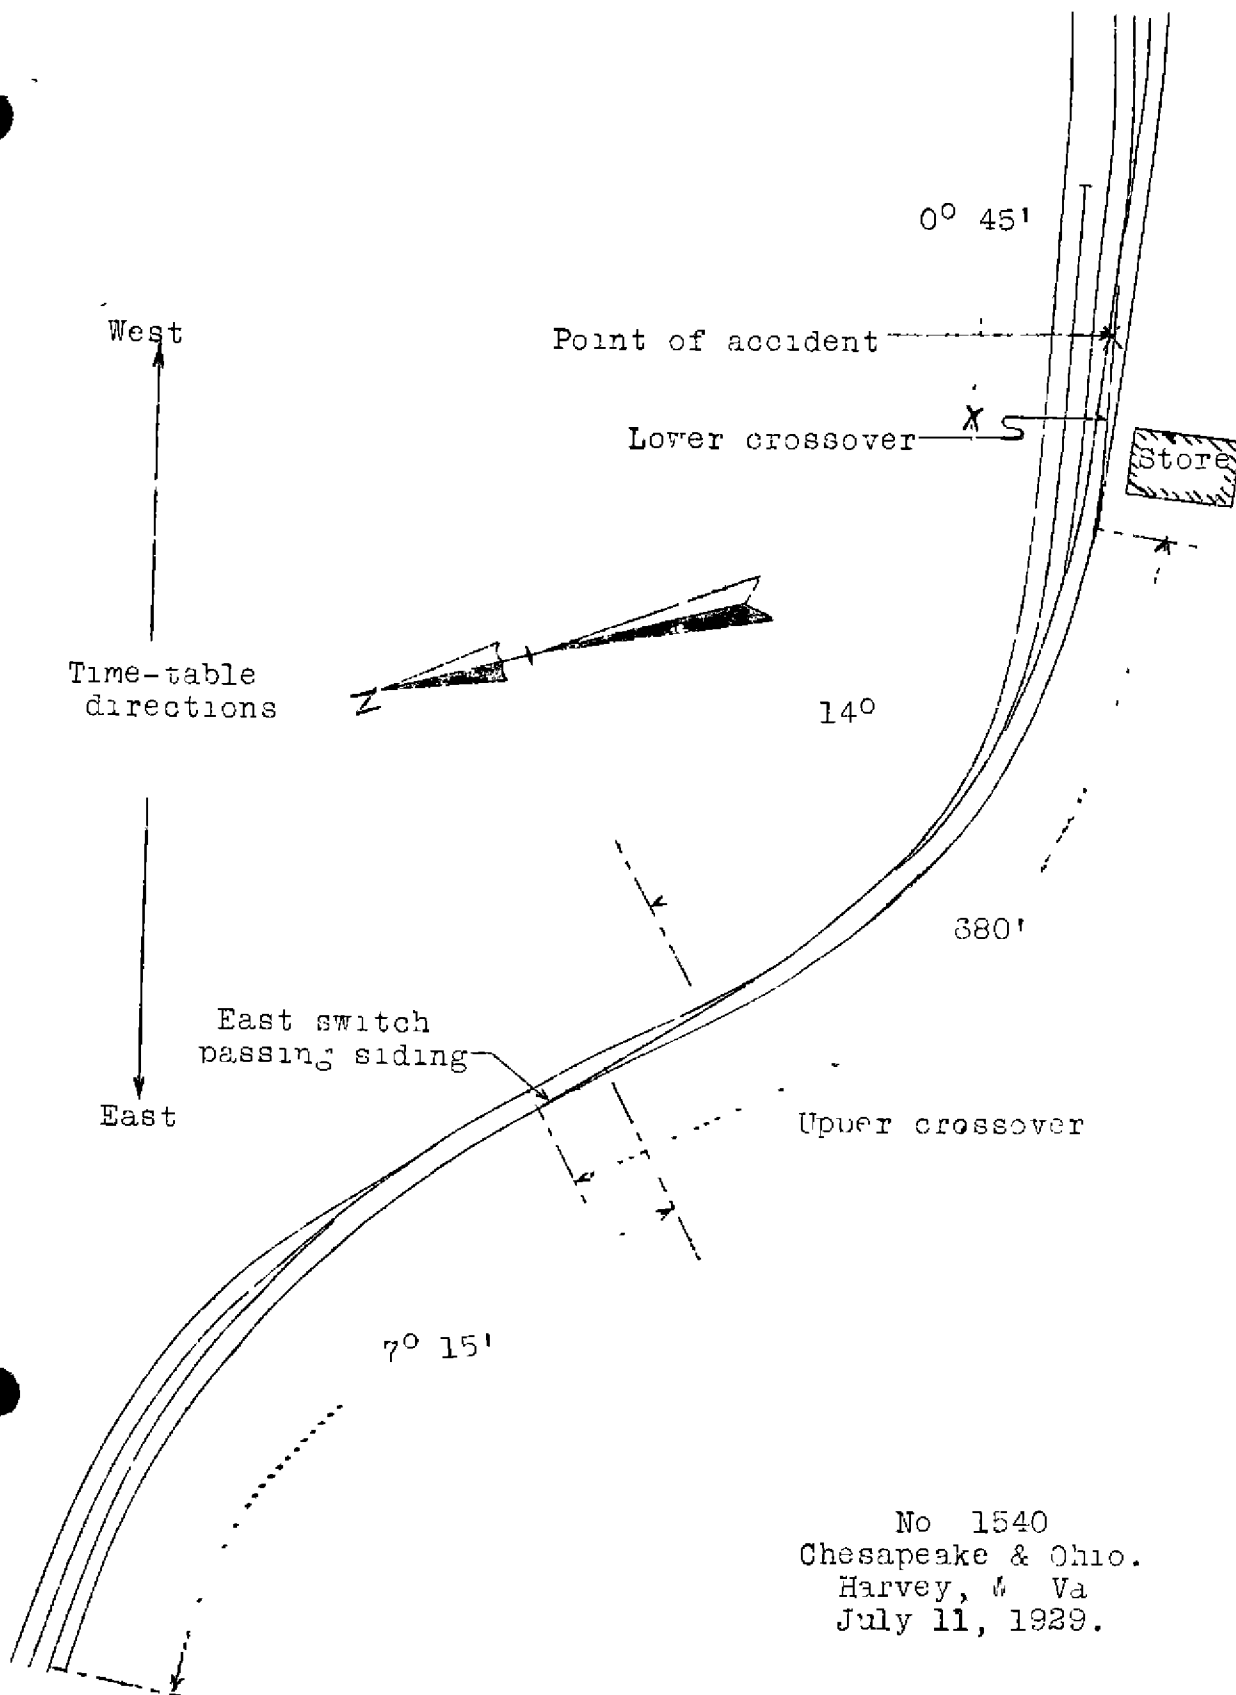
This accident was caused by an open switch.

Examination of the switch immediately after the occurrence of the accident indicated that it had been left open; the switch lock was hanging in the hasp, unlocked, and the switch lamp was not burning. Head Brakeman Anderson emphatically maintained that he closed and locked the switch, although he did not pull on the chain to test the lock, while Conductor Holliday said that he saw the head brakeman throw the switch; in this connection, however, the conductor thought it possible that some one either threw the switch and then the head brakeman threw it back to the wrong position.
