REPORT OF THE DIRECTOR OF THE BUREAU OF SAFETY IN RE  
INVESTIGATION OF AN ACCIDENT WHICH OCCURRED ON THE  
CHESAPEAKE & OHIO RAILWAY AT HAWK'S NEST, W. VA.,  
ON JUNE 21, 1930.

August 5, 1930

Inv. No. 1646  
 Chesapeake & Ohio Ry.  
 Hawk's Nest, W. Va.  
 June 21, 1930

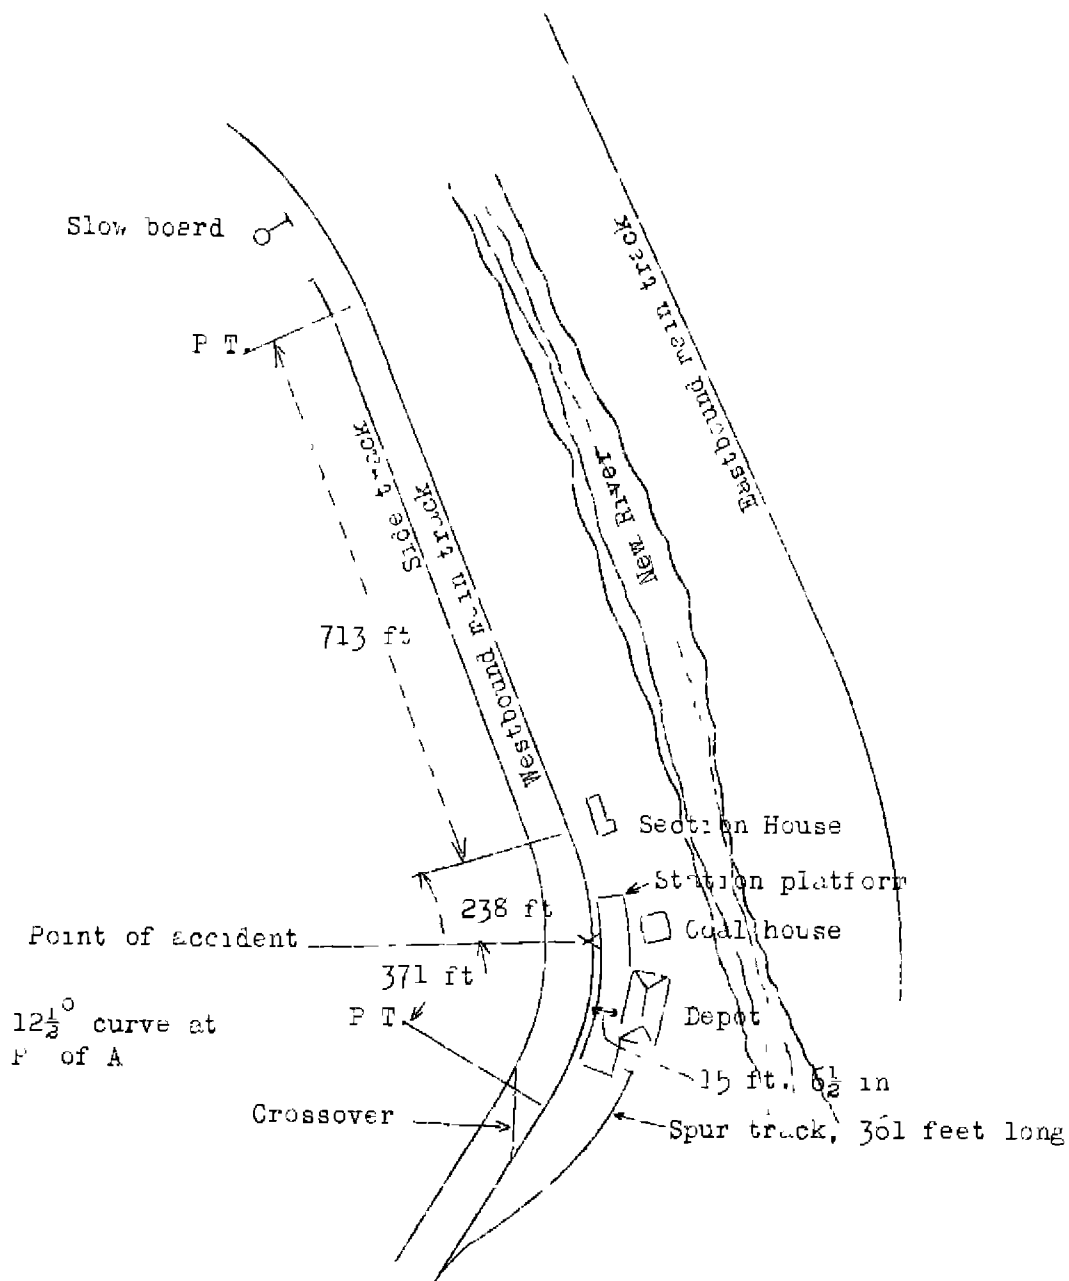
In the vicinity of the point of accident the main tracks are parallel and are separated by New River, the westbound main track being laid on a bench cut along the mountain side on the north bank of the river, while the eastbound main track is on the south bank. The station platform, depot, coal house and other buildings at Hawk's Nest are located on the south side of the westbound main track, the initial point of derailment being opposite the coal house. A side track parallels the westbound main track on the north and there is a crossover, extending from northeast to southwest, connect-

ing these two tracks, the east switch of the crossover being about 125 feet west of the initial point of derailment. A spur track, 361 feet in length, leads off and parallels the westbound main track on the south, the trailing-point switch being located 403 feet west of the point of derailment, at the time of the accident three box cars stood on this spur track.
