INTERSTATE COMMERCE COMMISSION

REPORT OF THE DIRECTOR OF THE BUREAU OF SAFETY IN RE
INVESTIGATION OF AN ACCIDENT WHICH OCCURRED ON THE
CHICAGO & EASTERN ILLINOIS RAILWAY AT SIDELL JUNCTION,
ILL., ON JANUARY 7, 1930.

March 14, 1930.

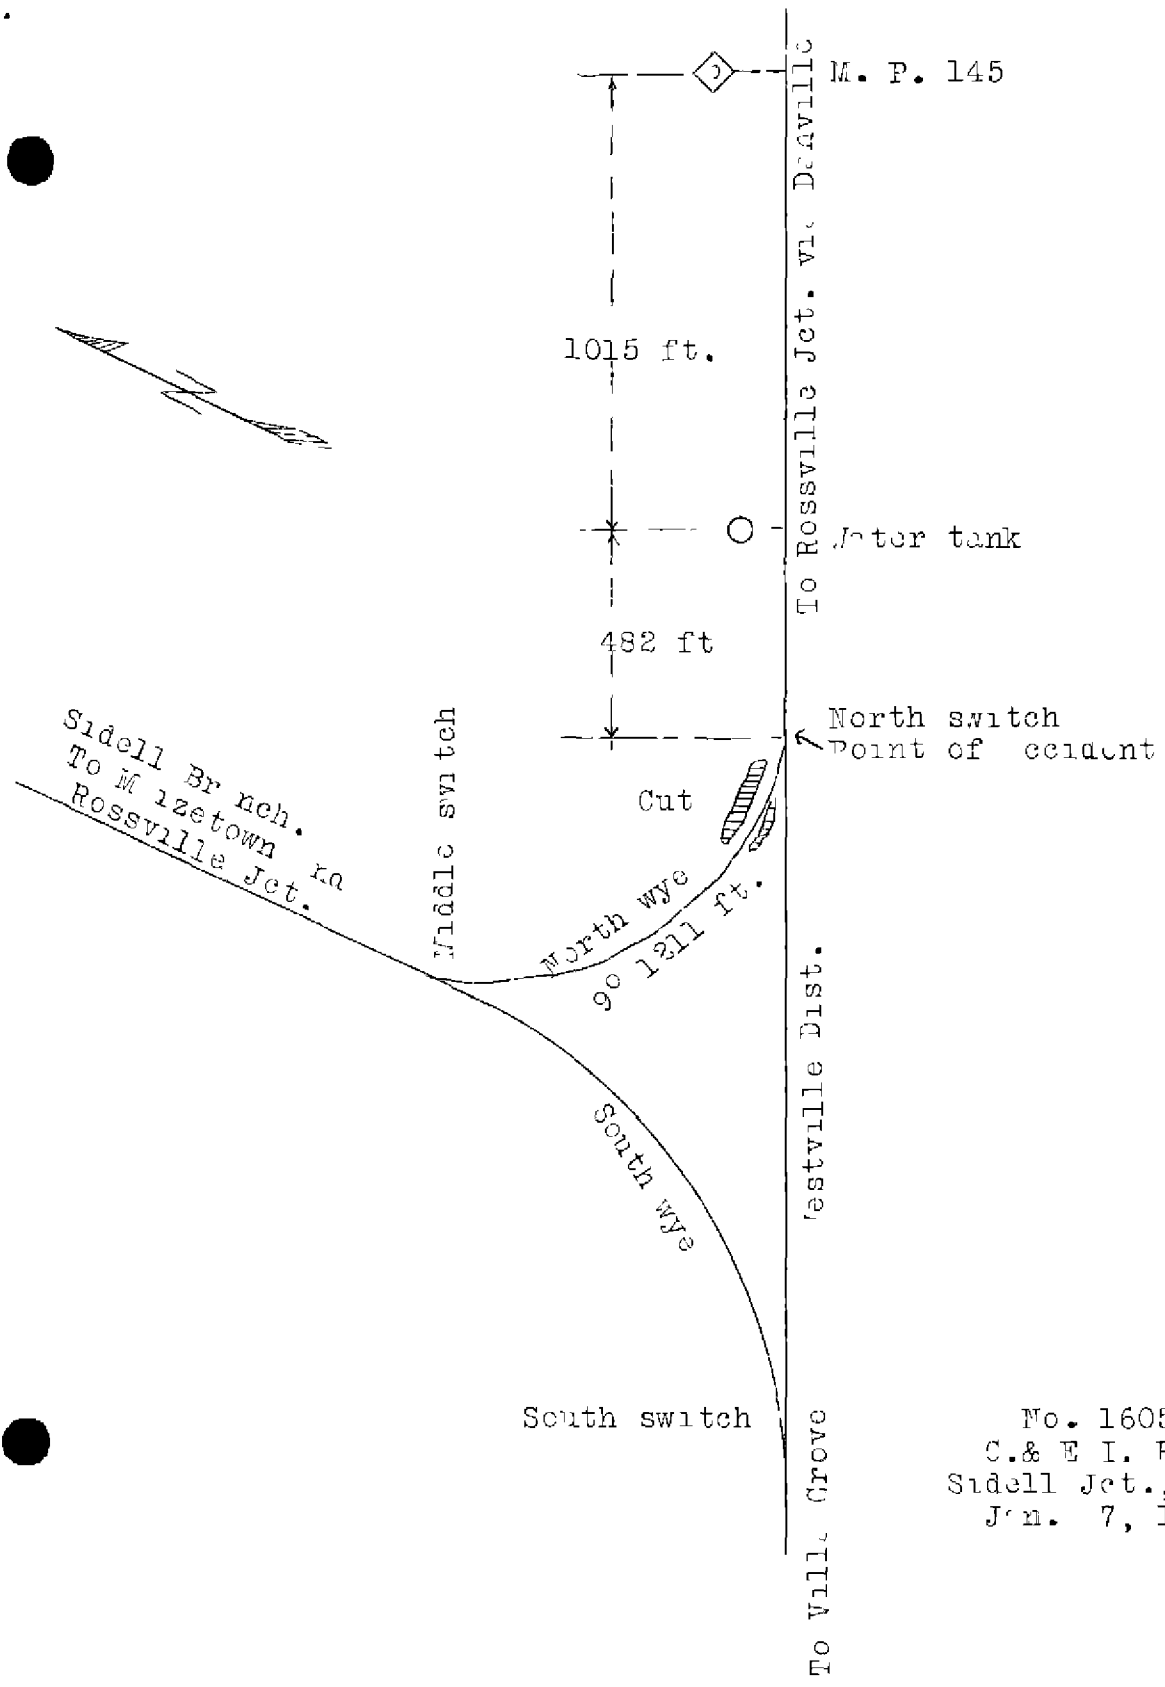
No. 1605
 C. & E. I. R.R.
 Sidell Jct., Ill.
 Jan. 7, 1930

As a result of the collision, the two rear cars of extra 759 were derailed and badly damaged, and three other cars in the same train were somewhat damaged. The forward end of engine 1917 was raised and rested on the truck of the rear car of extra 759; both trucks of the tender were derailed; the first car in extra 1917 had one truck derailed and one end damaged, the south end of the second car was resting on the car ahead and its rear truck was jammed between the tender of engine 1917 and the first car. The employee killed was the fireman of engine 1917, who jumped just before the collision occurred.
