INTERSTATE COMMERCE COMMISSION

REPORT OF THE DIRECTOR OF THE BUREAU OF SAFETY IN RE INVESTIGATION OF AN ACCIDENT WHICH OCCURRED AT THE INTERSECTION OF THE TRACKS OF THE CHICAGO & NORTH WESTERN RAILWAY AND THE CHICAGO, MILWAUKEE, ST. PAUL & PACIFIC RAILROAD AT JANESVILLE, WIS., ON JANUARY 18, 1930.

March 10, 1930.

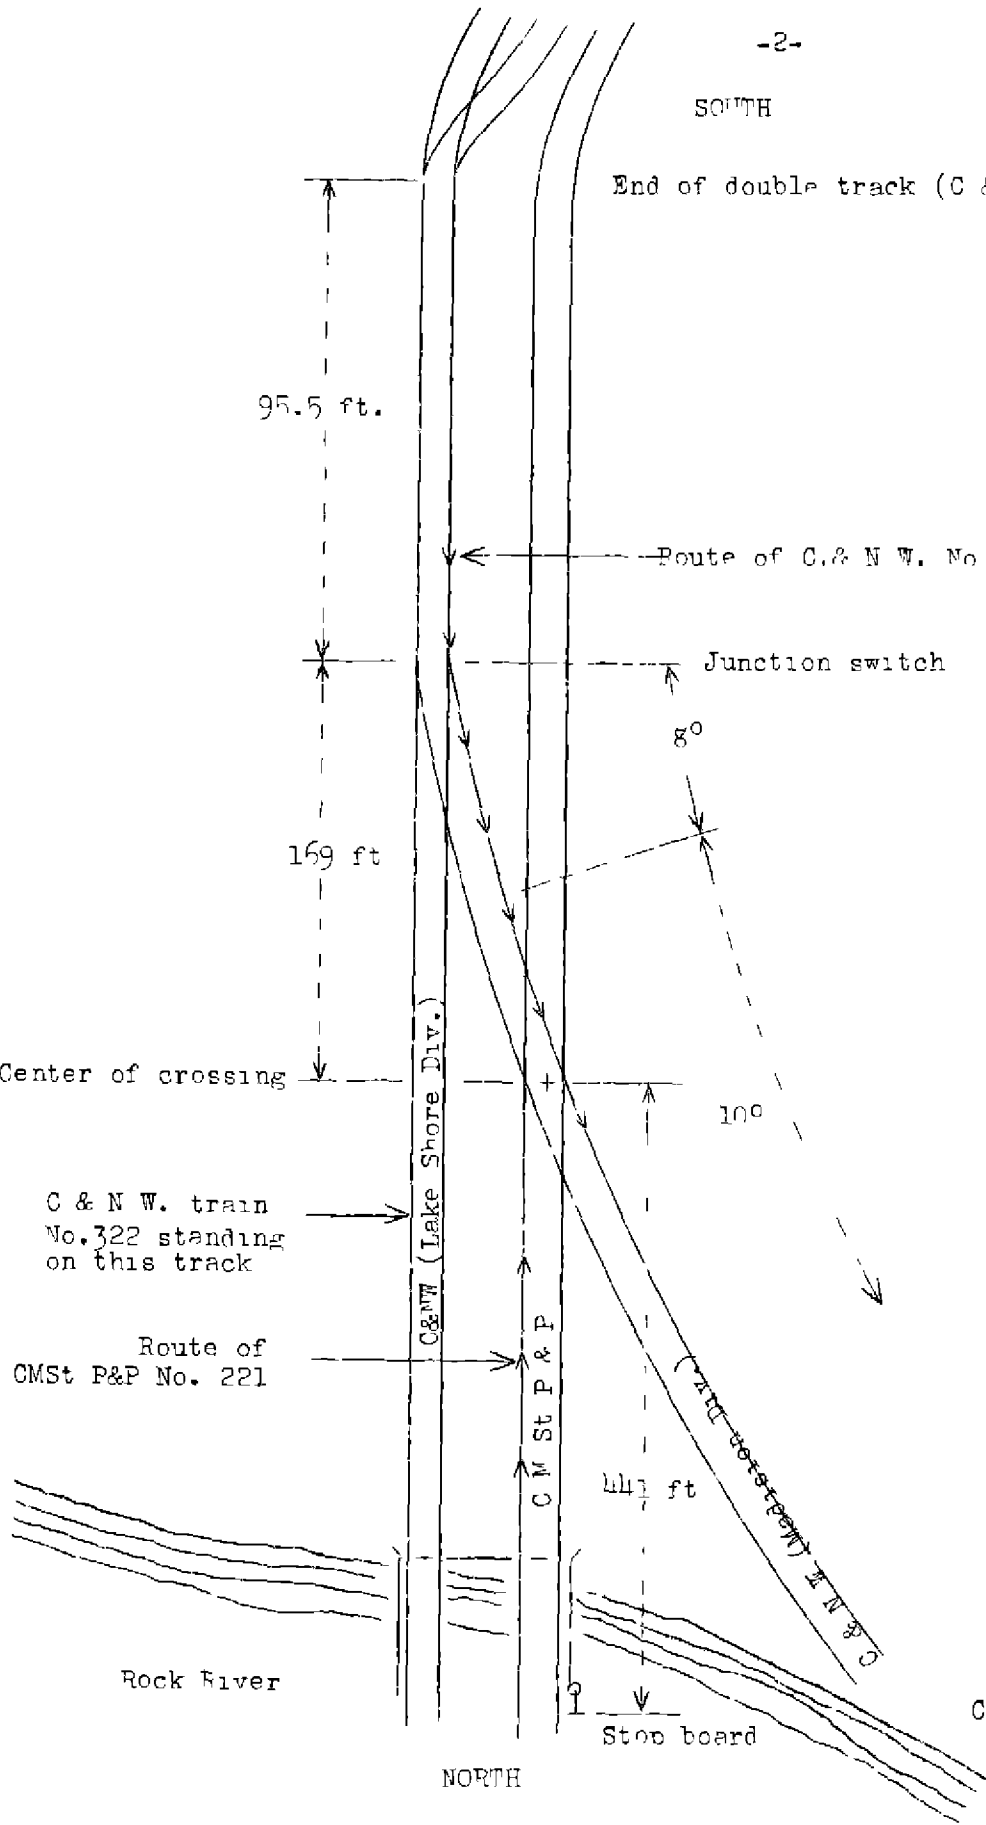
Inv No 1609
C M St. P. & P. - C & N W
Janesville, Wis
Jan 18, 1930

This accident occurred at the intersection of the tracks of the Madison Division of the C&NWRy and the Madison Division of the CMStP&PRP, near Race Street and between River Street and Franklin Street; in the immediate vicinity of the point of accident both roads are single-track. On the C&NW lines in each direction there are automatic block signals but for a distance of 366 feet adjacent to the crossing train movements are governed by time-table and train orders, trains of the CMStP&PRR are operated by time-table, train orders and a manual block-signal system. The tracks of the two roads intersect at an angle of $10^{\circ} 14'$ and the grade is practically level. Both trains involved were westbound, according to time-table direction, but for the purpose of this report compass directions are used. Approaching the crossing from the southwest, the direction from which the C&NW train approached, and beginning at the junction switch of the Lake Shore Division and the Madison Division, the switch being located 169 feet southwest of the center of the crossing, there is a compound curve to the left extending to and beyond the crossing. Approaching the crossing from the north, the direction from which the CMStP&P train approached, the track is tangent to and for a short distance beyond the crossing. On the CMStP&P RR there is a railroad crossing stop sign located on a telegraph pole on Rock River bridge at a point 441.5 feet from the center of the crossing, there was no stop sign on the C&NWRy at the time of the accident. There is no interlocking plant at this point, and it is provided by State law that all trains shall come to a full stop before arriving at or crossing the track of another railroad at grade, not protected by interlocking, and within 400 feet thereof; and the train arriving near said crossing first shall cross and move on first.

Approaching the crossing from the southwest on the track of the C&NWRy from the vicinity of the junction switch a view of the crossing can be had across the inside of the curve from the fireman's side of an engine cab, however, while rounding the curve the fireman's view of the tracks north of the crossing is obscured from view by the engine; from the engineman's side of the cab the view of the crossing is considerably restricted around the outside of the curve. Approaching the crossing from the north on the track of the CMStP&PRR a view of the crossing can be had from either side of an engine cab for a considerable distance; however, a view of the approaching C&NW train could be had only from the fireman's side of the engine cab. At the time of the accident there was a C&NW freight train standing on the Lake Shore Division track of the C&NWRy which track parallels the CMStP&P track on the east, with the front end of the engine at a point approximately 191 feet north of the crossing.

There is no form of crossing protection at this point except the stop board located on the CMStP&PRR at a point 441.5 feet north of the center of the crossing; there is a daily movement of approximately 45 trains over this crossing, and the need for additional protection which would be provided by an interlocking plant should be given careful consideration.
