## INTERSTATE COMMERCE COMMISSION

REPORT OF THE DIRECTOR OF THE BUREAU OF SAFETY IN RE  
INVESTIGATION OF AN ACCIDENT WHICH OCCURRED ON  
THE CHICAGO & NORTH WESTERN RAILWAY AT BARRINGTON,  
ILL , ON NOVEMBER 21, 1931

December 11, 1931.

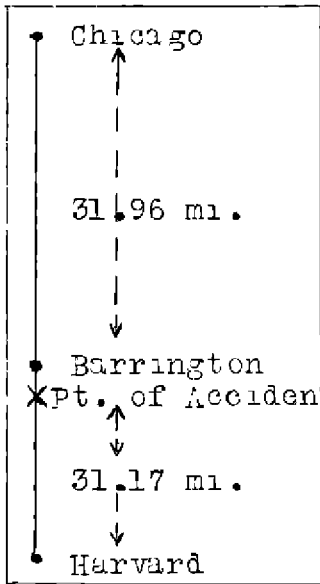
Inv. No. 1736  
Chicago & North Western Railway  
Barrington, Ill.  
November 21, 1931.

The signal governing eastbound movements in the block in which the accident occurred is interlocking home signal 2, a three-panel color-light signal, located at a point 565 feet west of the EJ&E crossing. The block extends a distance of 5,020 feet to the eastbound interlocking home signal for the remote control interlocking plant at the beginning of the three-track line. The circuits are so arranged that when the block is occupied the bottom or call-on panel may show yellow with the two top panels

displaying red lights, thus indicating "proceed at restricted speed" The approach or distant signal for the Barrington plant, governing eastbound movements, is a lower-quadrant, lever-controlled, slotted semaphore signal, located 3,350 feet west of home signal 2. This signal will have the blade in the horizontal position, displaying red and green lights, indicating "prepare to stop at next signal; train exceeding 30 miles per hour must at once reduce to that speed," when the track in advance is occupied, or when home signal 2 displays stop indications on the two top panels with the call-on arm displaying either red or yellow indications.
