INTERSTATE COMMERCE COMMISSION.

REPORT OF THE CHIEF OF THE BUREAU OF SAFETY COVERING INVESTIGATION OF AN ACCIDENT WHICH OCCURRED ON THE CHICAGO & NORTH WESTERN RAILWAY NEAR LEBANON, WIS., FEBRUARY 25, 1918.

DECEMBER 30, 1919

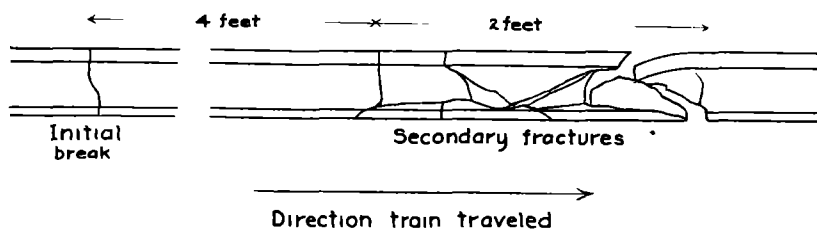
FIG 1 —Diagram showing lines of rupture of broken rail

A fracture of the base of the rail occurred, a partially developed crescent-shaped break, of the class of breaks commonly called half-moon fractures. The origin of the fracture was at a longitudinal seam

on the undersurface of the base about midway its width. The line of rupture followed the seam a short distance, then separated into three branches, two of which curved outward and extended to the edges of the flanges, while the third passed upward through the web and the head, thus completely separating the rail. At a distance of 4 feet beyond this point a group of secondary fractures were formed, covering a length of 2 feet. Here the rail was broken into six or eight small fragments. An opening in the track was made by the dispersion of these fragments, directly resulting in the derailment of the train.

Figure No. 1 is a diagram showing the lines of rupture in the present rail. The initial break, which was a brittle one, and which developed as above described, weakened the rail and led to the formation of the secondary lines of rupture. These are more fully
