INTERSTATE COMMERCE COMMISSION.

REPORT OF THE CHIEF OF THE BUREAU OF SAFETY COVERING THE INVESTIGATION OF AN ACCIDENT WHICH OCCURRED ON THE CHICAGO GREAT WESTERN RAILWAY NEAR WYETH, MO , ON JANUARY 3, 1920

APRIL 29, 1921

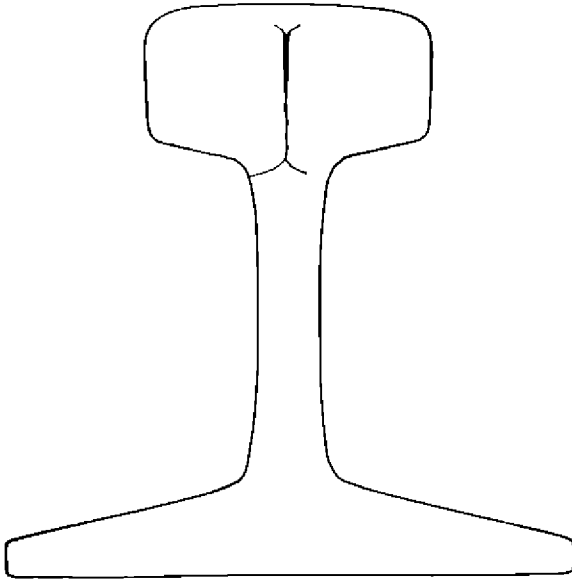
Fig A Typical split head fracture

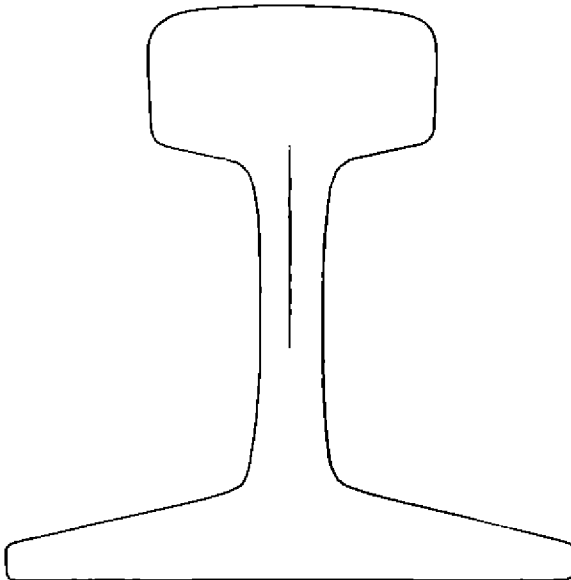
Fig B Typical piped rail

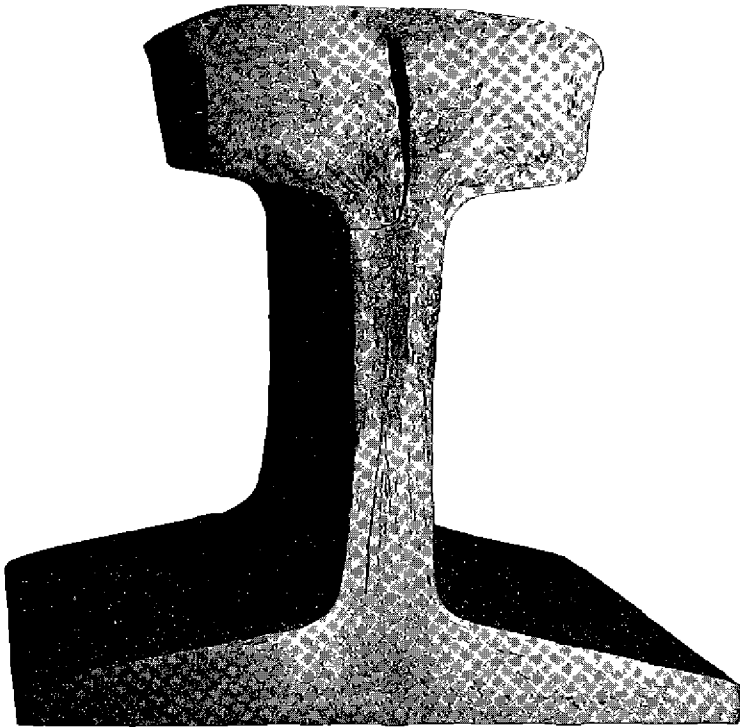
Figure No 1 shows the appearance of the rail, in cross section, near the fractured portion, after polishing and etching with tincture of iodine. The upper edge of the plane of rupture is characterized by the presence of markings on the end surface revealed by the tincture of iodine. These markings, here viewed on end, represent longitudinal streaks in the steel. They are lines of structural weakness, affecting the metal under crosswise strains.

The split in the head, shown at this stage of development, is much wider at its upper edge than elsewhere. The wedge-shaped rib of metal at its upper edge is forced by the successive wheel pressures between the faces of rupture, thereby increasing the width of the head.

The plane of rupture separated into two branches. One branch extended and reached the periphery of the section at the fillet under the head on the outside of the rail. The other branch extended toward the gauge side of the rail and appears in a partially developed stage.

FIG. 1—End view of rail polished and etched with tincture of iodine, showing relations of markings in upper part of head and origin of split head fracture

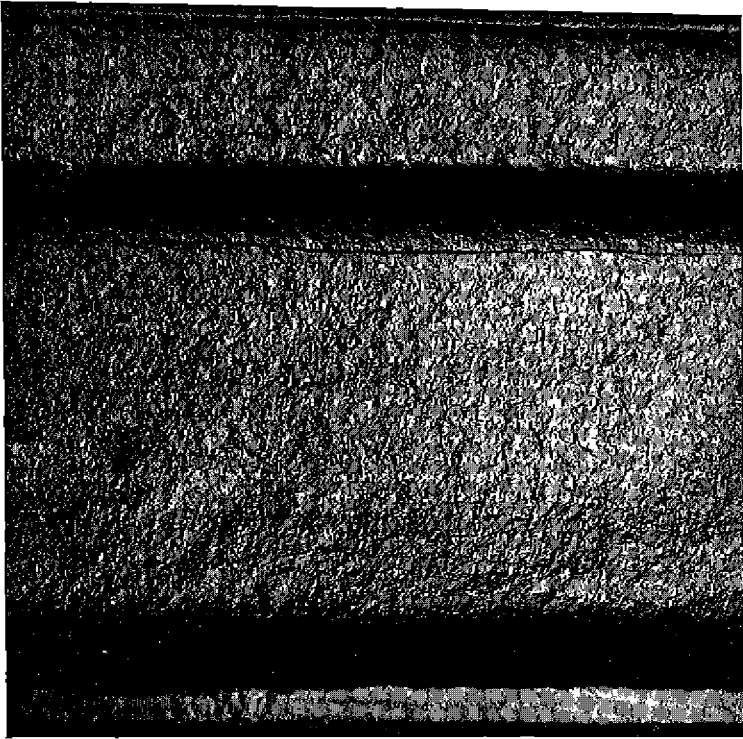
Figure No 2 is a side view of the rail showing the line of rupture under the head which had reached the peripheral surface. Figure No 3 is an endwise view farther along the length of the rail, where the split in the head was less developed. Fractures of this kind do not always continue in an unbroken course, but deviate under the influence of contiguous streaks in the metal. The end surface shown in this cut was polished and then etched with tincture of iodine.

FIG. 2--Side view of rail, showing longitudinal crack at the fillet under the head, where split head fracture had reached the peripheral surface of the rail

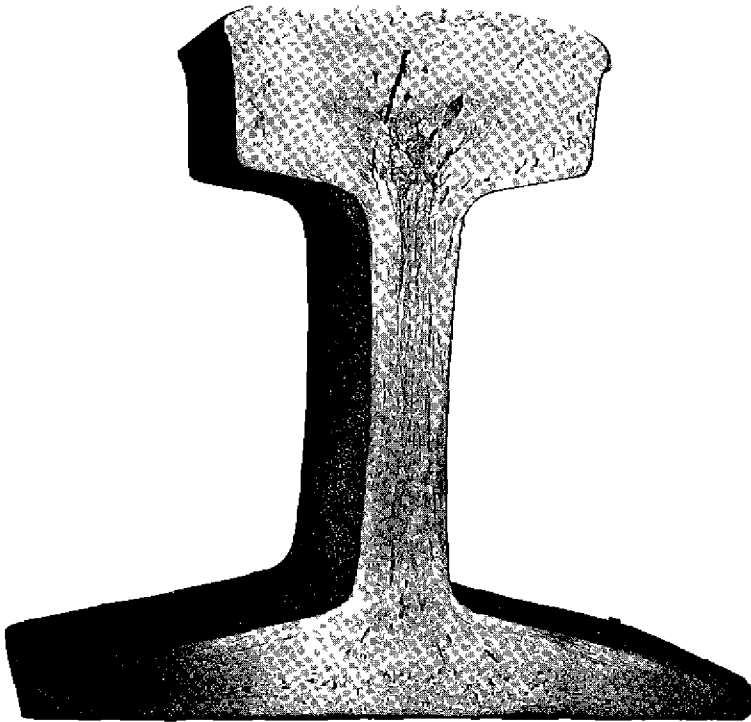
FIG 3—End view of rail, polished and etched with tincture of iodine. Cross section of rail where split head fracture was less developed than where shown by figure 1.

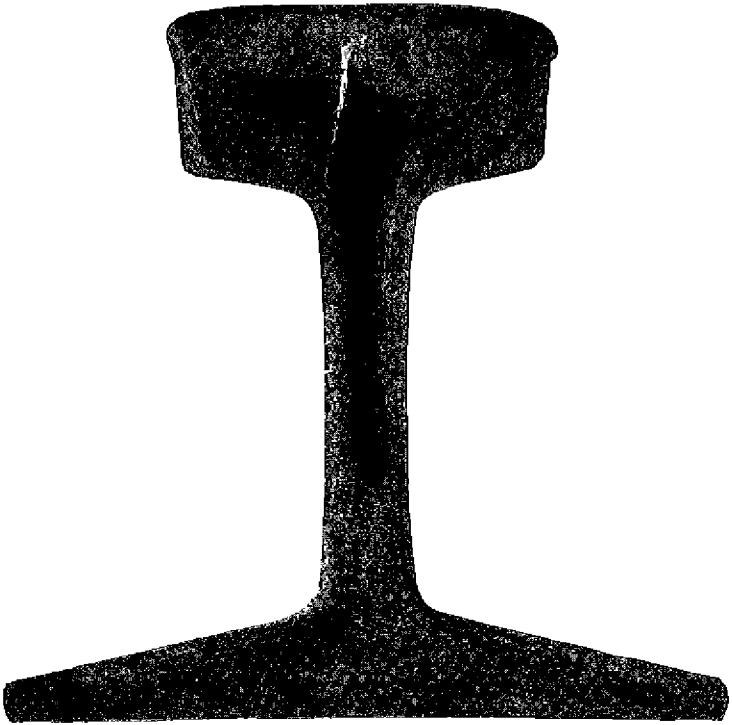
Figure No 4 is a sulphur print of the end surface shown by figure No 3. The markings are substantially the same as those revealed by the use of iodine. Figures Nos 5 and 6 are sulphur prints of longitudinal surfaces of the head and base, respectively, each about one-fourth inch below the peripheral surfaces. Other sulphur prints at different depths showed similar longitudinal streaks, but not coinciding with those on surfaces near by.

FIG 4--Sulphur pint of surface shown by figure 3
47603-21--3

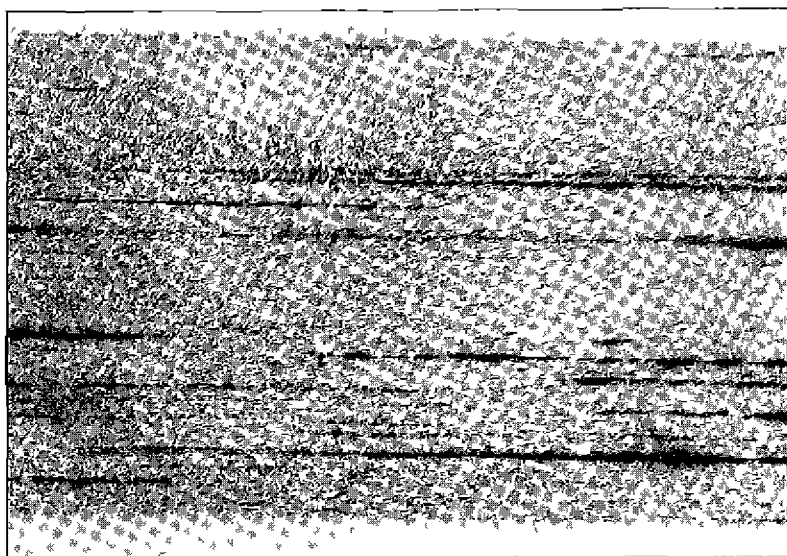
FIG 5—Sulphur print of longitudinal, horizontal surface of head of rail, $\frac{1}{4}$ "
planed off the running surface

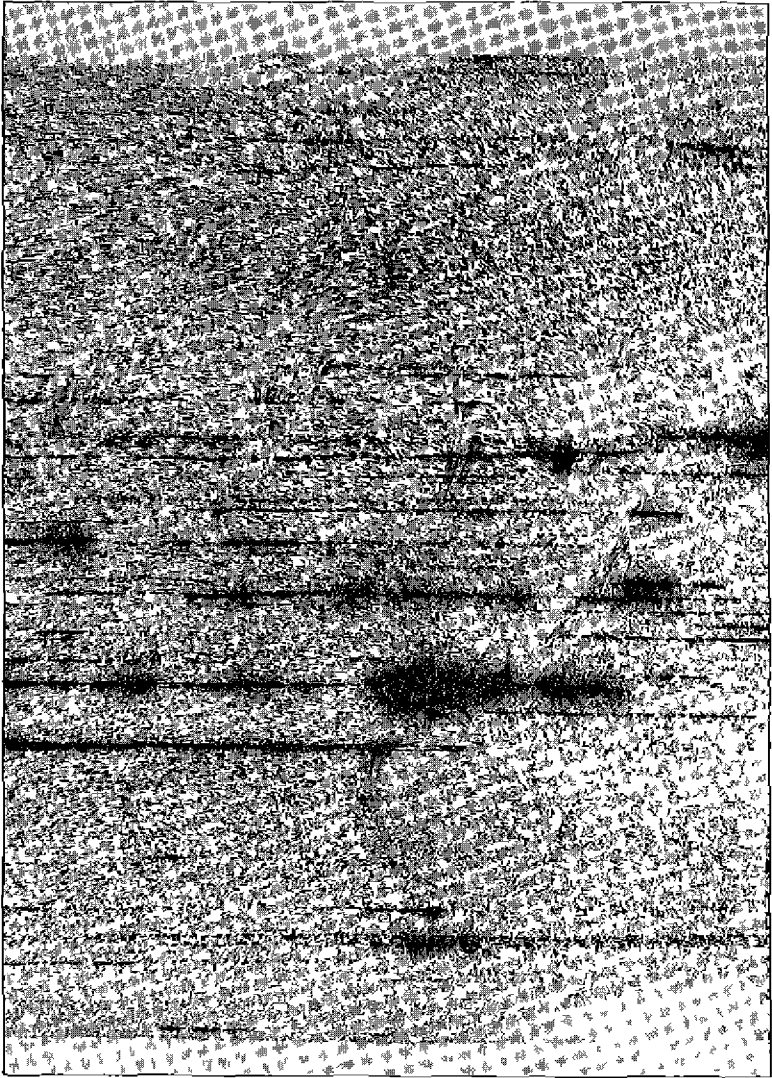
FIG 6—Sulphur print of longitudinal, horizontal surface of base of rail, $\frac{3}{4}$ "
planed off the bottom of the base

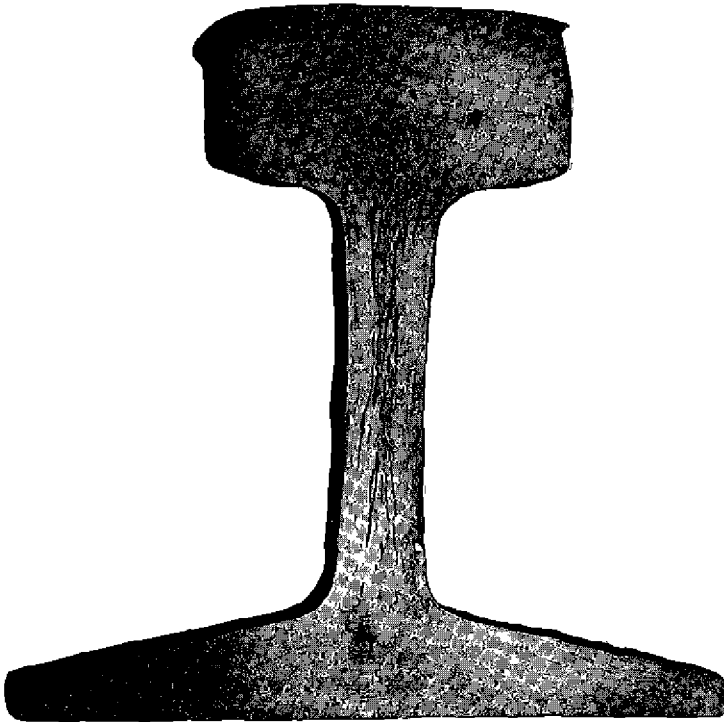
Figure No 7 represents the rail in cross section at a place where the head was intact. The iodine markings show the continuance of the structural conditions which prevailed in other parts of the rail. Figure No 8 represents another part of the rail where the head was intact. This section was pickled in hot hydrochloric acid. The same characteristic markings appear on the cross sections, whether revealed by polishing and etching with tincture of iodine, by means of sulphur prints, or upon pickling in hot acid.

FIG 7—Appearance of cross section of rail where head was intact, polished and etched with tincture of iodine

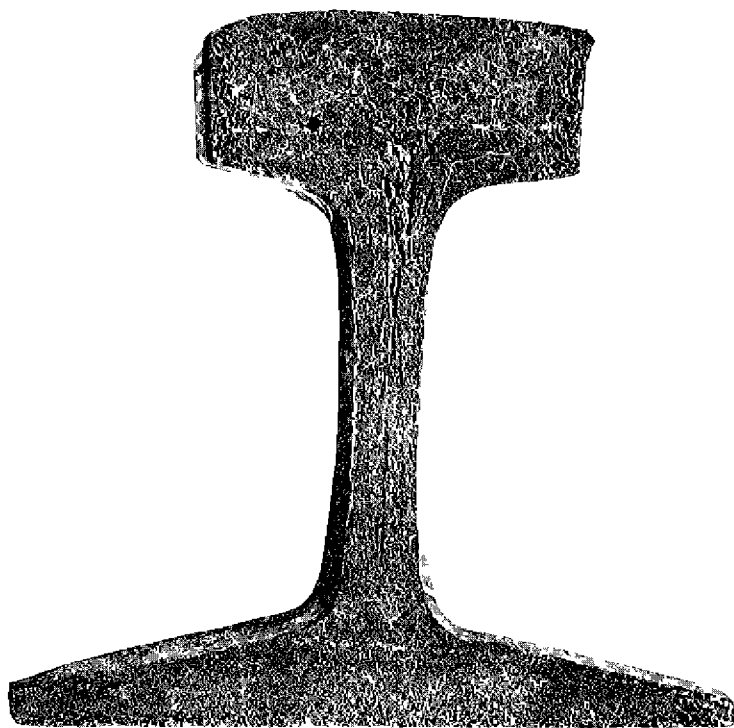
FIG 8—Appearance of cross section of rail, where head was intact, after pickling in hot hydrochloric acid

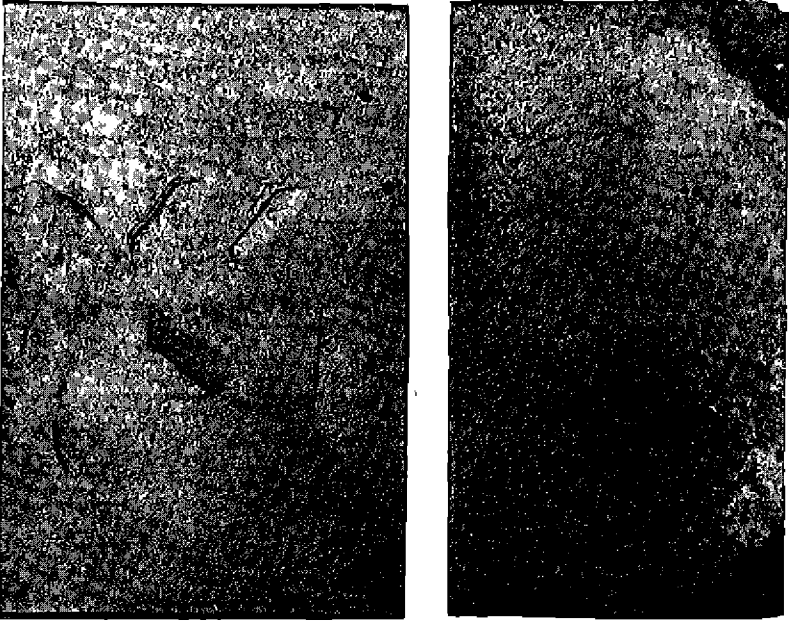
Opportunity was taken to further examine the Savan rail in quest of surface seaminess—a condition of the metal of the base which has led to many fractured rails. The results are shown by figures Nos 11 and 12. Figure No 11 represents the appearance of the base of the rail, two fragments, as it appeared when removed from the track. Spike-maul marks are shown on the left-hand figure of the cut. Figure No 12 shows the appearance of the surface of the base after pickling in hot hydrochloric acid. Surface seaminess, not in evidence on the rail as it came from the track, was revealed upon pickling.

FIG 11—80 pound rail which failed near Sayan, Pa Appearance of base before
pickling in hot acid

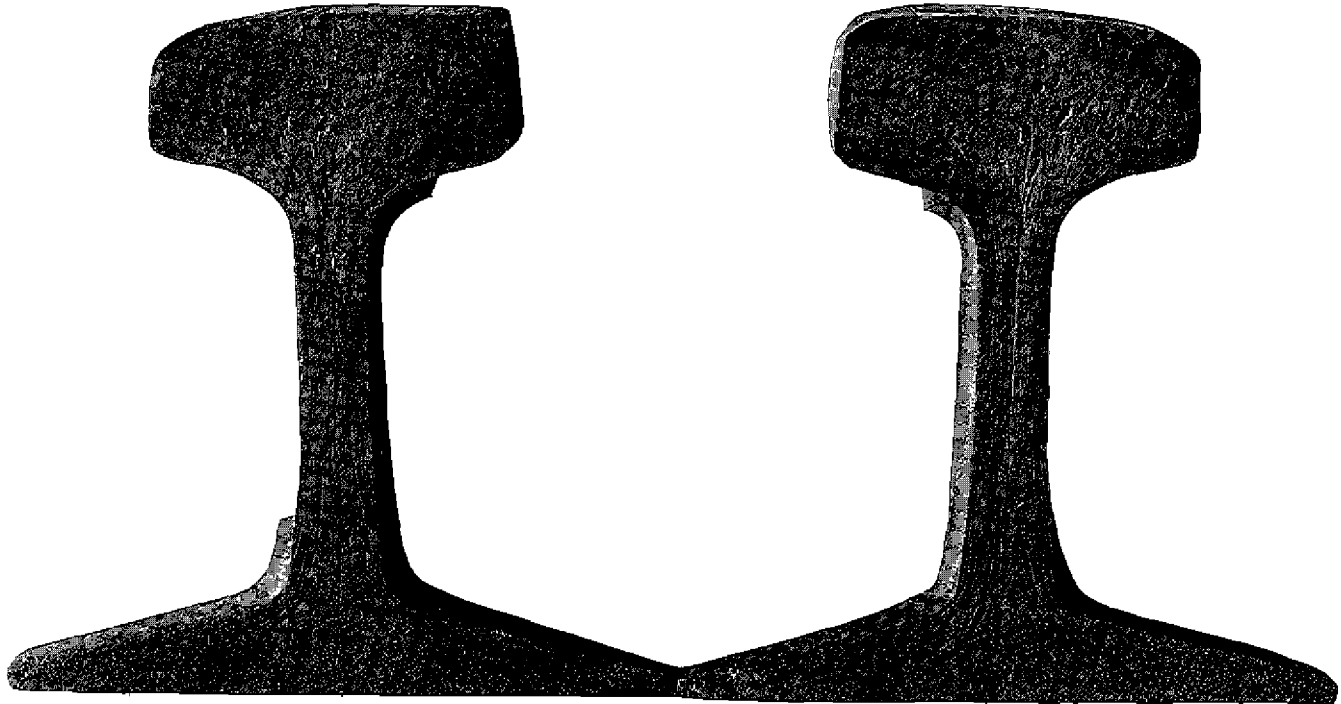
Two end surfaces of the Savan rail as they appeared after pickling are shown by figure No 13.

FIG. 13—80 pound rail which failed near Savan, Pa. Cross sections near place of fracture, showing appearance after pickling in hot acid

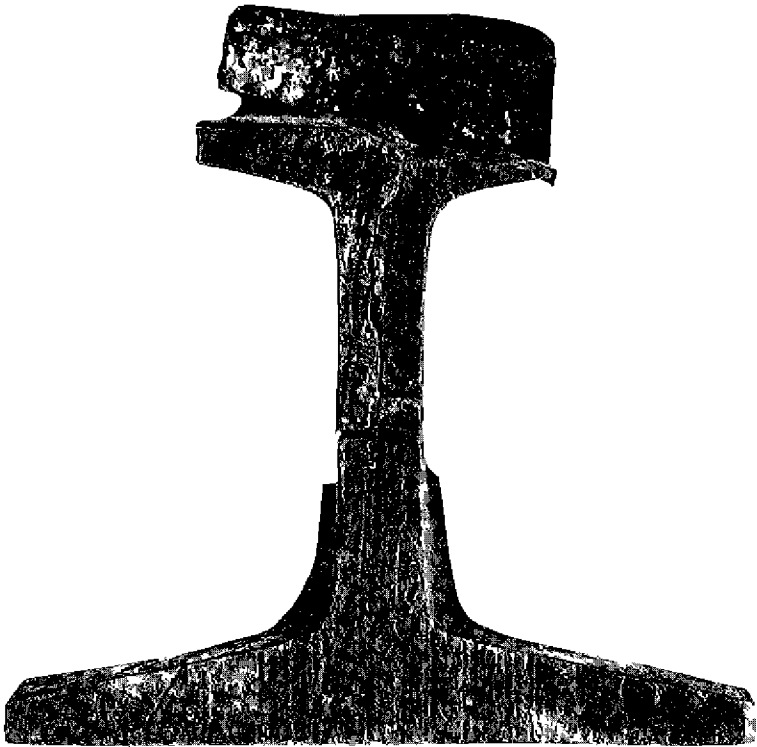
Figure No 14 shows the hot sawed end of the Friendship rail. The vertical line of separation in the web shows the characteristic feature of a piped rail. This rail displayed a composite fracture in which its piped condition was probably the leading cause. Associated with the plane of rupture in the web, there was a horizontal

shearing fracture in the head and also a split-head fracture. The piped state of the rail was embraced in part and reinforced by the splice bars. The support given the rail by the splice bars doubtless accounts for the display of the several types of rupture in immediate association with each other.

FIG 14—90 pound rail which failed near Friendship, N Y, Erie Railroad
View of hot sawed end showing piped fracture in web, and horizontal
shearing fracture in the head

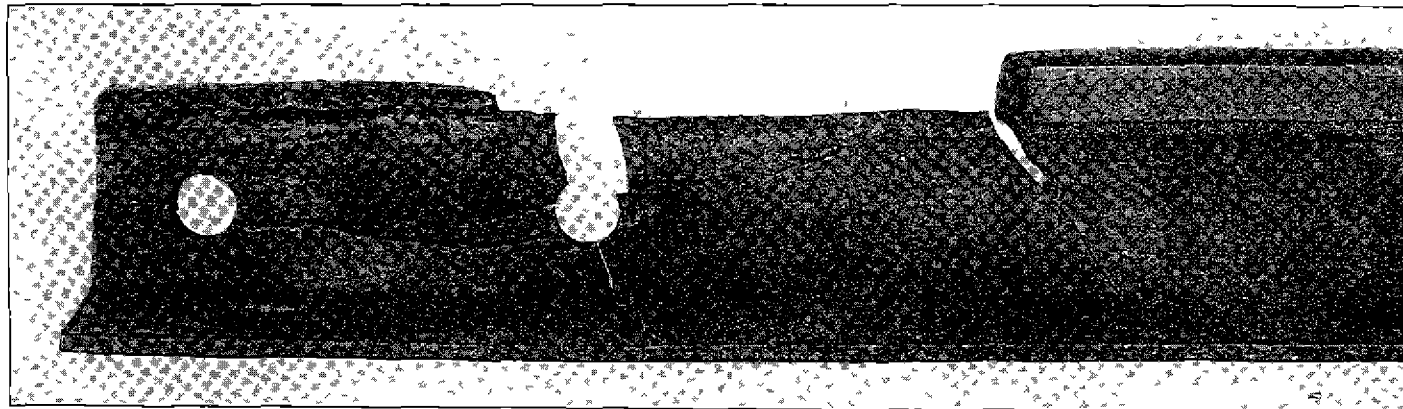
Figure No 15 is a side view of this rail showing the fractured surface of the web between the bolt holes and partially exposed a short distance beyond. Above this portion of its length the head of the rail was broken in a crosswise direction in addition to a vertical plane of rupture which nearly separated it into halves. Both the pipe and the split-head fracture continued beyond the limits of this photograph.

FIG 15—90 pound rail which failed near Friendship, N Y Side view, showing surface of piped fracture of web Head detached

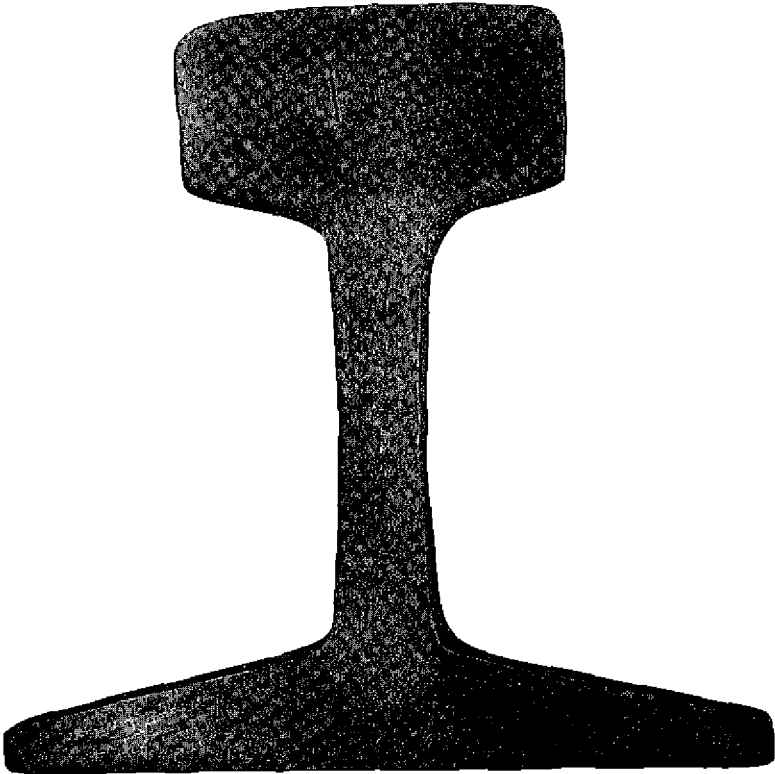
Figure No 16 is a view in cross section of the Friendship rail farther along its length, photographed after polishing and etching with tincture of iodine. The pipe extended into this section. The opposite faces were in close proximity to each other, hence the pipe does not show in this cut. The split in the head had separated and is clearly visible.

FIG 16---90 pound rail which failed near Friendship N Y Cross section at place beyond the limits of figure 15 Pipe in web obscurely shown, split in head visible

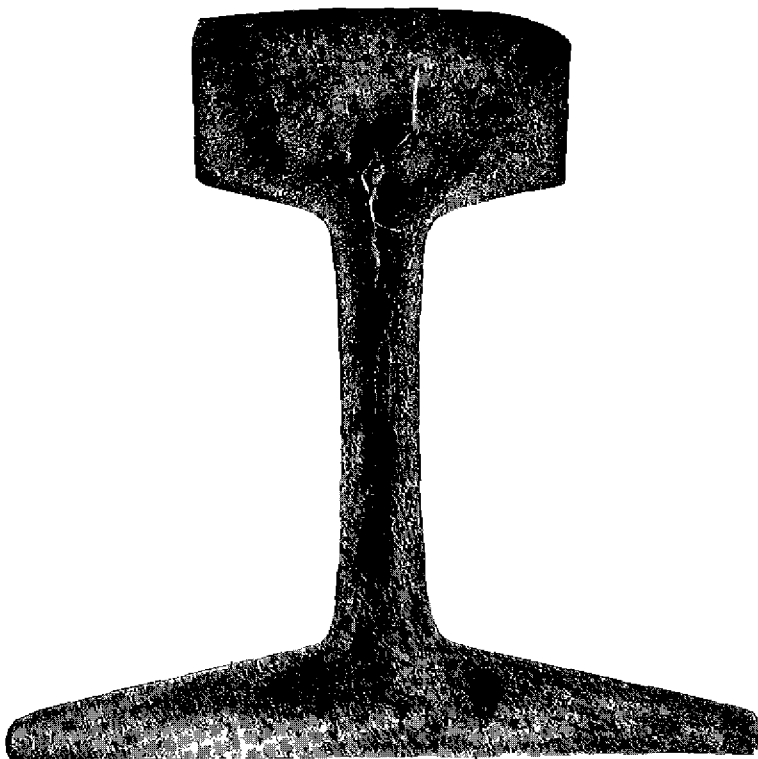
Figure No 17 is a sulphur print of the Friendship rail at a place where the pipe was clearly visible, and also where the split in the head was in an advanced stage. A lateral branch of the split-head fracture had nearly reached the peripheral surface of the rail at the fillet under the head on the gauge side. The fracture of the rail at this point is of interest in showing the dominating influence of the wheel pressures in relation to fractures in the head. The formation of a lateral branch of the split-head fracture doubtless resulted from the wheel pressures exerting a spreading effect on the metal at the top of the head. In the order of development the formation of this lateral branch probably was the last part of the fracture to occur. The walls of the split-head fracture were separated by the wedge action of the cold-rolled metal of the top of the head. When the medial line of pressure between the wheel and the rail occurs near either the gauge side or the outside edge of the head there is an overturning moment applied to the head. Such eccentric loading leads to the bifurcation of the line of rupture in the case of a split head. The different contours of the treads of wheels are responsible for different elements along the running surface receiving the maximum impinging pressures and causing the alternate loading of one side and then the other of the head of the rail. This alternate eccentric loading of the head accounts for the bifurcation of the vertical plane of rupture in a split-head rail abreast the junction of the head and the web where bending stresses in crosswise direction under such circumstances attain high limits. It will be inferred from the present exhibit and the remarks which are submitted that relatively there is a greater tendency, under the influence of track conditions, for

a rail to fail by the development of a split head than by reason of the presence of a pipe

FIG 17—90 pound rail which failed near Friendship, N Y Sulphur print at a place where it exhibited a piped web and a split head fracture a branch extending in the direction of the fillet on the gauge side of the web

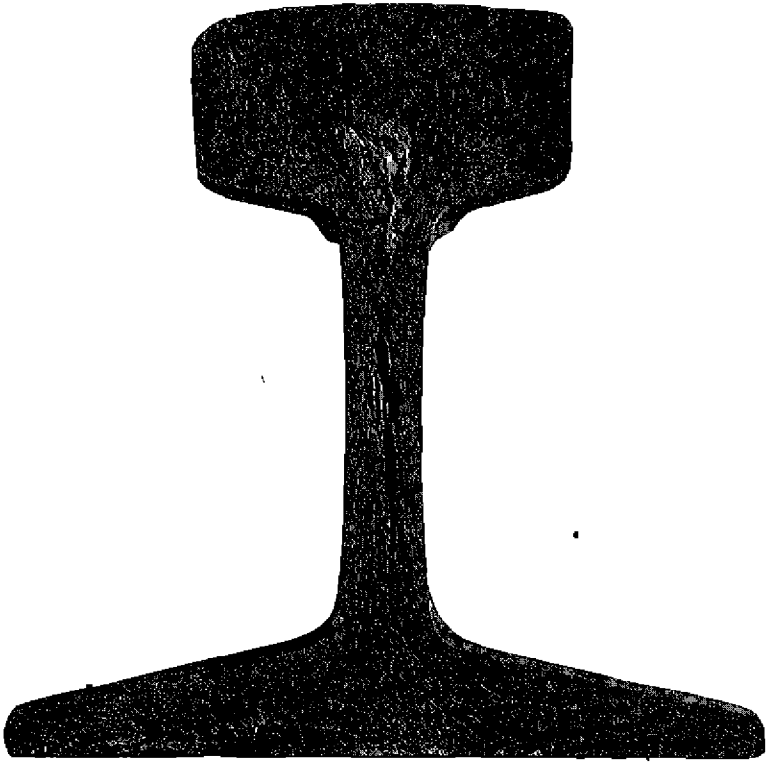
Figure No 18 shows the appearance of the Friendship rail after pickling in hot acid at the cross section upon which the preceding sulphur print was taken Greater solubility of the metal takes place at those places which are stained by the iodine, or marked on the sulphur print, than on other parts of the cross section, resulting in the close similarity of the illustrations furnished by these three methods

FIG 18—90 pound rail which failed near Friendship, N Y Appearance after pickling in hot acid, same cross section as shown by figure 17

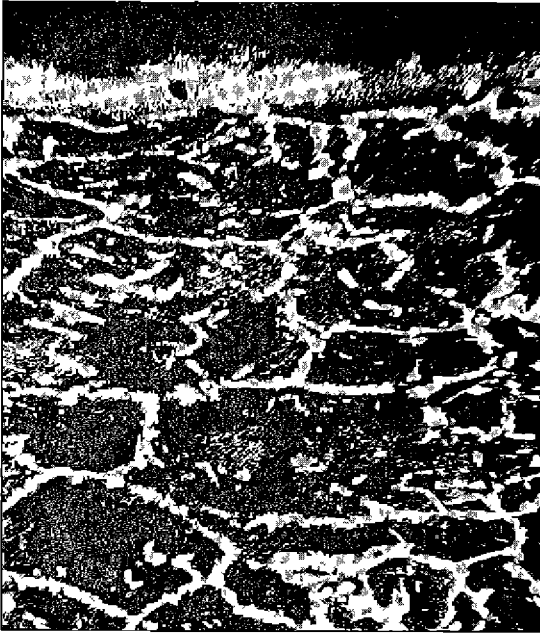
FIG 19—Photomicrograph of Wyeth rail, cross section shown by figure 7, just below running surface about in line with gauge side of web, showing flattening of the grain by wheel pressures. Magnification 100 diameters

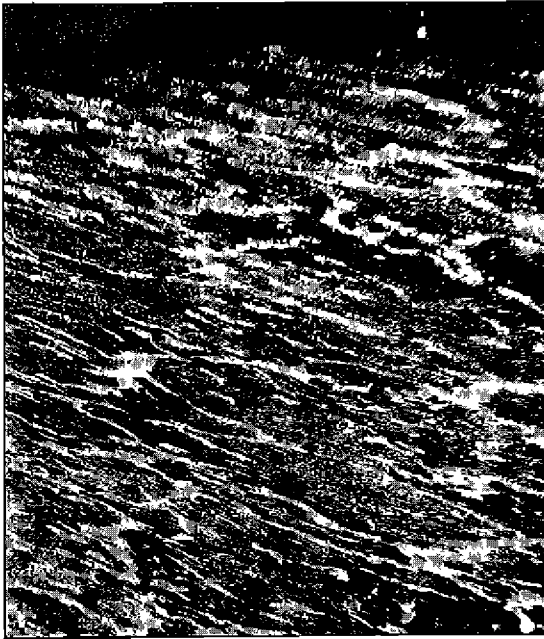
FIG 21 —Wyeth rail, same surface as shown by figure 19. Showing flattening of the grain and flow toward the outside of the head at a place between the outside of the head and surface shown by figure 19. Magnification 100 diameters.

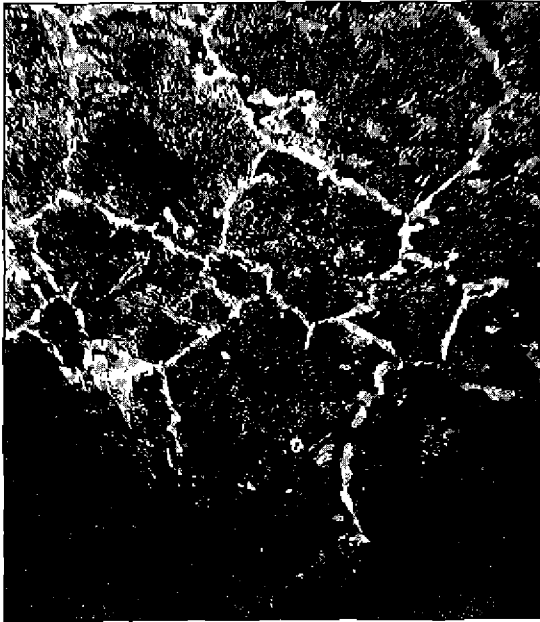
Figure No 23 represents the apex of the wedge-shaped rib at the upper terminal of the split-head fracture shown by figure No 1 There was no distortion of the grain at the apex of this wedge This illustration touches upon another feature in the behavior of metals--namely, that cubic compression, however great, and it has been observed up to a pressure of 117,000 pounds per square inch, has no permanent effect upon the structural state of the steel The wedging apart of the split-head fracture, therefore, does not demand there should be of necessity a distortion of the grain of the wedging member

FIG 23—Yyeth rail Microstructure of apex of wedge shaped rib at upper terminal of split head fracture shown by figure 1 Shapes of grains undisturbed Magnification 100 diameters

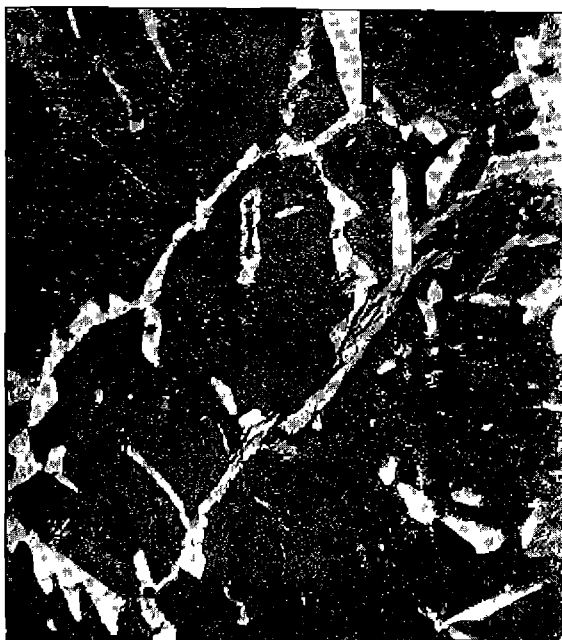
Figure No 24 shows the termination of the shorter branch of the bifurcated split head fracture illustrated in figure No 1 The crack in the steel is indicated by the oblique irregular line which appears in the cut, darker than the ferrite boundaries of the grains and lighter than the pearlite grains This appearance of the crack is due to its being filled with iron rust

FIG 24 —Wyeth rail Microstructure at shorter branch of bifurcated head fracture shown by figure 1 Crack shown by irregular oblique line intermediate in color between the ferrite boundaries and the pearlite grains penetrating steel without distortion of the grain Magnification 300 diameters

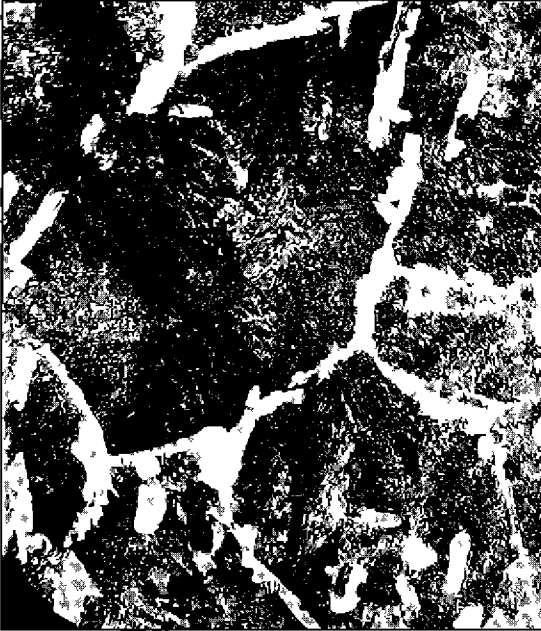
Figure No 25 shows the termination of the split-head fracture illustrated in figure No 3 The plane of the fracture at this place had deflected and approached nearer the fillet under the head than shown by figure No 1 The irregular black line extending obliquely downward in this cut represents the termination of the crack The surfaces of the fracture were not oxidized in this case

FIG. 25—Wyeth 1a1. Micro structure at lower terminal of split head fracture shown by figure 3. Crack shown by irregular dark line extending obliquely downward penetrating the steel without distortion of the grain. Magnification 300 diameters.
