# INTERSTATE COMMERCE COMMISSION

## REPORT OF THE CHIEF OF THE DIVISION OF SAFETY COVERING THE INVESTIGATION OF AN ACCIDENT WHICH OCCURRED ON THE CHICAGO, MILWAUKEE & ST PAUL RAILWAY AT OAKWOOD, WIS., ON JANUARY 30, 1915

APRIL 28, 1915

#### REPORT OF THE ENGINEER PHYSICIST

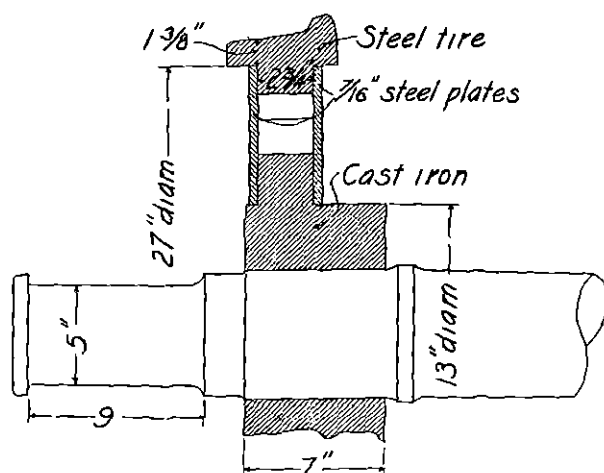
Figure No 2 shows the construction of this type of wheel, in a cross section, with cast-iron spider in place on the axle, inner and outer steel plates, and rolled-steel tire. The thickness of the tire here shown,  $1\frac{3}{8}$  inches in the plane of the outer plate, represents thickness at time of derailment.

No 2—Sectional view showing details of construction of built-up wheel consisting of cast iron hub, two  $\frac{7}{16}$ -inch steel plates and rolled steel tire

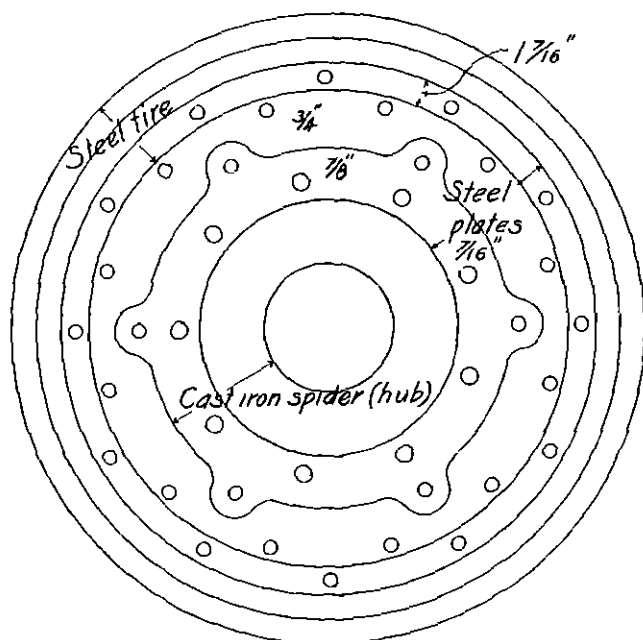
No 3—Side view of built-up wheel showing cast-iron spider with one  $\frac{7}{16}$ -inch steel plate and steel tire in place the outside  $\frac{7}{16}$ -inch steel plate removed

Figure No 3 is a side view of the wheel showing the cast-iron spider and the tire, with one of the plates, the outer one, removed

The cast-iron spider shown in figure No 3 represents the pattern used in 33-inch wheels, the size which failed in the truck of baggage car No 522. In wheels of larger diameter cored spiders of greater size are used in order to provide for the desired distribution of the bolts over the flat surfaces of these plates of increased width.

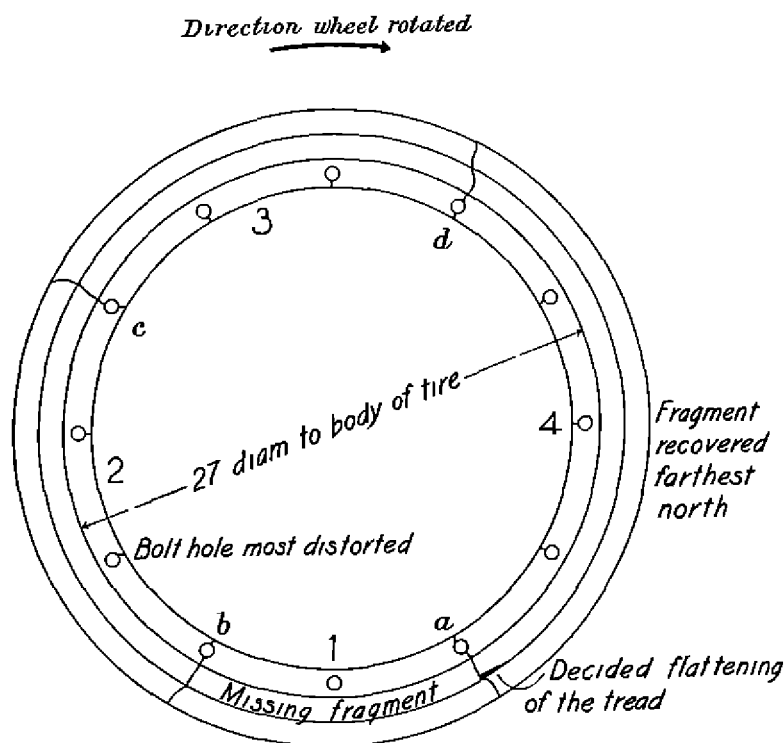
An examination of the fractured surfaces showed that each line rupture had its origin at the inner diameter of the tire, thence passing through the metal in an outward direction to the surface of the tread and through the flange.

The thin sections of metal between the bolt holes of the inner web and the inner diameter of the tire were fractured at each bolt hole. These incipient fractures, however, did not extend beyond the thin sections, excepting at those places where the full cross section was separated in forming the four detached fragments.

The principal lines of rupture are shown on figure No. 4, marked "a," "b," "c," and "d," on which the incipient fractures at the bolt holes are also indicated. The initial line of rupture of the tire is believed to have occurred between fragments 1 and 4, on the line marked "a," followed by that marked "b," thereby detaching the short fragment which was not recovered. The indications are that the line of rupture next to occur was that marked "d," in the development of which one-half of the tire was detached from the plate. This half, in its flight, evidently came into collision with some object which caused it to break apart at the middle of its length, at the line marked "c," in this manner forming the two fragments numbered 2 and 3.

No. 4.—Tire of built up wheel showing location of the four lines of rupture which were found at time of derailment separating the tire at bolt holes a b c and d. Incipient lines of rupture present at each of the other bolt holes of the recovered fragments.

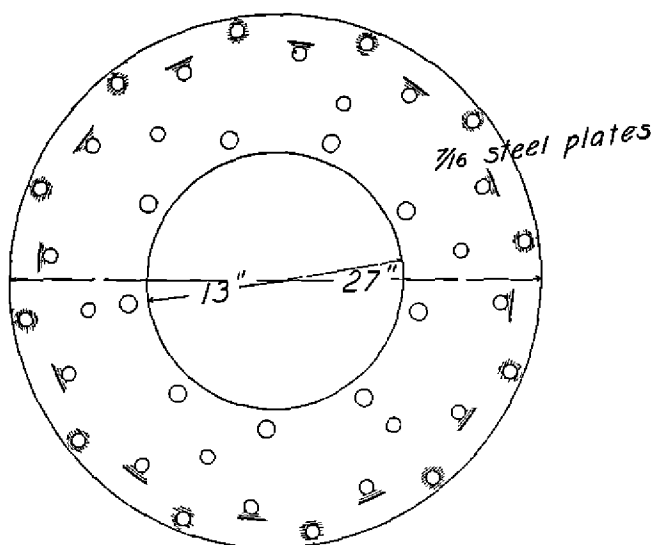
In the ruptured wheel it was found that appreciable wear had taken place at the bearing between the rims of the plates and the inside diameter of the tire, that is, at the junction of the inside web and tread. The tire was grooved, in some places the groove reached a depth of three-hundredths of an inch. This grooving evinced that a movement had occurred between the tire and the plates during the time the wheel was in service, and which doubtless had an influence in promoting rupture.

No. 5.—Plate of built up wheel. Evidence of movement between plate and tire found as indicated by the annular shaded zones around outer circle of bolt holes, the formation of shoulders on the face of plate by lines at the sides of the second circle of bolt holes.

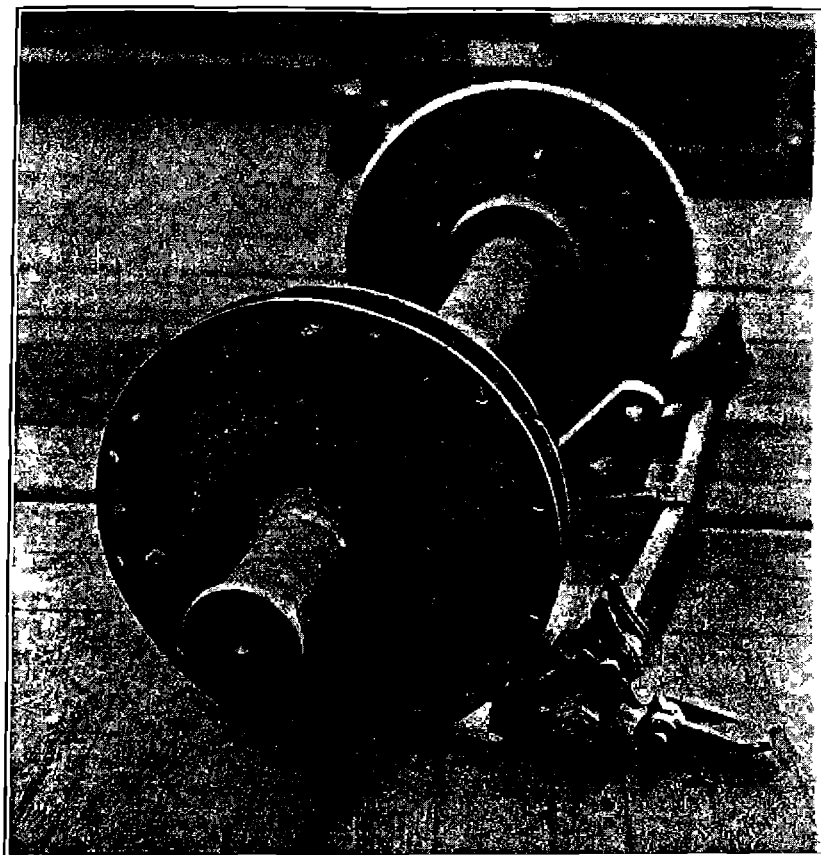
Figures Nos. 6 and 7 show the axle and wheels, one of which had the fractured tire. All of the fragments of the right-hand wheel were detached from the plates, as shown in figure No. 6, prior to the time the train came to rest. The left-hand wheel, shown in figure No. 7, which was otherwise intact was found upon examination to have incipient cracks at each of the bolt holes of the interior web of the tire. Heavy lines have been sketched on the cut to indicate more clearly the positions of these lines of rupture.

No 6 —Appearance of fractured wheel on axle as removed from truck after derailment. All fragments of tire were detached when train came to a rest.

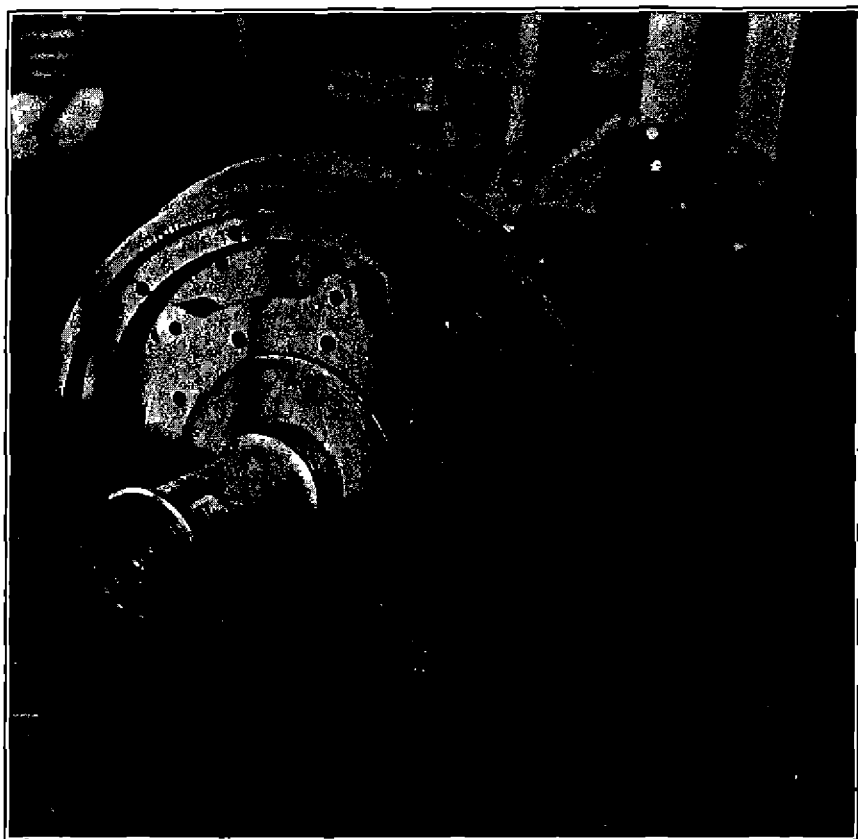
Grooving had taken place in the tire where the rims of the plates seated, although not to the same extent as that which was witnessed in the fragments of the broken wheel. Incipient cracks were found at each of the 12 bolt holes in this tire, across the thin sections between the bolt holes and the interior diameter of the web. None had extended to the metal on the opposite sides of the holes. When such extension occurs an early and complete failure of the tire would be expected, resulting in a cracked tire, visible at the tread. These incipient cracks, which were found to be comparatively numerous in wheels which were dismantled in quest of them, are not visible until the outer circle of bolts are taken out or one of the plates removed.

No 7—Wheel on opposite end of axle mate to fractured wheel Outside plate removed showing cast iron hub or spider steel tire and inside plate There were incipient cracks at each bolt hole of the tire as indicated in the cut

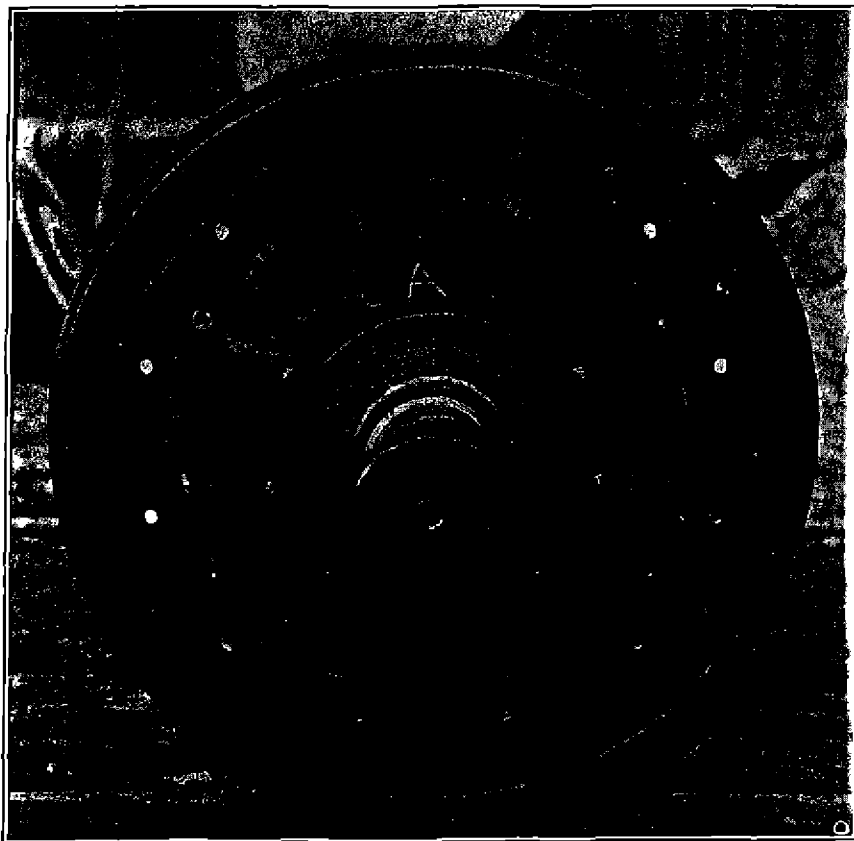
The incipient cracks which were found in the tires of wheels on an axle from sleeping car Beaver Dam are shown by figures Nos 8 and 9. These were 38-inch wheels, one of which developed a crack in service separating the tire at a bolt hole as shown by figure No 8. In this tire there was an additional fracture, an incipient crack at the fourth bolt hole from the line of rupture which separated the tire.

No 8 —38-inch built-up wheel from sleeper Beaver Dam. A. Removed from service on account of cracked tire. One additional crack at bolt hole shown when wheel was dismantled. Complete line of rupture of tire and incipient cracks indicated by crosses sketched on the cut.

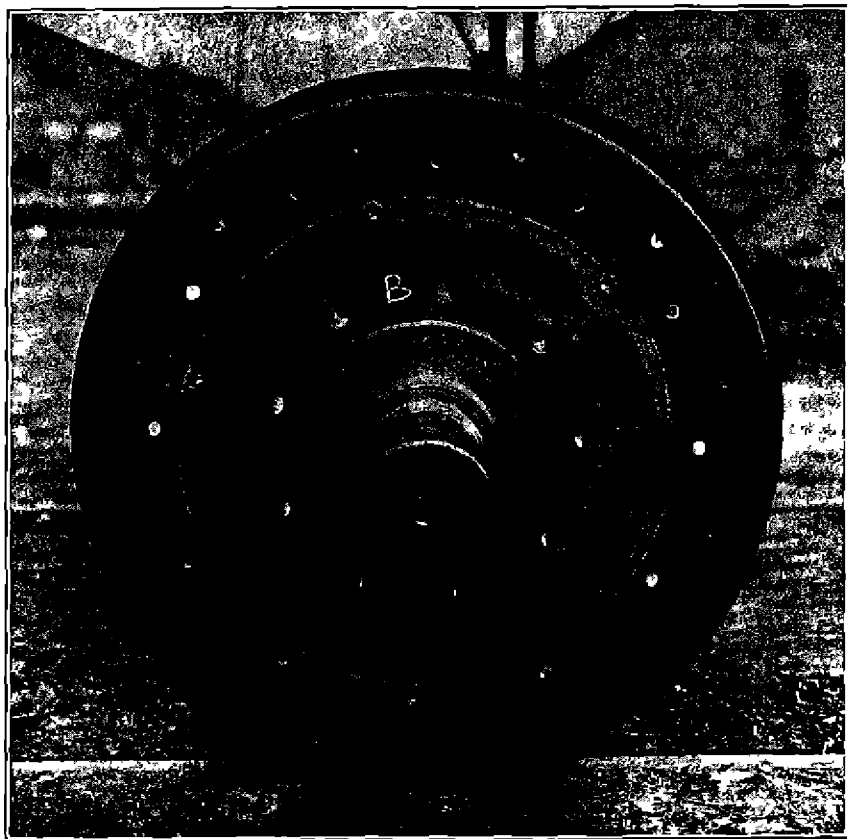
In the mate to this wheel there were six incipient cracks at bolt holes, the positions of which are shown on figure No 9. These two cuts represent the wheels with their outside plates removed, crosses sketched thereon indicating the positions of the fractures. Cored spiders are used on wheels of this diameter, as shown in these cuts.

No 9—38 inch built-up wheel from sleeper Beaver Dam B Mate of wheel A Six incipient cracks at bolt holes revealed when outside plate was removed and web of tire examined Position of cracks indicated by crosses sketched on the cut

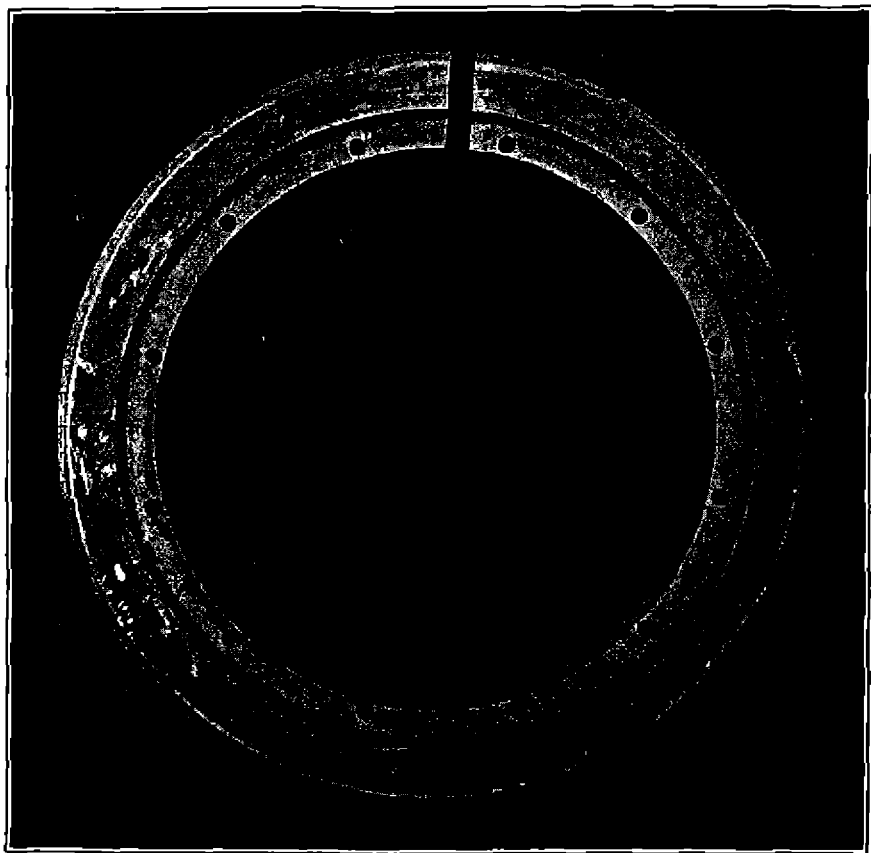
Figure No 10 shows a tire which had been cut apart radially. Two cuts in the slotter were made on this tire, each cut being 1 inch wide. After the first cut was made the ends sprung together, leaving an opening one-sixteenth inch wide. A second cut, 1 inch wide, was made which left the ends  $1\frac{1}{16}$  inches apart as shown in the illustration.

No 10.—Tire of built up wheel cut apart radially. Ends closed in  $\frac{1}{16}$  inch. Two inches width of metal was slotted out leaving the opening between the ends  $1\frac{1}{16}$  inches as shown in this illustration.

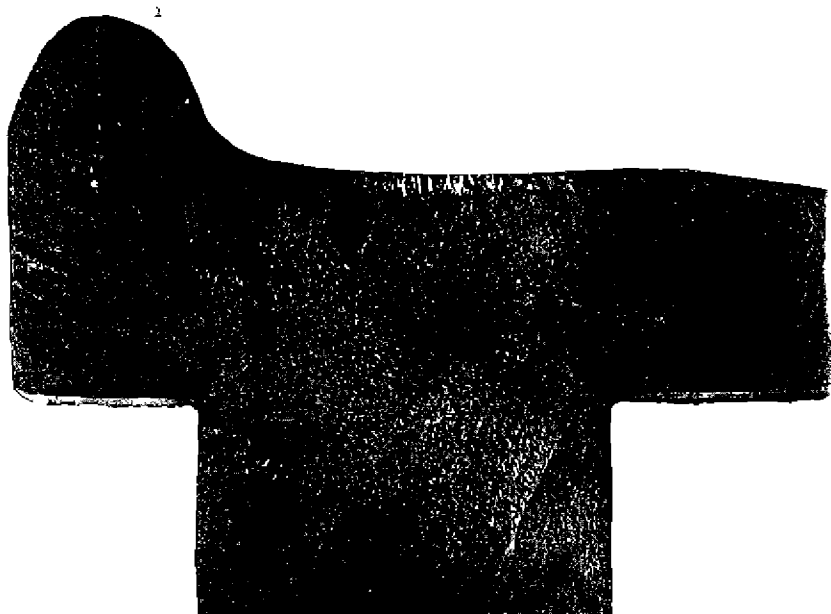
The seventh tire was from a detached wheel, which had been moved from service on account of a crack separating it. The failure of this tire differed from the others which were included in present examination, in respect to its passing through the full cross section between bolt holes. Furthermore, in its development it traveled in an opposite direction, starting from the outside or tread of the tire and extending across and radially inward.

No. 11.—Cross section of tire of built up wheel which fractured across full section of metal  $1\frac{1}{2}$  inches from a bolt hole. The line of rupture started at the corner of the outside face of the tire indicated by sketch on the illustration.

The incipient point of rupture was at the corner of the tread, the outside face of the tire. It was slotted along the line of rupture whereupon the ends closed in one-half inch. The appearance of the fractured surface of this tire is shown in figure No. 11, on which stars have been sketched to indicate the place where the line of rupture had its origin. This fracture had its origin at that part of the tire which is not exposed to cold rolling on the rail head, and only reached by the brake shoe. The metal appeared sound in that vicinity, but harder than at other parts of the tire. This illustrates a fracture occurring where increased hardness and brittleness of the steel has probably been induced by the action of the brake shoe, the severity of such action not having reached, however, a stage in which the

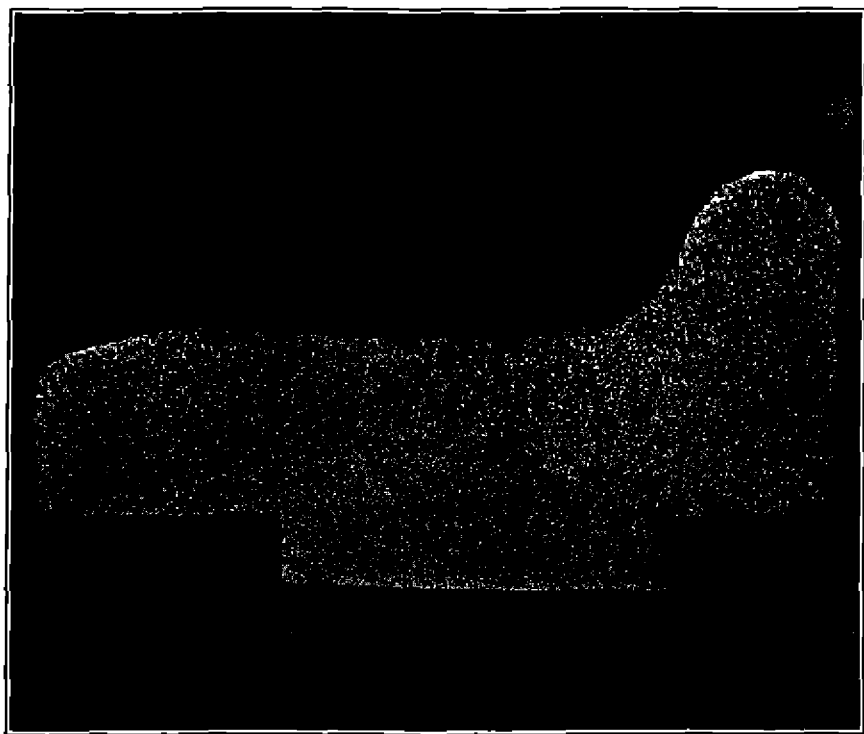
No. 12.—Cross section of tire of built up wheel showing the darkened surface of an incipient crack in the thin section of metal at side of bolt hole of the web. Line of rupture extended outward radially from the bolt hole.

Figure No 12 is introduced to show a line of rupture which traveled in the opposite direction from that illustrated in cut No 11 This line of rupture traveled radially outward from the bolt hole to the surface of the tread and through the flange It represents also a section of tire in which an incipient crack had formed, shown by the darkened metal between the bolt hole and the inner diameter of the web

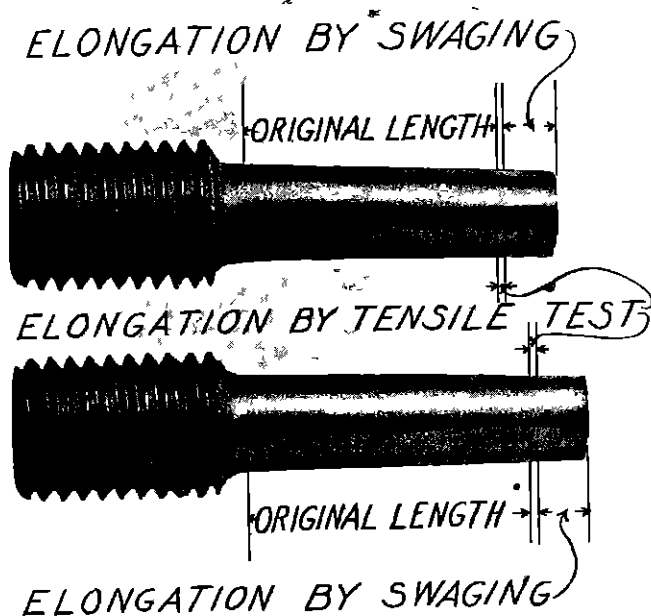
No. 14.—Fractured ends of tangential test piece. This specimen displayed 2.3 per cent extension in the tension test. Fractured ends subsequently cold swaged an additional extension of 16 per cent the metal still remaining intact tangentially.

Figure No. 14 shows the fractured ends of the tangential test piece after swaging. Lines are sketched across the stems indicating the amount of extension which was displayed in the tension test and the additional extension which was subsequently given the steel by the operation of swaging, representing its malleability.
