## INTERSTATE COMMERCE COMMISSION

### REPORT OF THE DIRECTOR OF THE BUREAU OF SAFETY IN RE INVESTIGATION OF AN ACCIDENT WHICH OCCURRED ON THE CHICAGO, MILWAUKEE & ST PAUL RAILWAY NEAR SACRED HEART, MINN., ON NOVEMBER 15, 1925

DECEMBER 10, 1925

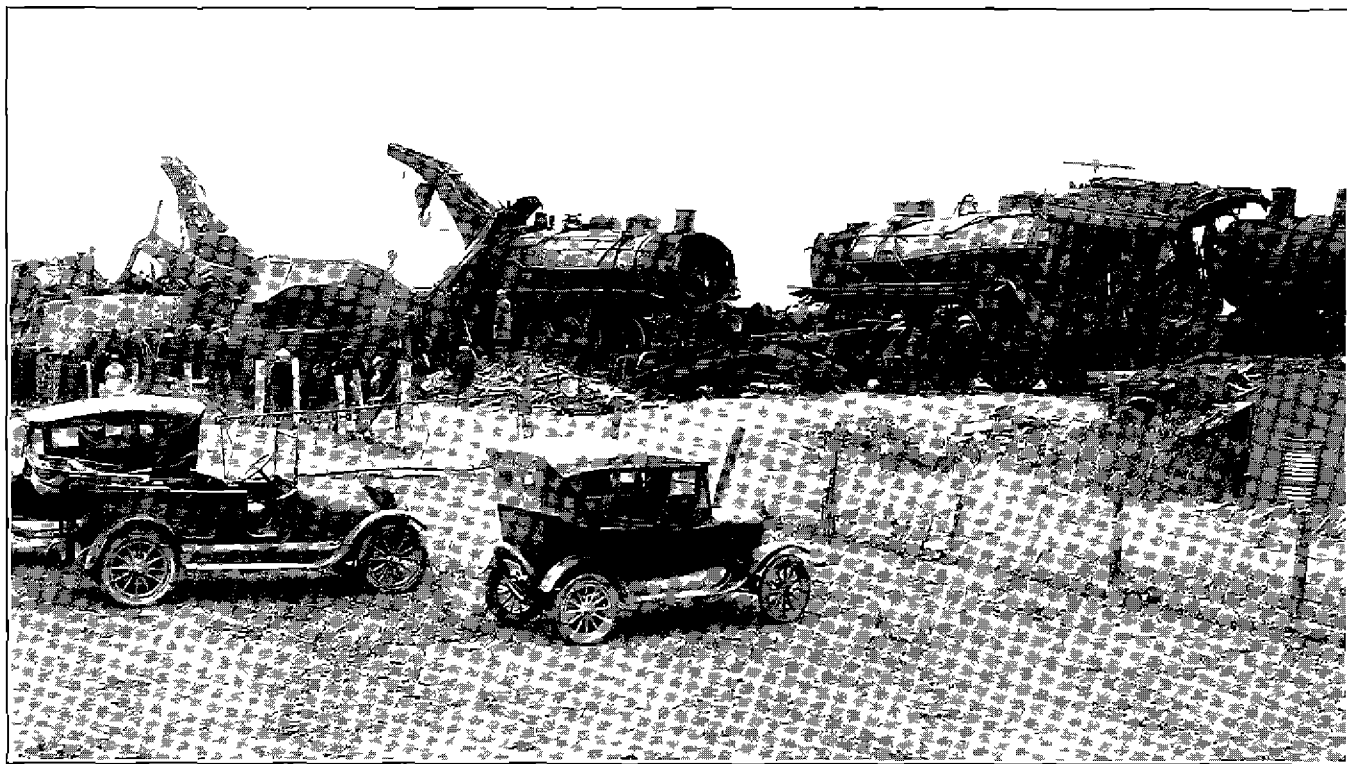
Engine 6305 was not derailed but was badly damaged, while its tender was destroyed, as was also the case with the first car in this train, other cars in train No 17 sustained minor damage. Engine 8100, the lead engine of train No 264, was not derailed, but engine

8052 was derailed and turned over on its right side, both of these engines being quite badly damaged. The first 10 cars in train No 264 were derailed, 3 of them being destroyed and the others more or less badly damaged. The employees killed were the engineman of train No 17, the engineman in charge of the second engine of train No 264, and the head brakeman of train No 264, who was riding on the lead engine.

FIG No 1—View from south side of track looking westward front of engine which appears on extreme right belongs to relief train

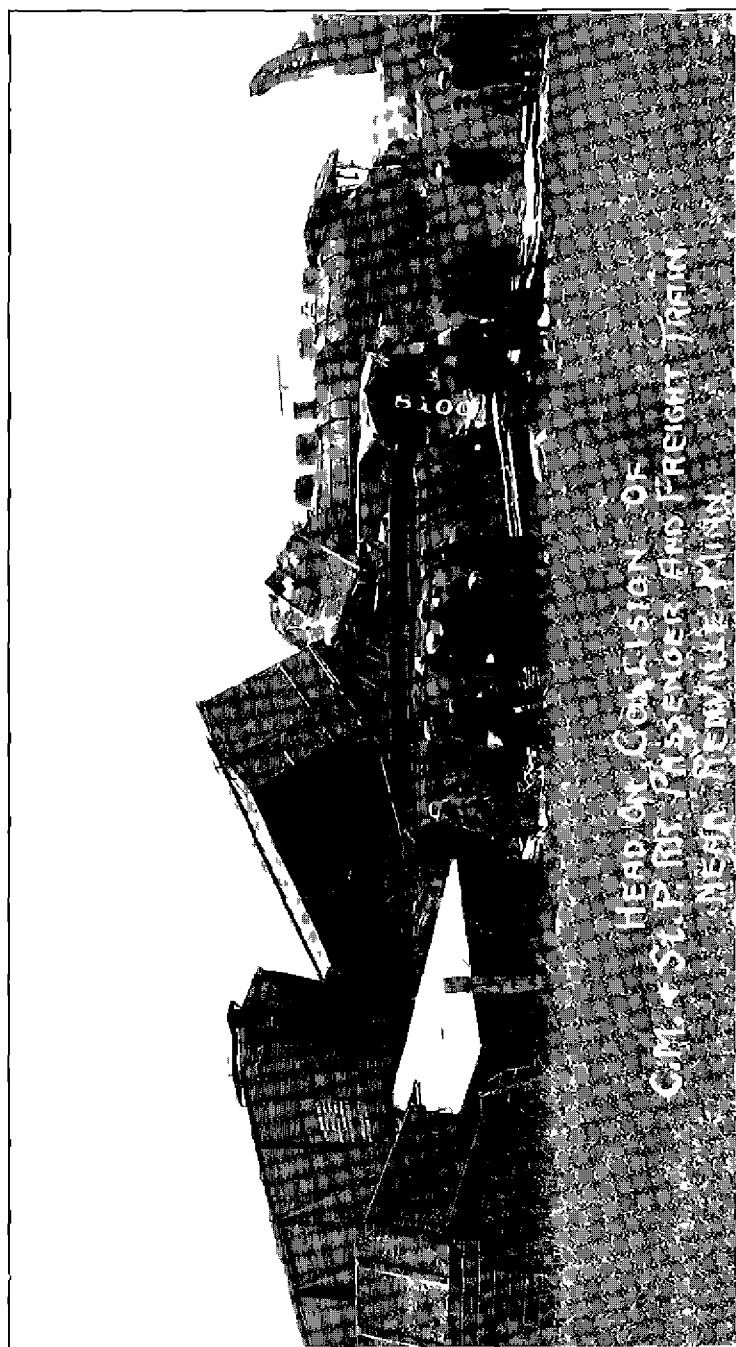
FIG No 2 — View from south side of track looking eastward

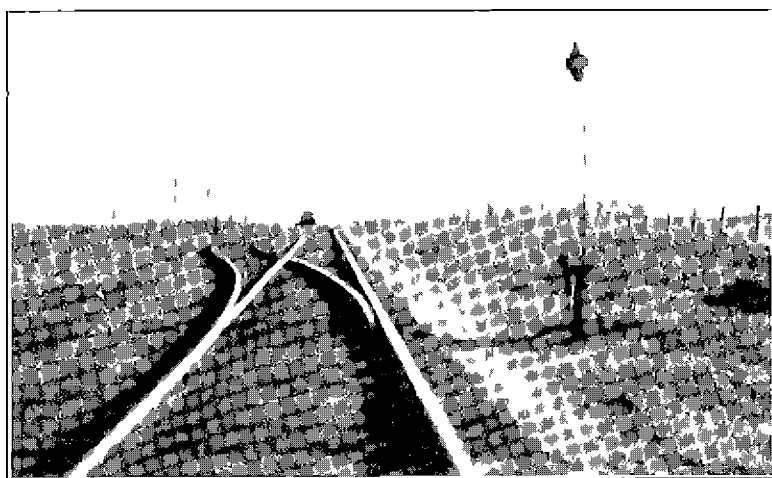
to the occurrence of the accident, the testimony of the three surviving members of the engine crews of train No 264 indicating that their train was some distance east of the storage-track switch, located only 1250 feet from the point of accident, before they realized that a collision was imminent, while the statements of the fireman of train No 17 as well as of the members of the train crew of that train indicated that there was a very short time interval between the application of the air brakes and the shock of the collision.

FIG. No. 3 - Looking toward point of accident from west storage track switch
