INTERSTATE COMMERCE COMMISSION

REPORT OF THE DIRECTOR OF THE BUREAU OF SAFETY IN RE INVESTIGATION OF AN ACCIDENT WHICH OCCURRED AT THE IN- TERSECTION OF THE TRACKS OF THE CHICAGO, MILWAUKEE, ST. PAUL & PACIFIC RAILROAD AND THE CHICAGO, ST PAUL, MINNE- APOLIS & OMAHA RAILWAY AT CAMP DOUGLAS, WIS, ON FEBRUARY 28, 1931

APRIL 3, 1931

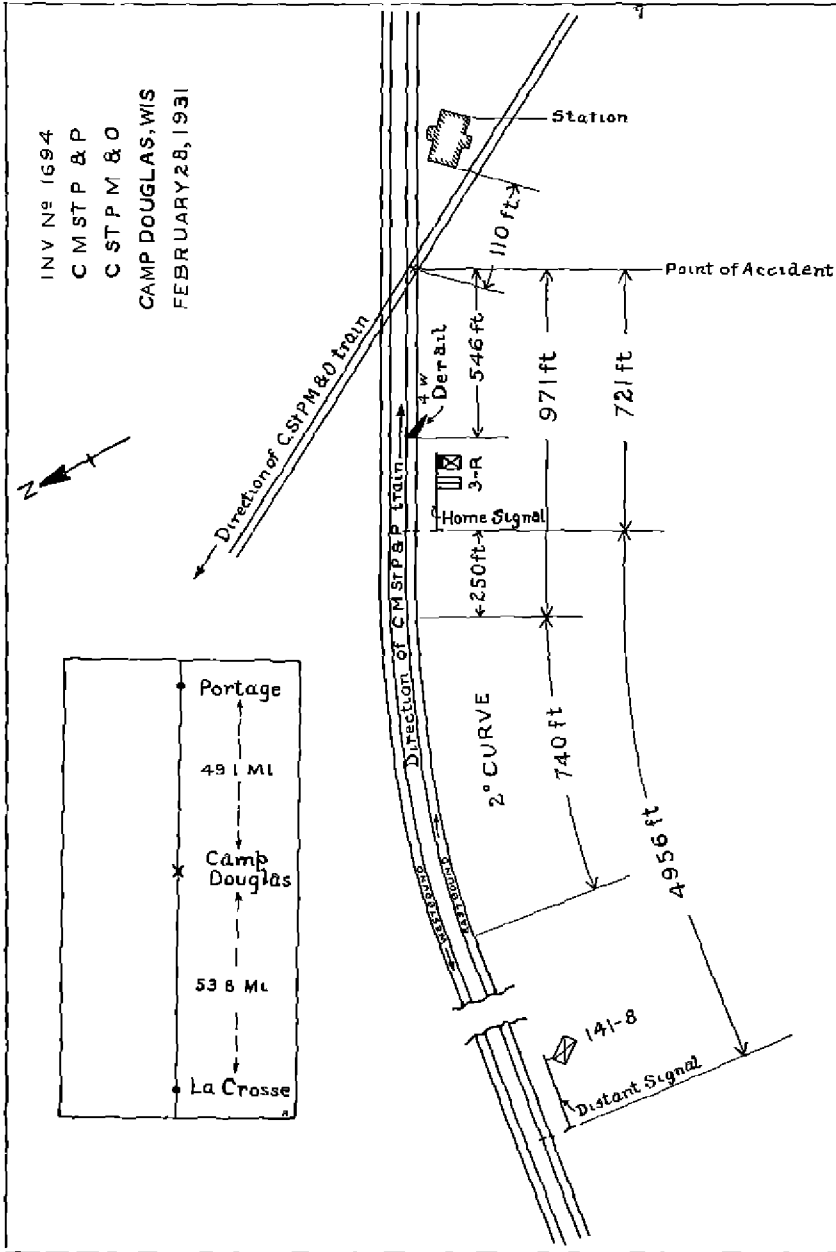
FIGURE 1—Track layout at Camp Douglas, with signals involved in accident

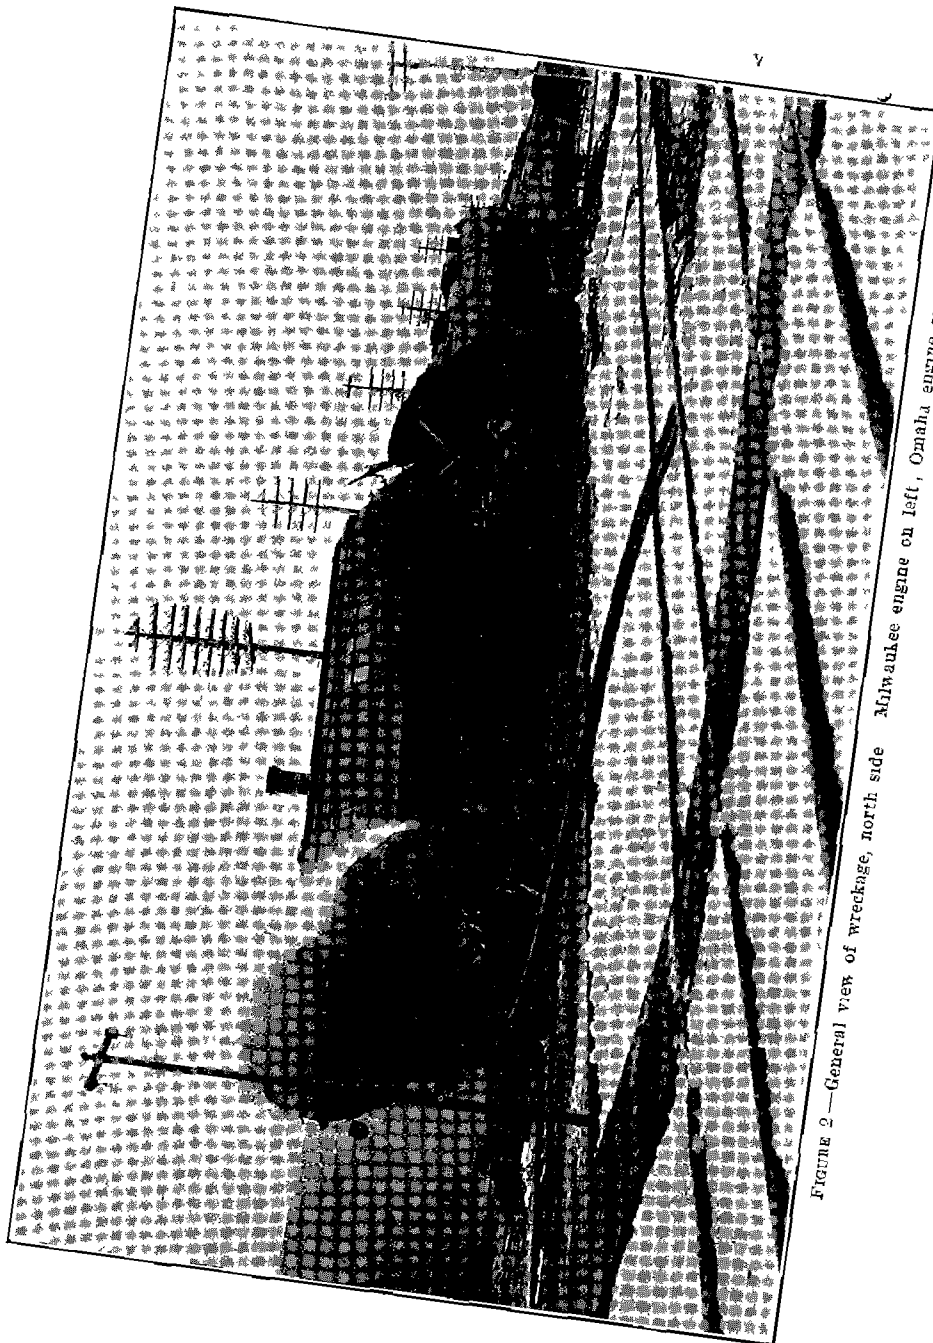
Chicago, Milwaukee, St Paul & Pacific engine 6409 collided with the left sides of the tender and the first car of Chicago, St Paul, Minneapolis & Omaha train No 515, passed over the crossing, and came to rest derailed and leaning to the right at an angle of 45°, near the west end of the station, in a badly damaged condition, the tender was also derailed but remained upright behind the engine. The first car of train No 16 stopped in an upright position in line with the Chicago, St Paul, Minneapolis & Omaha track and on top of the first car of train No 515. The second car of the Chicago, Milwaukee, St Paul & Pacific train stopped on the crossing, derailed and badly damaged, the front truck of the third car and one pair of wheels of the rear truck of the fifth car were also derailed, while the remaining equipment in this train was not derailed or damaged. Chicago, St Paul, Minneapolis & Omaha engine 601 was partly derailed and considerably damaged, and the tender and the first car of that train were derailed and badly damaged. The employee killed was the fireman of Chicago, Milwaukee, St Paul & Pacific train No 16, and the employees injured were the conductor and engineman of that train, the injured mail clerks, the Pullman employee and the passengers injured were also on Chicago, Milwaukee, St Paul & Pacific train No 16.

FIGURE 2—General view of wreckage, north side Milwaukee engine on left, Omaha engine on right
