U.S. INTERSTATE COMMERCE COMMISSION,

REPORT OF THE DIRECTOR OF THE BUREAU OF SAFETY IN RE  
 INVESTIGATION OF AN ACCIDENT WHICH OCCURRED ON  
 THE CHICAGO, MILWAUKEE, ST. PAUL & PACIFIC RAIL-  
 ROAD AT WADSWORTH, ILL., ON AUGUST 9, 1929.

November 18, 1929

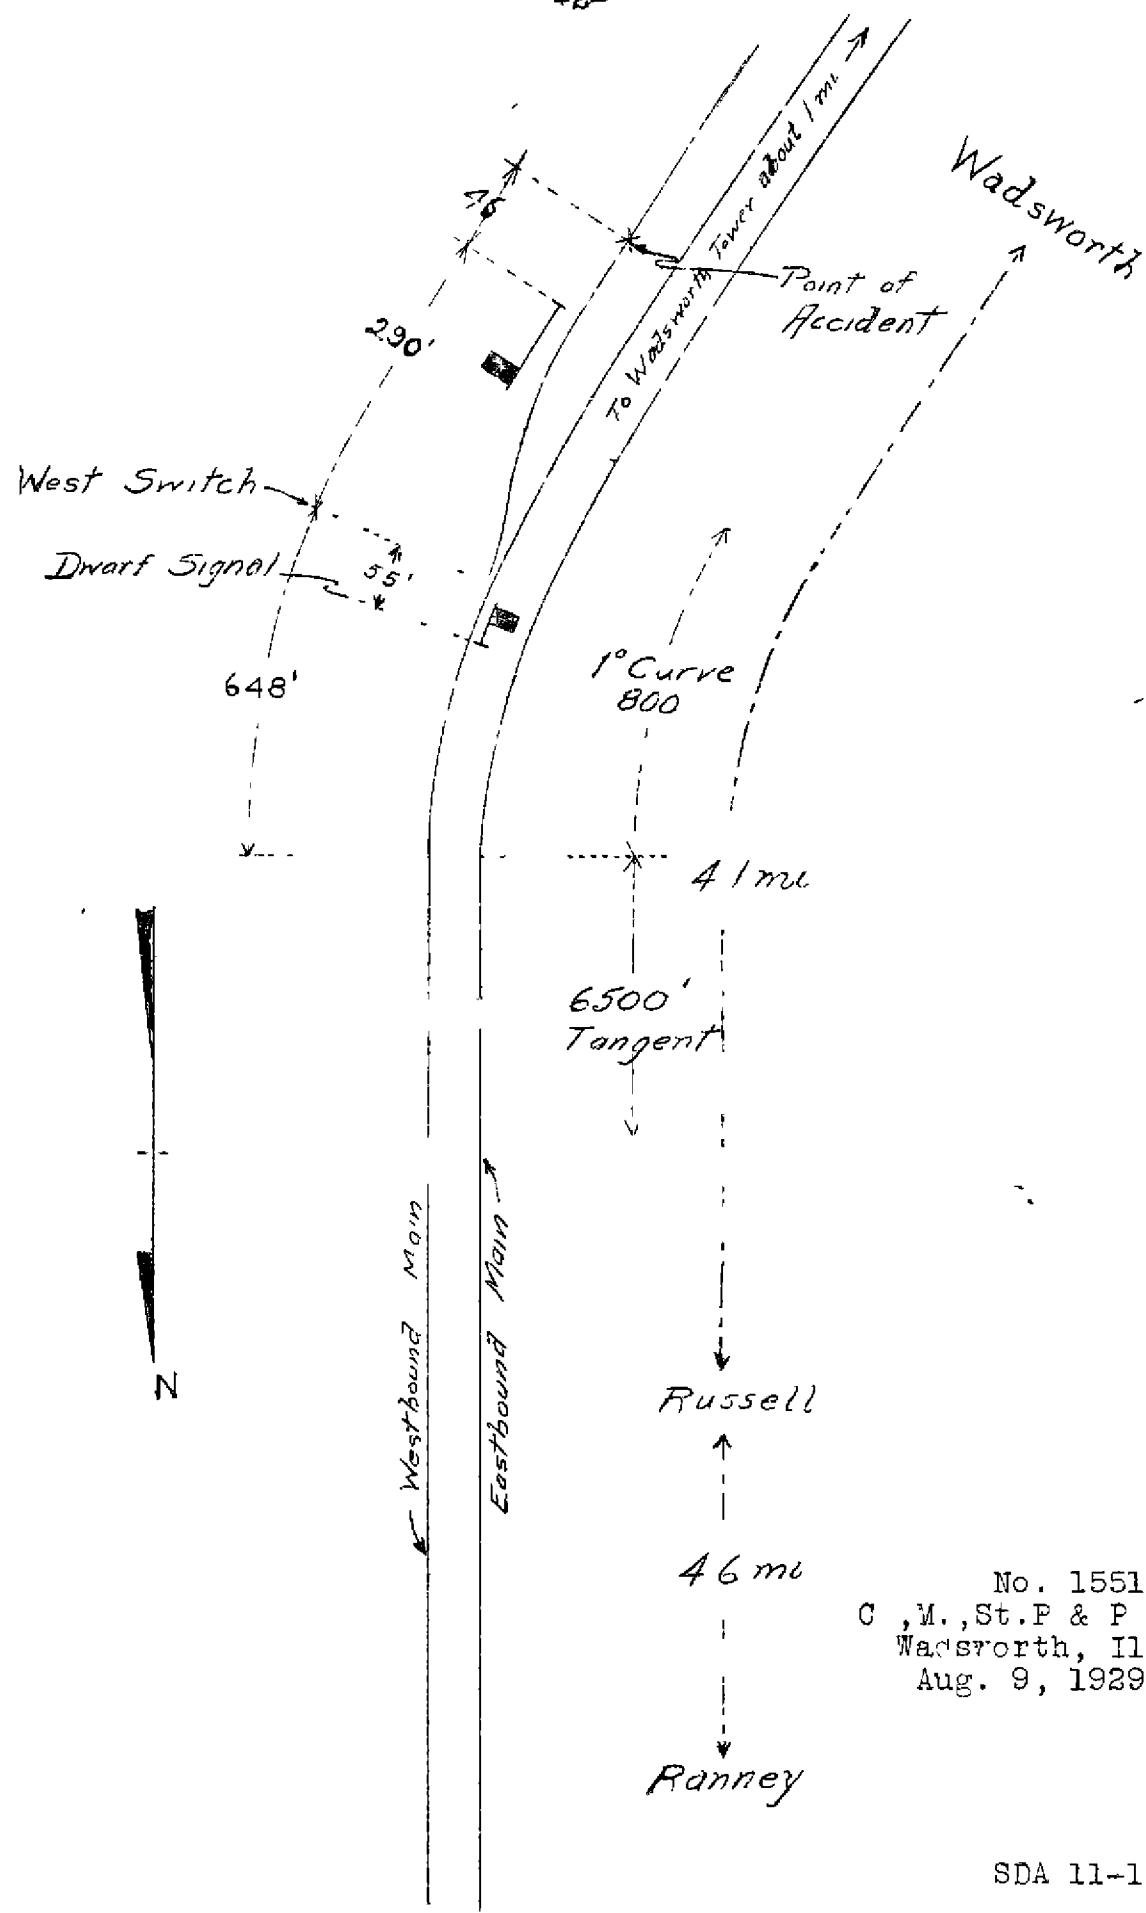
No. 1551  
 C, M., St. P & P R R.  
 Wadsworth, Ill.  
 Aug. 9, 1929.

The general direction of the track is north and  
 south, but the time-table directions are east and west,  
 and these latter directions are the directions used in  
 this report. The accident occurred just in the interlocking  
 limits of Wadsworth, at a point about 1 mile west of the  
 tower, at the west switch of the passing track, a facing-  
 point switch for trains moving against the current of  
 traffic on the westbound track, the passing track parallels  
 the main tracks on the north. Approaching from the west  
 the track is tangent for a considerable distance, followed  
 by a 1° curve to the right 800 feet in length, the switch  
 being located on this curve at a point 152 feet from its  
 eastern end. The grade for eastbound trains is slightly  
 descending.
