INTERSTATE COMMERCE COMMISSION

REPORT OF THE DIRECTOR OF THE BUREAU OF SAFETY IN RE
INVESTIGATION OF AN ACCIDENT WHICH OCCURRED ON THE
CHICAGO, ROCK ISLAND & PACIFIC RAILWAY, AT BELLEVILLE,
ARK , ON OCTOBER 21, 1931

December 4, 1931.

Inv. No. 1729
Chicago, Rock Island & Pacific Ry,
Belleville, Arkansas
October 21, 1931

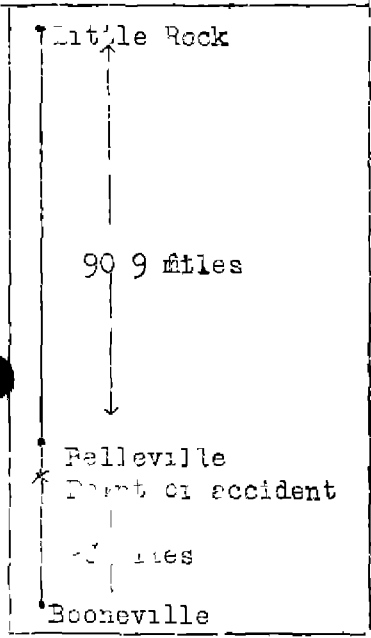
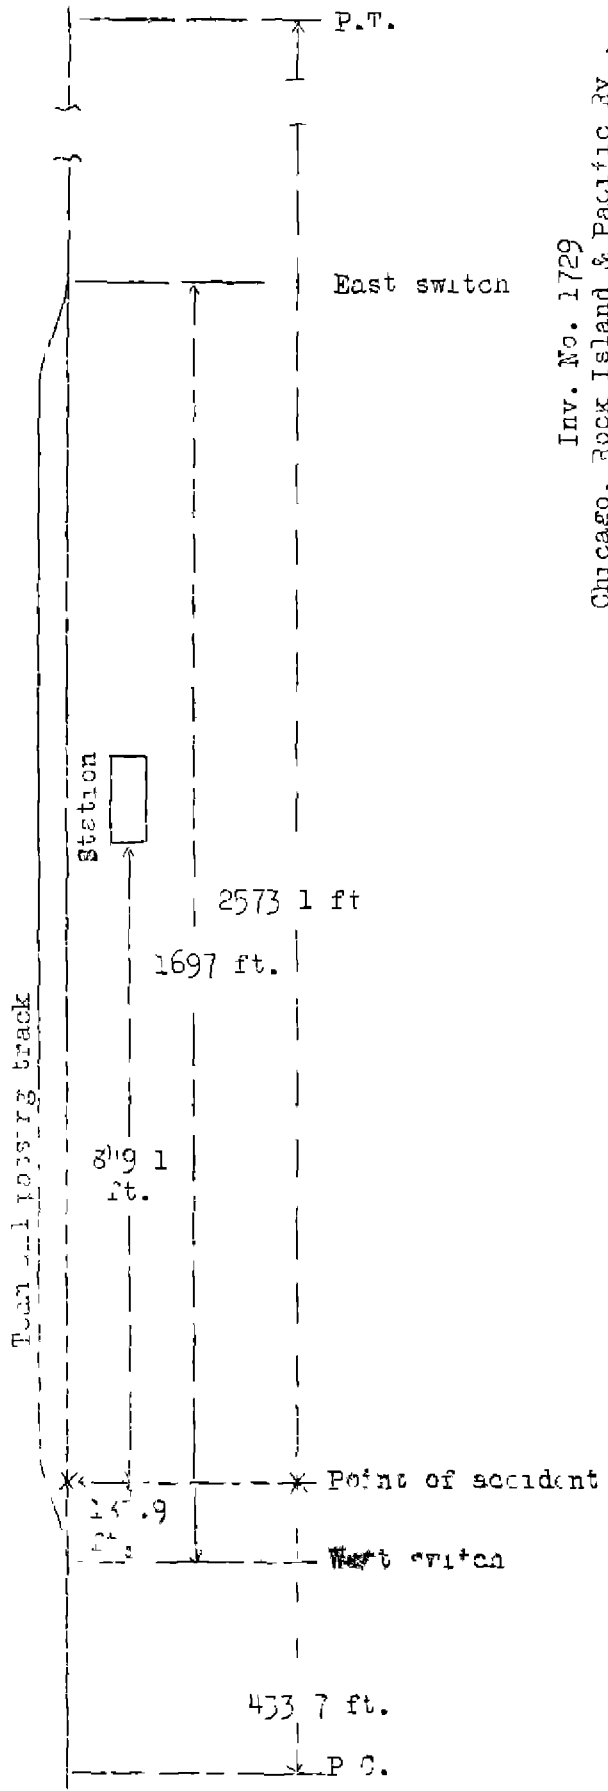
Engine 836 struck the right side of the second car in train No. 42 at a point about 15 feet from its front end, scraping it from that point back to the rear end and then striking the right front corner of the vestibule of the third car, considerably damaging this car. None of the equipment in train No. 42 was derailed, although the entire train was criven back a distance of about 70 feet by the force of the collision. Engine 836 turned over on its left side and was considerably damaged, the tender was leaning at an angle of about 45° but remained coupled to the engine and the first car in the train. None of the remaining equipment in train No. 111 was derailed or damaged. The employees injured were the engineer, fireman and head brakeman of train No. 111, while the injured dining-car employe was on train No. 42.

This accident was caused by the error of Engineman Scott, of train No. 111, in accepting a proceed signal not intended for the movement of his train, resulting in his failure to stop his train clear of the track used by an inferior train taking the siding at a train-order meeting point.
