INTERSTATE COMMERCE COMMISSION

REPORT OF THE DIRECTOR OF THE BUREAU OF SAFETY IN RE
INVESTIGATION OF AN ACCIDENT WHICH OCCURRED ON THE
CHICAGO, ROCK ISLAND & PACIFIC RAILWAY AT CASTON, OKLA.,
ON OCTOBER 30, 1931.

December 5, 1931.

Inv. No 1730
Chicago, Rock Island & Pacific Ry.,
Caston, Oklahoma
Oct. 30, 1931

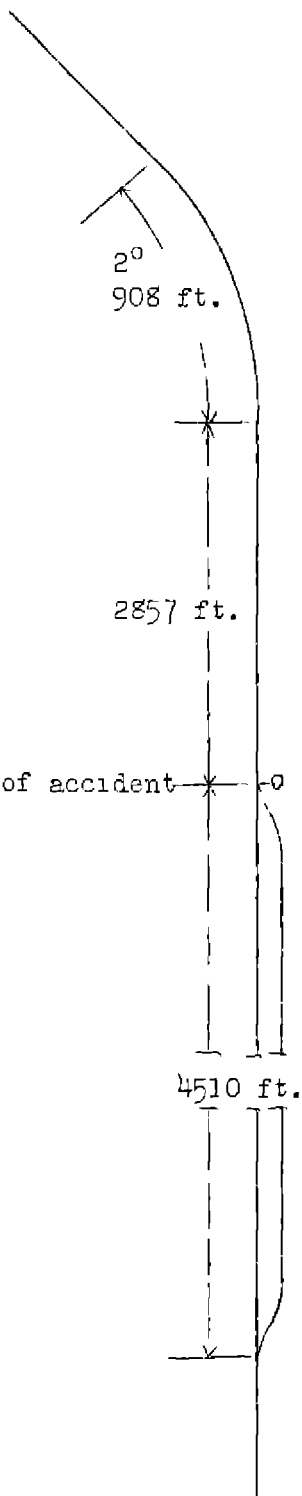
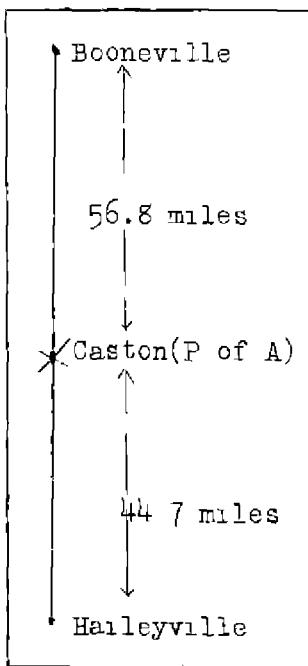
An examination of the track was made by the Commission's inspectors subsequent to the accident and numerous marks were found west of the east passing-track switch but none east of that point. The first mark appeared to be a flange mark across the top of a tie-plate about 6 inches from the gauge side of the turnout rail, on the south side of the track, and 12½ feet from the switch point. From this point the marks continued westward on the

tie-plates and spike-heads for a distance of about 35 feet, when the flange marks began to appear on the ties, these marks gradually bearing to the left for an additional distance of approximately 133 feet to where the track began to be destroyed; corresponding marks appeared on the north side of the track. The receiving end of the main track rail on the south side of the track at the heel of the switch point was bent downward about 3 inches. There was nothing wrong with the switch stand except that the hasp on the lever was broken through the eye, and the switch lock, still locked, was hanging on the chain and showed evidence of having been hammered.

Subsequent to the accident the south switch point of the east passing-track switch was found to have been disconnected and lying about 10 inches from the stock rail, towards the center of the track, thus leaving a gap between where the heel of the point should have been, and the receiving end of the adjoining rail to the west. The clip of the head rod was missing but was later found some distance from the switch, the bolts of the bridle rod had been removed but the clip remained intact, the rod having been slipped off the clip, and the angle bars at the heel of the switch point also had been removed. The hasp on the switch stand was broken off, and the switch lock, which was in locked position, was damaged. The switch was lined for a main track movement, and, according to the evidence, the light was burning and displaying green for an approaching train. An examination of the equipment as well as the track east of the switch disclosed nothing that could have contributed to the cause of the accident, and in view of the condition of the switch as it was found after the accident it is evident that the switch had been tampered with, but at the time of the investigation it had not been determined when or by whom the tampering was done.
