# INTERSTATE COMMERCE COMMISSION

## REPORT OF THE CHIEF OF THE DIVISION OF SAFETY COVERING THE INVESTIGATION OF AN ACCIDENT ON THE CHICAGO, ST PAUL, MINNEAPOLIS & OMAHA RAILWAY NEAR BIGELOW, MINN., ON FEBRUARY 9, 1914

NOVEMBER 5, 1914

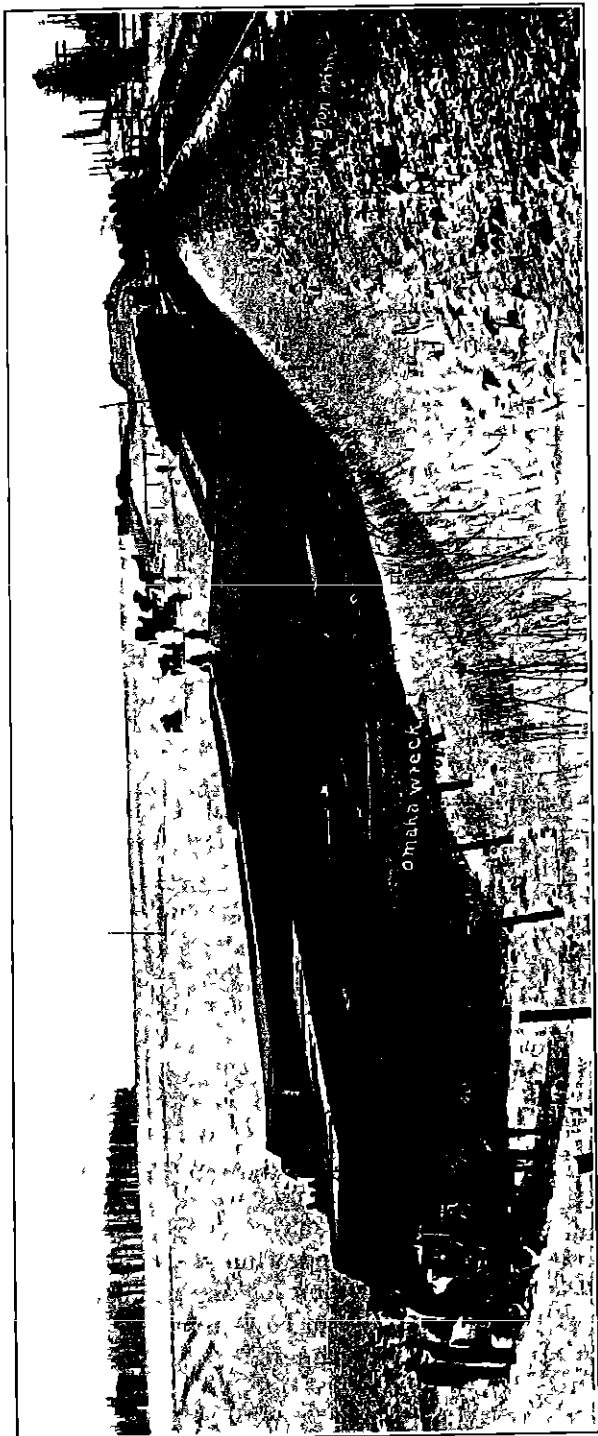
The locomotive broke away from the cars and came to a stop at a point about 1,650 feet beyond the point of derailment, the forward pair of engine truck wheels and the rear pair of tender truck wheels being derailed. All of the cars in the train were derailed, and with the exception of the express and smoking cars all came to rest on their sides. The express car was bottom up and damaged to such an extent that it was afterwards burned, while the smoking car remained upright. Illustration No 1 is a view looking in a westerly direction. The remains of the express car can be seen at the right of the mail car, which is shown on the extreme left.

No 1 General view of the derailment, looking west

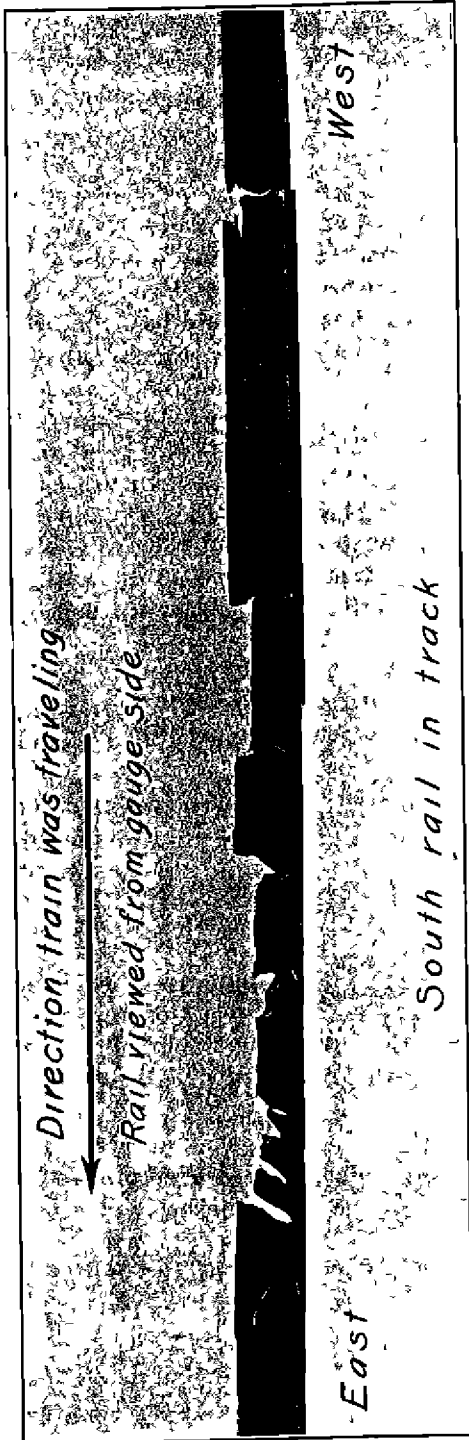
PLATE A —South rail in track

The rail was broken into a large number of pieces, 74 of which were recovered. Plate A shows the fractured portion of the rail, near its west end, with pieces of the head placed near the base of the rail.

Plate A is a view of the fractured rail as it appeared from the gauge side and near the west end.

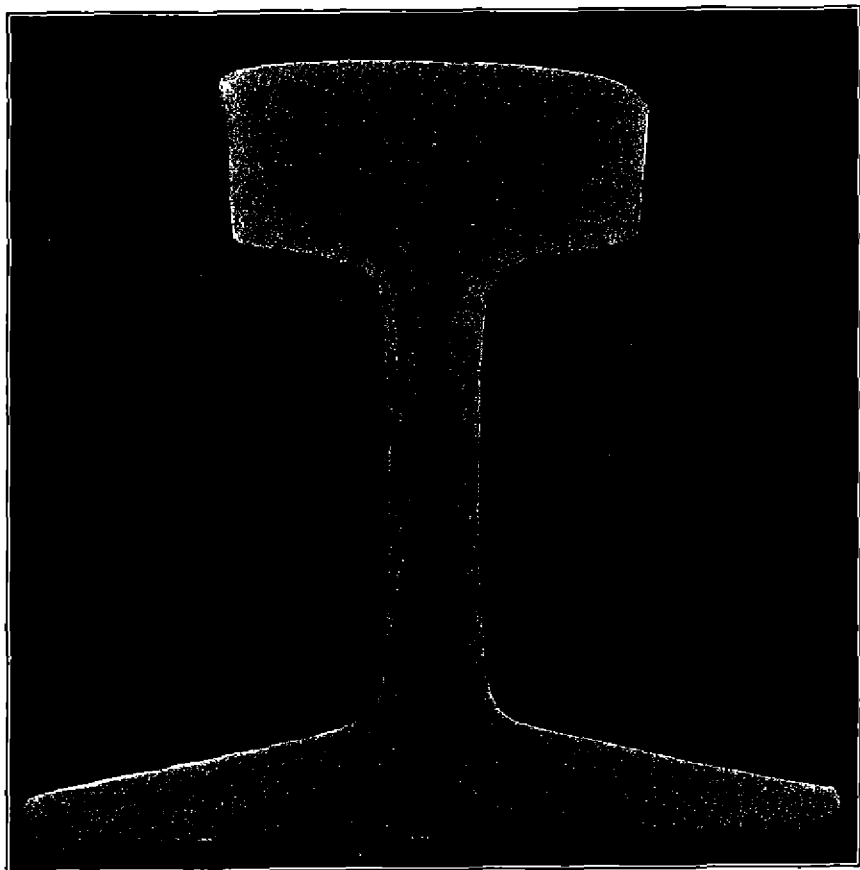
PLATE B—Section W, 12 inches from the west end of the rail Etched with ammonium chloride solution

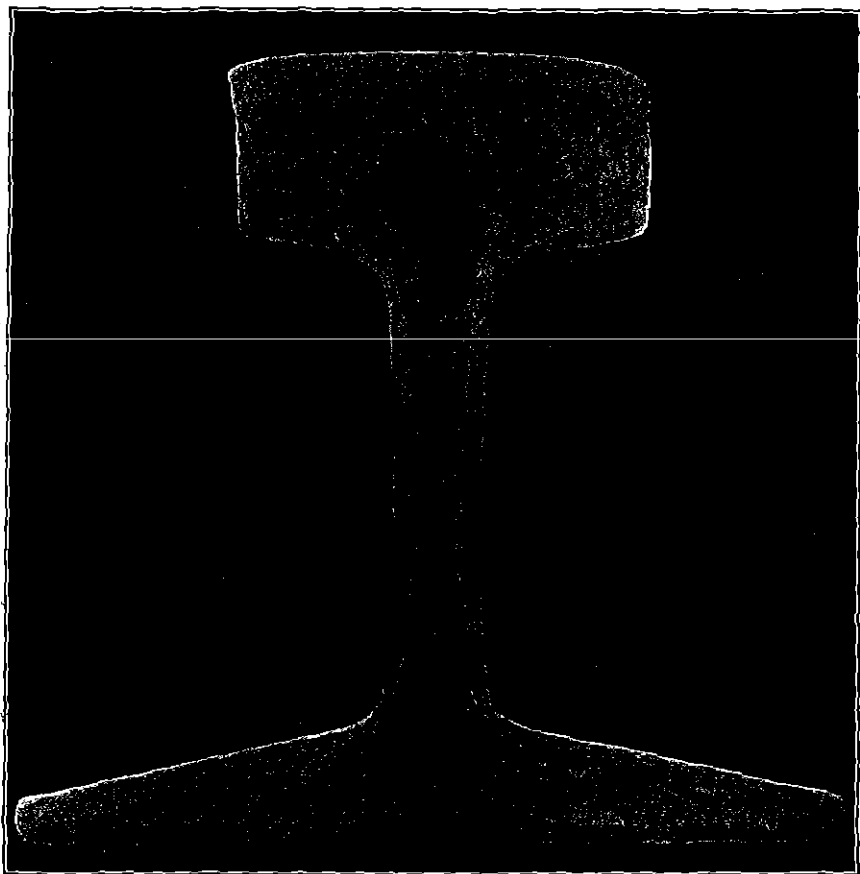
PLATE B --Section E, 24 inches from the east end of the rail Etched with ammonium-chloride solution

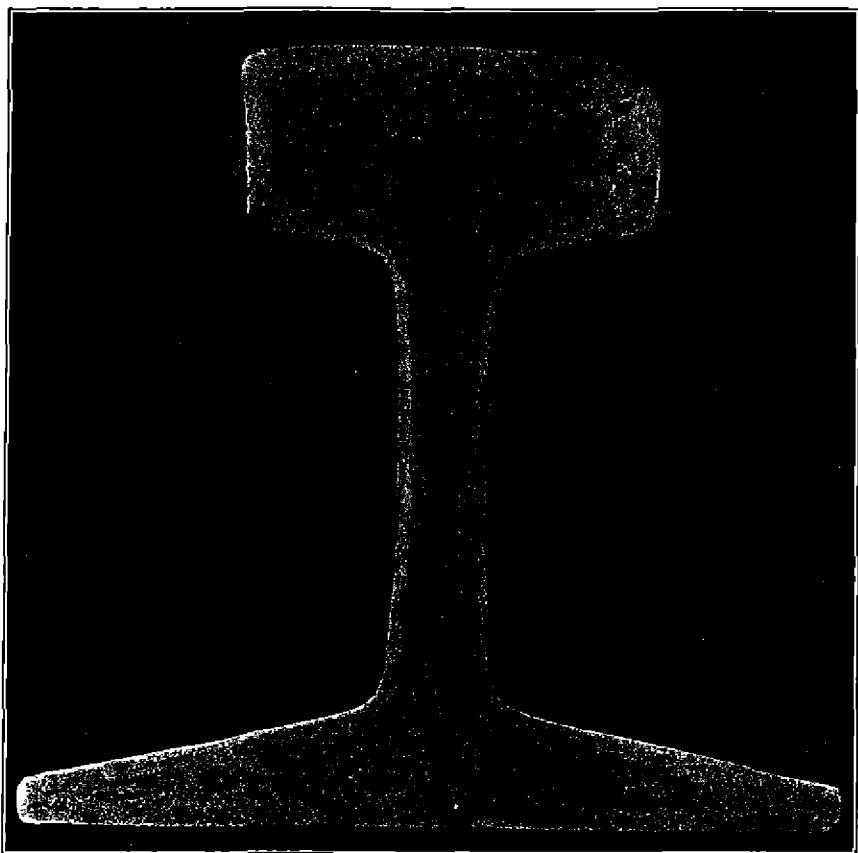
PLATE C —Section X, from one of the unidentified pieces from the central part of the rail Etched with ammonium chloride solution

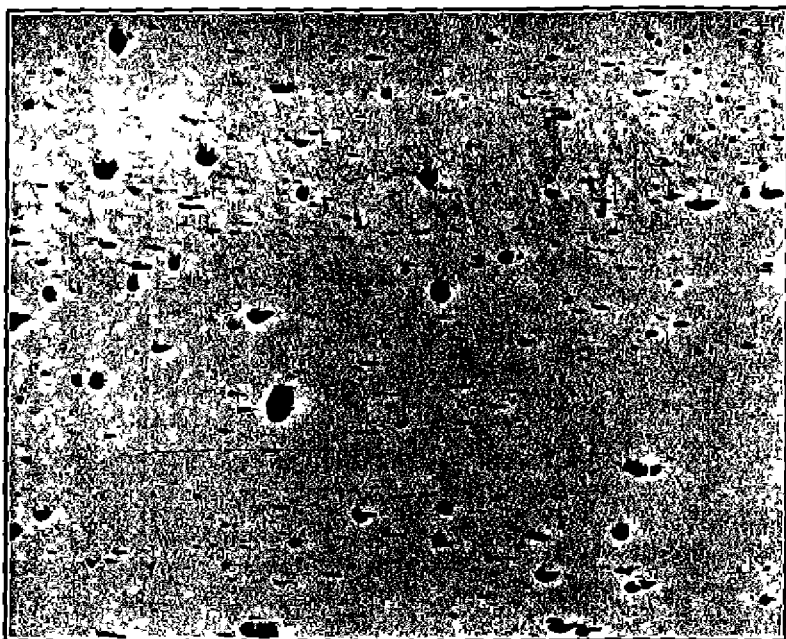
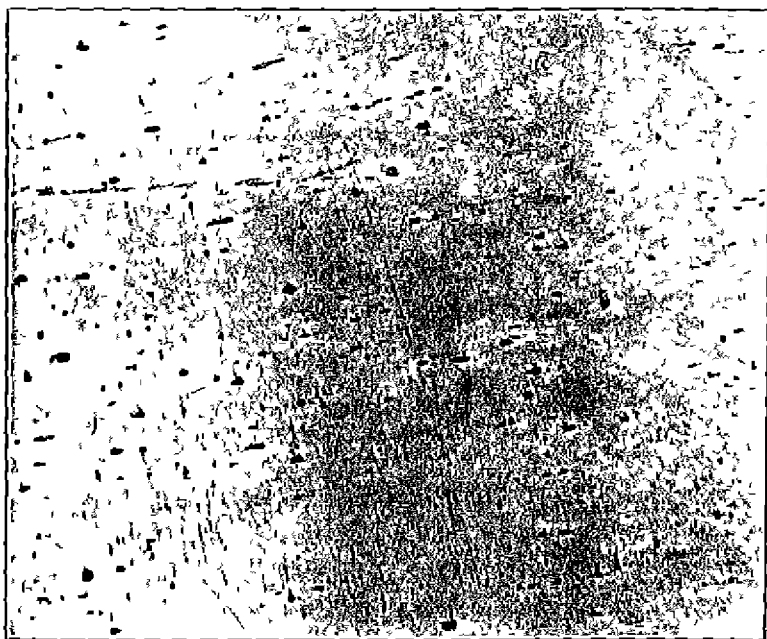
PLATE D—Unetched specimens, magnification 25 diameters

Section W6 (at top), 6 feet from the west end center of the sound portion of the head  
Section W6 (at bottom) 6 feet from the west end directly adjacent to the split in the head

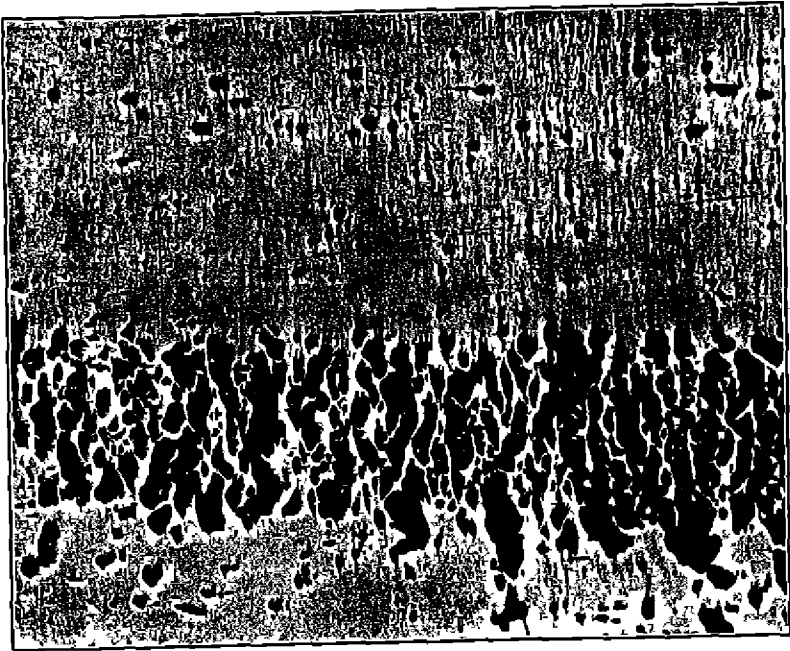
PLATE E--Unetched specimens, magnification 25 diameters  
 Section W6 (at top) 6 feet from the west end view of the center of the base of the section, showing one of the bad streaks in the metal  
 Section W6 (at bottom), 6 feet from the west end view of the metal of the web

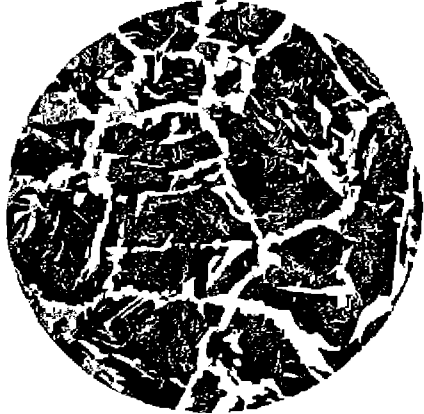
PLATE F—Magnification 100 diameters

A and B represent the structure of the head of the rail at section E. A shows the structure directly adjacent to the split, while B is the center of the remaining part of the head. Though there is some segregation near the center of the head as shown in A by the increased amount of pearlite (the dark constituent) still the carbon content is considerably below the eutectoid composition (i. e. 85) as indicated by the ferrite which forms the boundaries for the large crystals of pearlite.

C and D represent the structure of the head of the rail at section W adjacent to the split and near the center of the remaining portion respectively. There has been but little, if any, segregation of carbon here as shown by the relative amounts of pearlite in the two cases.

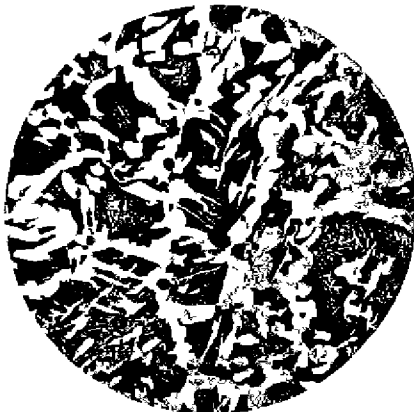
Photomicrographs Nos 3a and 3b show the normal structure of a rail and the structure immediately below the running surface of the head where the metal had been affected by the wheel loads, causing a flattening of the grain. The appearance of the metal on the gauge side of the head of this rail was the same as that immediately below the running surface. Distortion of the metal, such as shown by this photomicrograph, or even of a lesser degree, would menace the integrity of the steel when the cold-rolled metal reached that part of the head in which streaks were prevalent.

No. 3 Microstructure of head of a rail, cross section, magnification 110 diameters

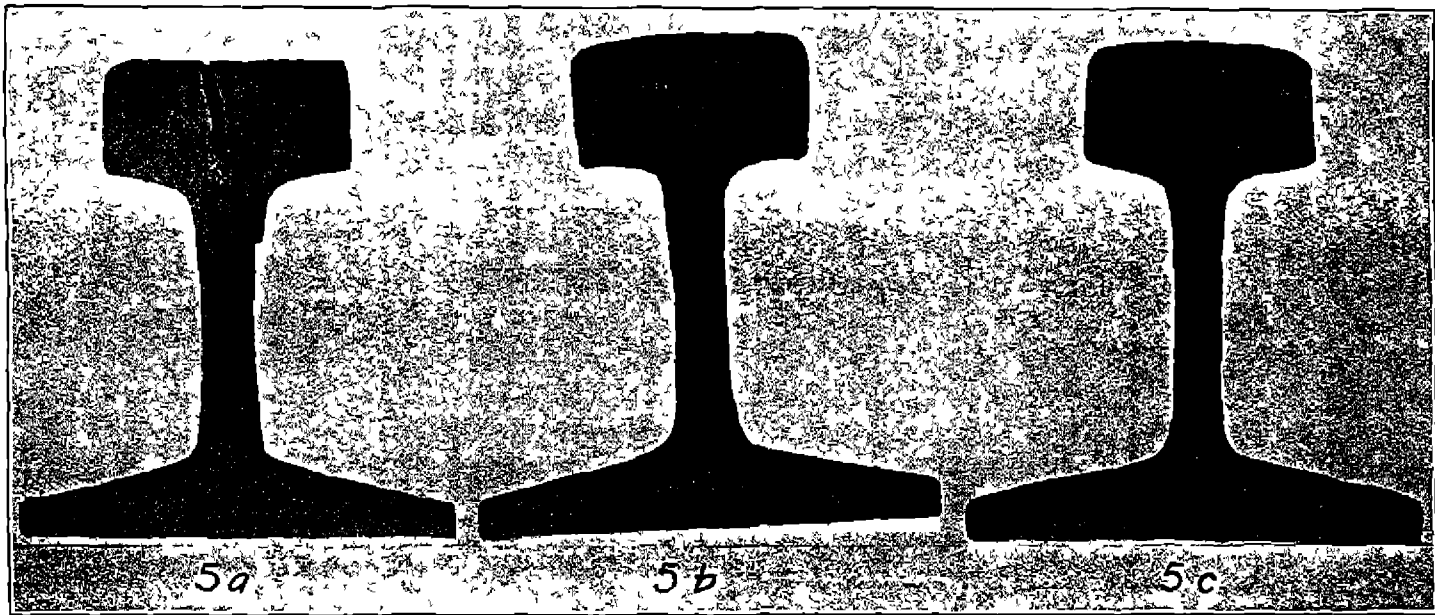
No 5 Cross sections of rails which had developed split heads, surfaces polished and etched with tincture of iodine.

- 5a Branded "10030 Illinois Steel Co South Wks Ill 1910," A rail, heat number 16296, in service 4 years, removed on account of split head
- 5b Branded "Cambria 100 lbs 1911 VII " D rail, heat number 20746, same rail as shown in Figure No 4, cross section where split in the head was in early stage of development, split shown by dark line at center of head
- 5c Branded "OH 10030 I S Co Gary VI 1910," A rail, heat number 32703, in service 3 years and 6 months, removed on account of split head and fracture in web 18½ inches long

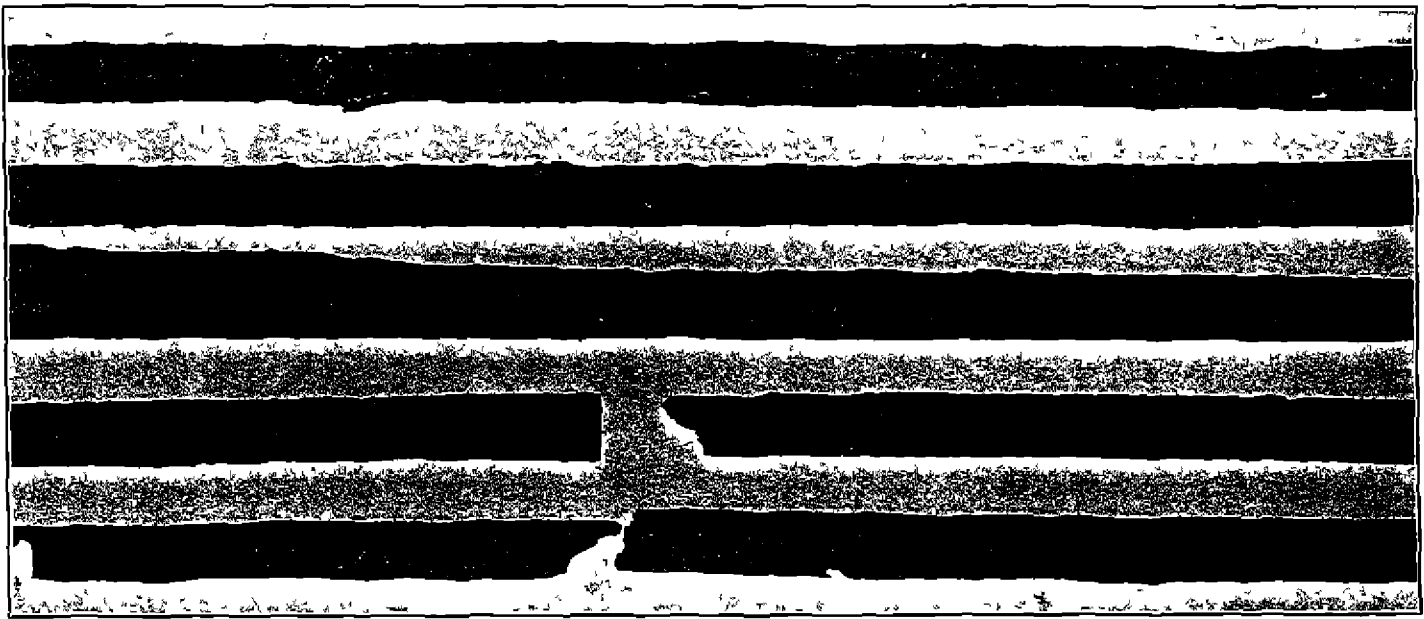
No 7 Strips from head of rail shown in Fig No 6, showing the presence of seams and streaks in the metal, surface of seams bright, lustrous, with a fine granular structure incipient splits have been found as such lamellar streaks

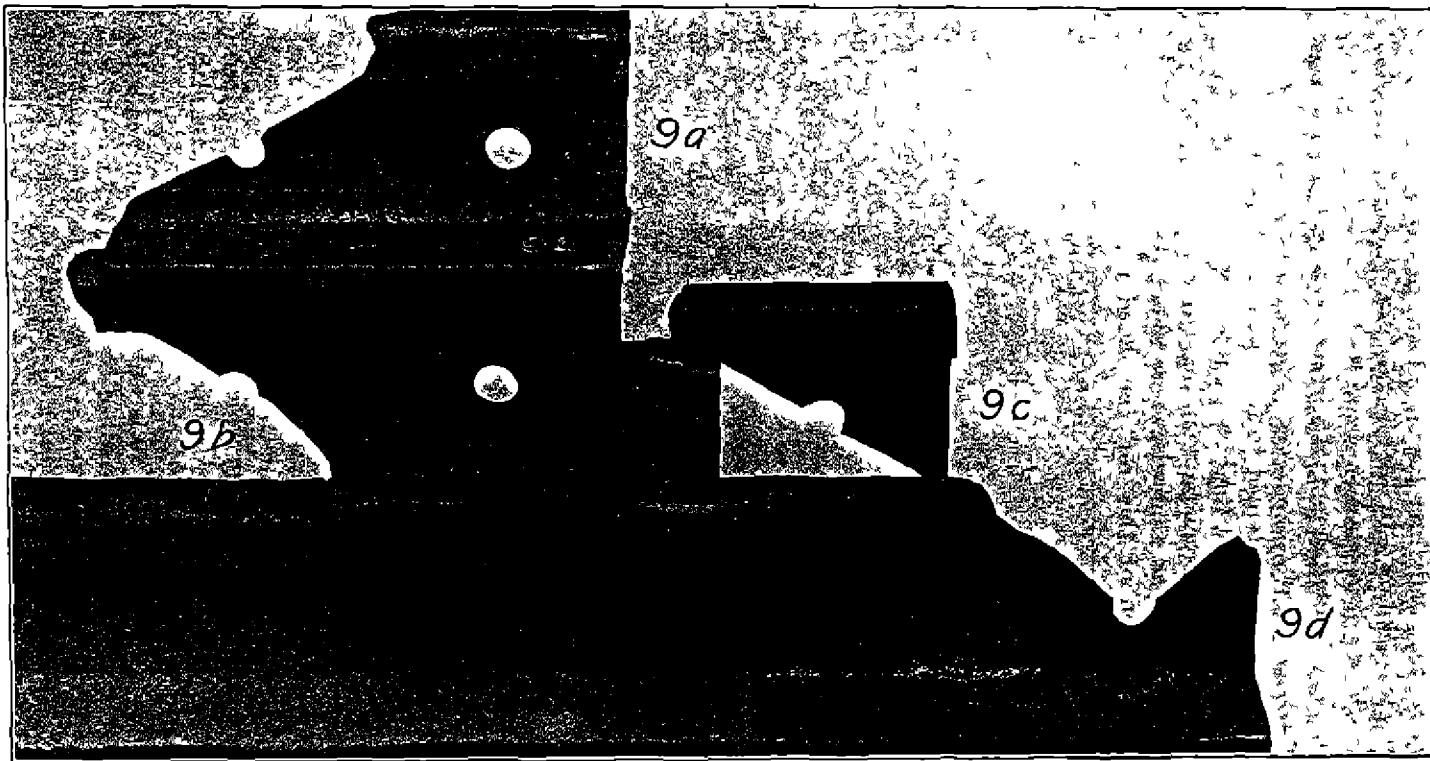
No 9 Group of rails which fractured in webs at bolt holes. Fractures, in each case, had their origins at sides of holes, extending thence toward heads and bases of rails. Fractures took place without appreciable enlargement of bolt holes.

9a. Branded "10035 I S Co South IX 1912," A rail, heat number 35270, in service 9 months

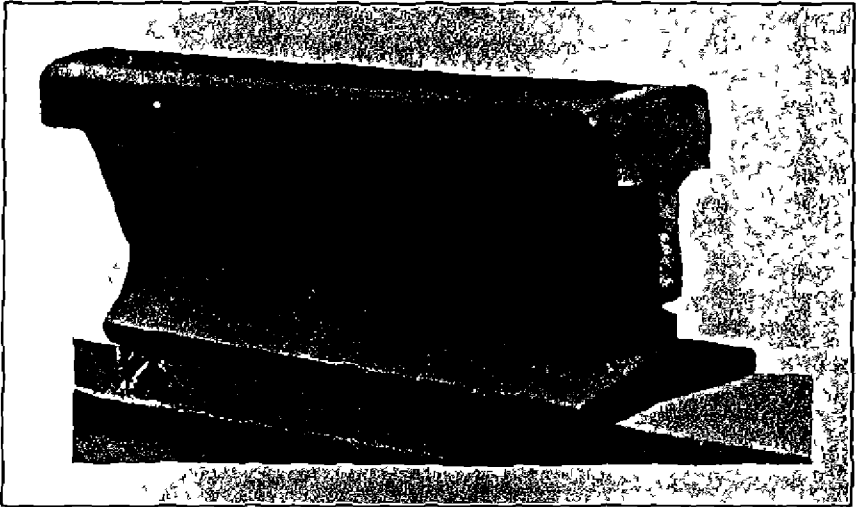
No. 10 Fracture of web caused by indentation in surface made by dog carrying heat number figures. Furrow made in hot metal was origin of web fracture 16 inches long. Dangerous type of failure. Branded "10030 Illinois Steel Co South Wks V 1911." A rail, heat number 28198, in service 2 years, 4 months.

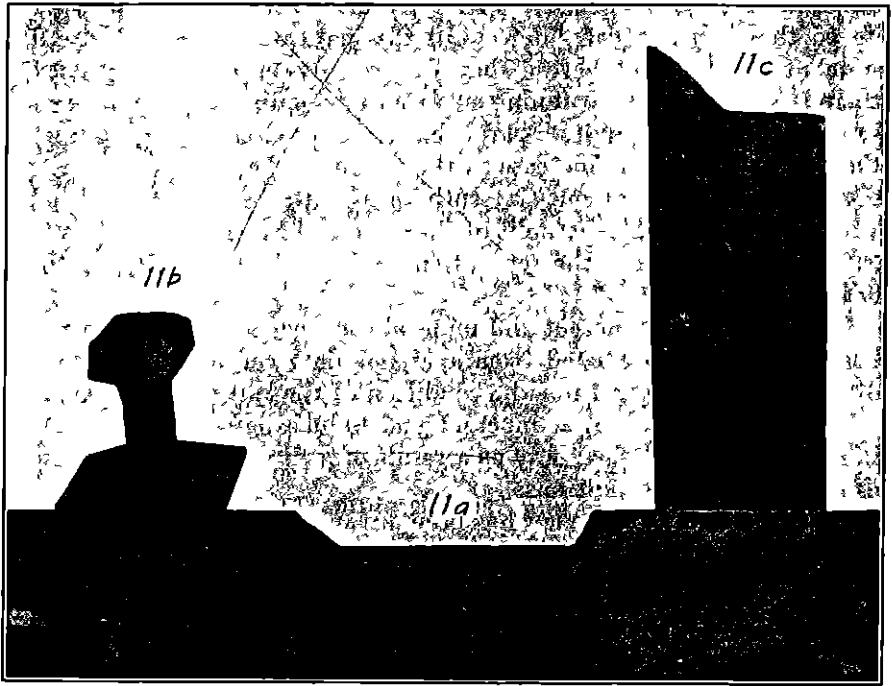
Figure No 11 shows different stages in the fracture of rails having their origins as crescent-shaped base fractures. The lower figure in the cut represents a rail, viewed from the base, in which a short crescent shaped fragment had been detached—a rail in the first stage of rupture. The section viewed on end shows a fracture which had extended through the base and web and into the head. About three-fourths of the head remained unfractured at the time this rail was removed from the track. The final stage of fracture is shown by the figure on the right of the cut. This had a longitudinal split in the base, from which the line of rupture started, passing through the web, and then extending through the head, completing the fracture of the rail.

No 11 Different stages in the fracture of rails having their origins at seamy metal in base

11a First stage of rupture Crescent shaped piece detached from base due to presence of a longitudinal seam
