## INTERSTATE COMMERCE COMMISSION

REPORT OF THE DIRECTOR OF THE BUREAU OF SAFETY IN  
RE INVESTIGATION OF AN ACCIDENT WHICH OCCURRED  
ON THE CHICAGO, ST. PAUL, MINNEAPOLIS & OMAHA  
RAILROAD AT SIOUX CITY, IOWA, ON JUNE 2, 1930.

August 4, 1930.

Inv. 1645  
Chicago, St Paul, Minneapolis  
& Omaha Railway,  
Sioux City, Iowa  
June 2, 1930

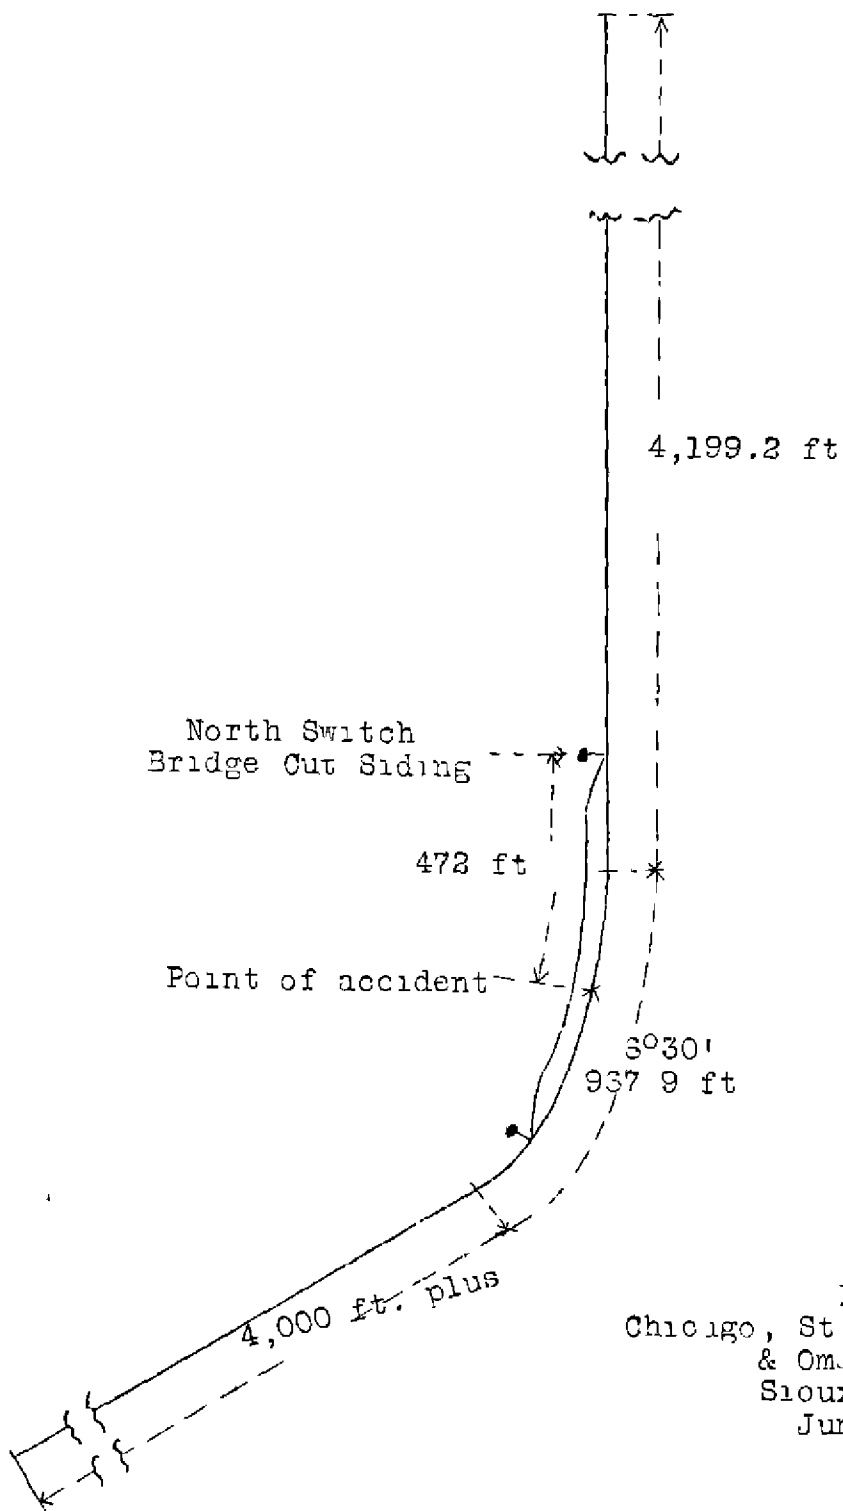
This accident occurred on Subdivision No. 1 of the Nebraska Division, extending between Sioux City, Iowa, and Omaha, Nebraska, a distance of 125.4 miles, this is a single-track line over which trains are operated by time-table, train orders, and a manual block-signal system. Between First Street, Sioux City, and Ferry, Nebraska, a distance of 3.5 miles, within which territory the accident occurred, trains of the CB&QRR are operated over the tracks of the CStPM&ORR. The accident occurred on the main track between the switches of Bridge Cut siding; the siding is 822 feet in length and parallels the main track on the west, the accident occurring at a point 472 feet south of the north switch. Approaching the point of accident from the north, the track is tangent for 4,199.2 feet, followed by a 6° 30' curve to the right 967.9 feet in length, the accident occurring on this curve at a point about 400 feet from its northern end. Approaching from the South, the track is tangent for more than 4,000 feet, followed by the curve on which the accident occurred. The grade for south-bound trains is 0.75 per cent ascending around the curve involved.

Owing to the deep cut, neither crew could see the opposing train around the curve until they were within a short distance of each other.
