## INTERSTATE COMMERCE COMMISSION

### REPORT OF THE DIRECTOR OF THE BUREAU OF SAFETY IN RE INVESTIGATION OF AN ACCIDENT WHICH OCCURRED ON THE CINCINNATI, NEW ORLEANS & TEXAS PACIFIC RAILWAY, SOUTHERN RAILWAY SYSTEM, AT CARDIFF, TENN., ON MAY 29, 1924

AUGUST 4, 1924

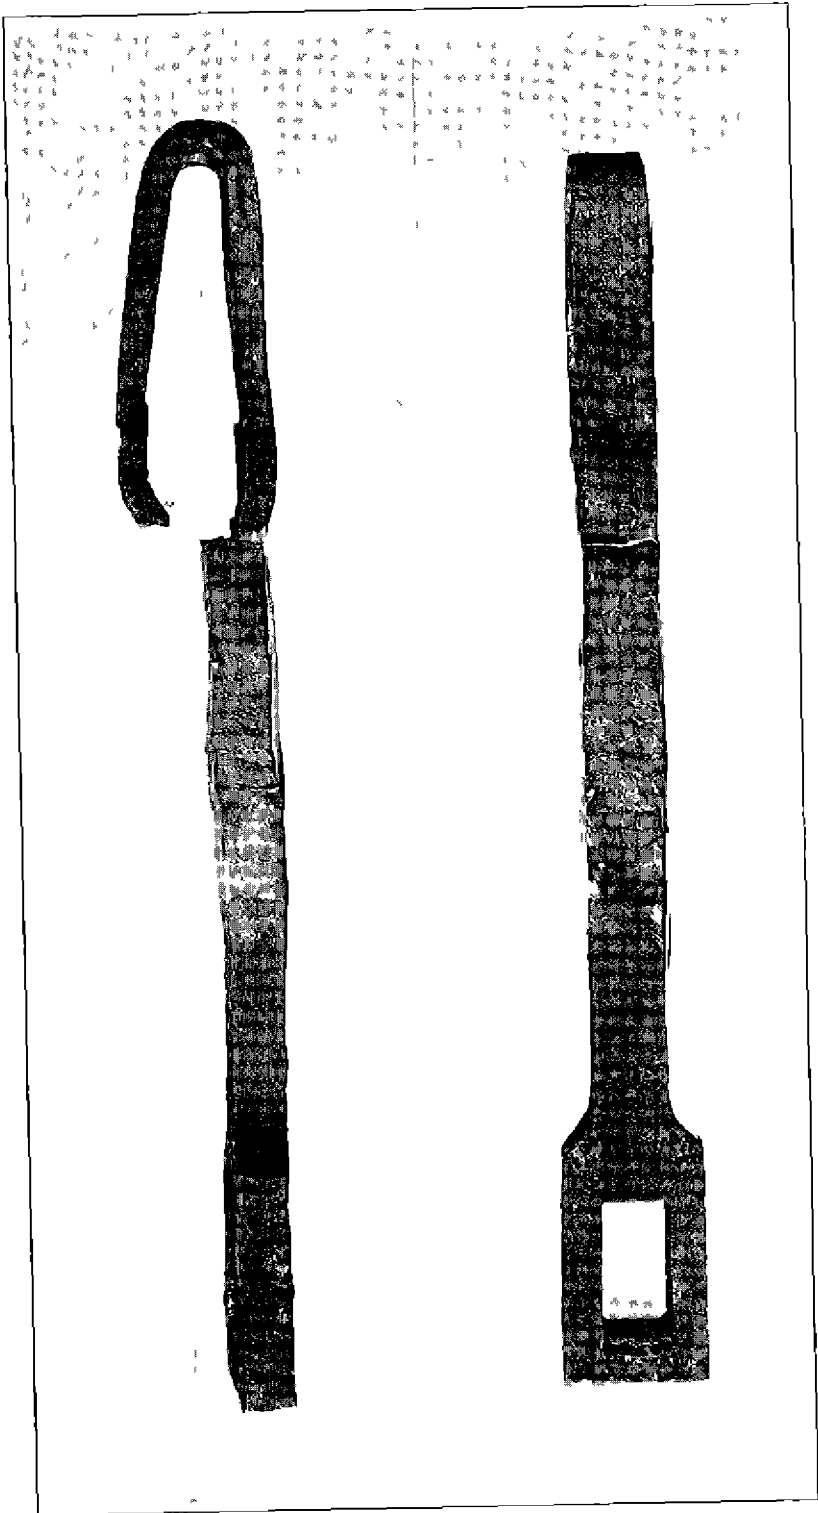
Figure No. 1 shows two views of the hanger as it appeared after recovery from the derailed engine. The upper end was separated from the shank and the loop partially opened. The left leg of the loop, as shown on the cut, appears to have been the one which fractured first but was immediately followed by the other. The seat of the loop, on the cross equalizer beam from which it is suspended, was battered as well as that of the stump at the lower end of the hanger. The battering of the seats of hangers does not appear, however, to be an unusual occurrence.

The cross-equalizer beam passes through the loop at the upper end of the hanger. This beam has a depth at the middle of its length of 10 inches, the ends tapering off to about  $3\frac{1}{2}$  inches. It is notched at its end bearings where connections are made with leaf springs and also notched at the middle of its length where the hanger is seated. This beam is subject to rocking motion on its seat when the engine is running, the amplitude of which is limited by the sides of the loop of the hanger. Abrasion of the sides of the loop results. In the present case, one leg of the loop was abraded a depth of one-fourth inch, the other leg a depth of three-sixteenth inch.

FIG. 1—Two views of the fractured hanger. This hanger consisted of four pieces

The wearing away of the metal in this manner is a slow process, therefore the depth to which the loop was worn is taken to indicate that this forging was made at a time considerably antedating its failure.

Responsibility for the fracture of the hanger in part attaches to its use, which was continued after so much abrasion at the sides of the loop. Eccentricity of loading on the legs of some degree, would occur as one leg was abraded and then the other during the locking of the crossbeam. The battering of the seats of the loop and stirrup ends respectively is significant. They had received loads of varying intensity.

Furthermore since it is the practice of the railroad company to fabricate hangers from a single piece of wrought iron to avoid the uncertainty of welds, the opportunity should have been taken to replace this hanger with one of improved fabrication.

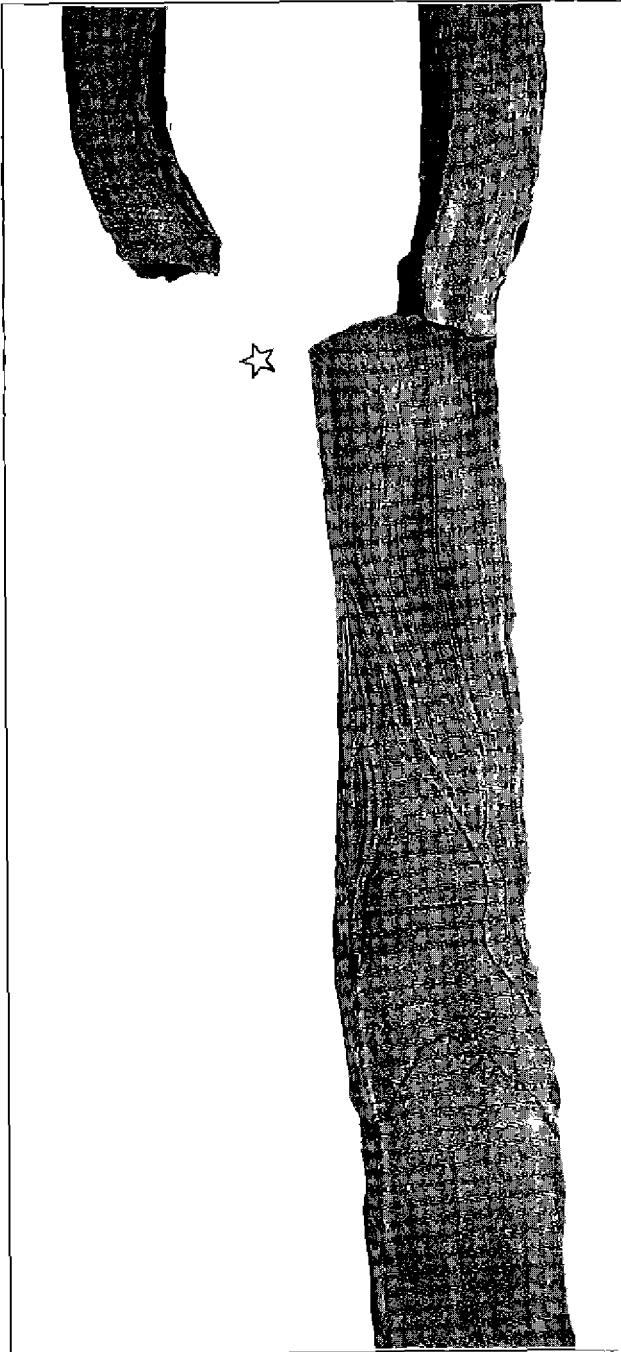
FIG. 2—View showing welds in hanger and distortion of the fibers of the iron at incipient point of fracture. Star on cut indicates the place where fracture began.

Figure No. 2 shows the appearance of the hanger in the vicinity of the loop. It was photographed after taking off a chip in a machine tool and light pickling in hydrochloric acid. A V-shaped weld in the shank is shown. The short intermediate section next above was scuffed and the loop welded to that piece. These were good welds. A very hot fire apparently was used in which pitting of the iron on the inside of the loop took place.

The objectionable feature of the forging was at the junction of the two legs at the base of the loop, indicated by a star on the cut. At this place, it is believed, the fracture of the hanger began. Locally the fibers of the iron were distorted. A fuller was probably used in the smith shop for closing the loop and was accountable for the distortion of the grain of the iron. The reliability of a forging depends upon the manner in which the work is done. In order to judge of its excellence the proper time for inspecting a forging is when and where the work is being done.

It is well known that the strength and ductility of wrought iron is greatest in the direction of its grain, showing a considerable reduction in crosswise direction. Specifically, the forging defect in the present hanger was the distortion of the grain of the iron at the lower end of one of the legs of the loop. Stresses of tension on the

hanger were virtually crosswise the fibers of the iron at that place. Rupture was facilitated by this circumstance.

Hangers preferably should be made of one piece of wrought iron, avoiding the use of welds. Single-piece forgings constitute the practice at the Knoxville shops of the Southern Railway. This hanger, however, consisted of four pieces in all. Enumerated in their order from bottom upward they were as follows: A reinforcing strip across the lower end, the stirrup and lower half of the shank, an intermediate section of the shank, and the loop at the upper end.
