INTERSTATE COMMERCE COMMISSION

REPORT OF THE DIRECTOR OF THE BUREAU OF SAFETY IN RE INVESTIGATION OF AN ACCIDENT WHICH OCCURRED ON THE CINCINNATI, NEW ORLEANS & TEXAS PACIFIC RAILWAY, SOUTH- ERN RAILWAY SYSTEM, LINES WEST, AT GLEN MARY, TENN, ON NOVEMBER 11, 1929

APRIL 12 1930

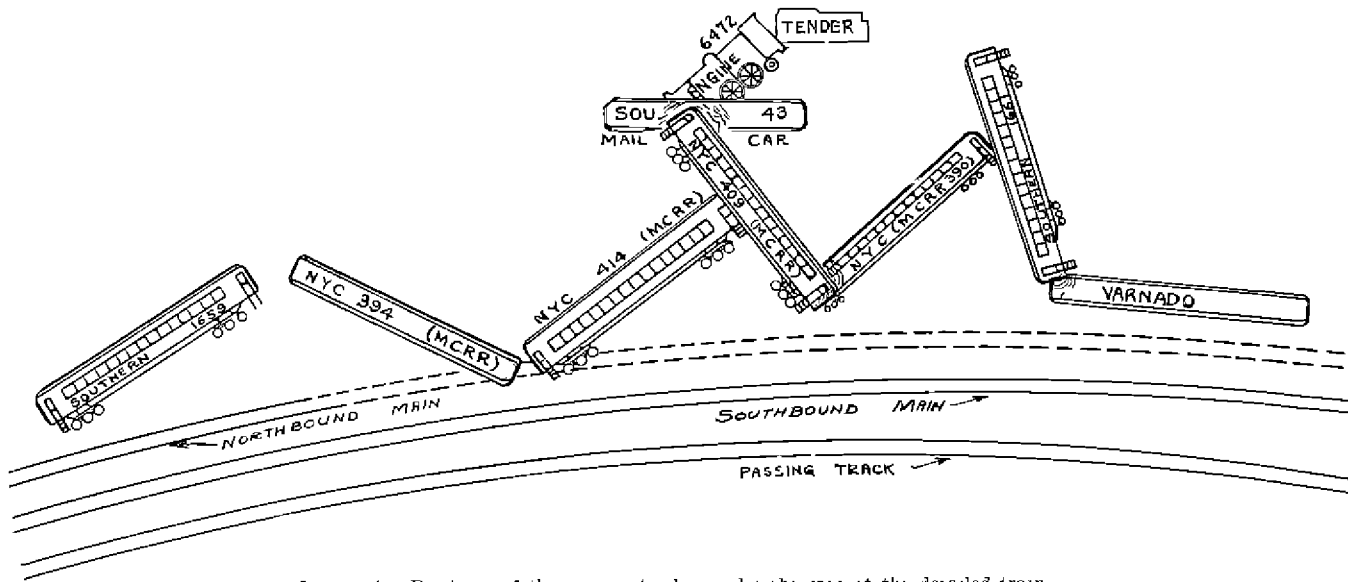
Figure No. 1, a diagram reproduced from a blue print furnished by the Southern Railway shows the position of the engine, tender, and eight cars of the derailed train. Mail car 43 was next to the tender in the train. Combination car 3602, the second car of the train, remained on the road bed, to the left of and beyond the limits of the diagram while the Pullmans were beyond on the right.

Figure 1—Positions of the engine, tender, and eight cars of the derailed train

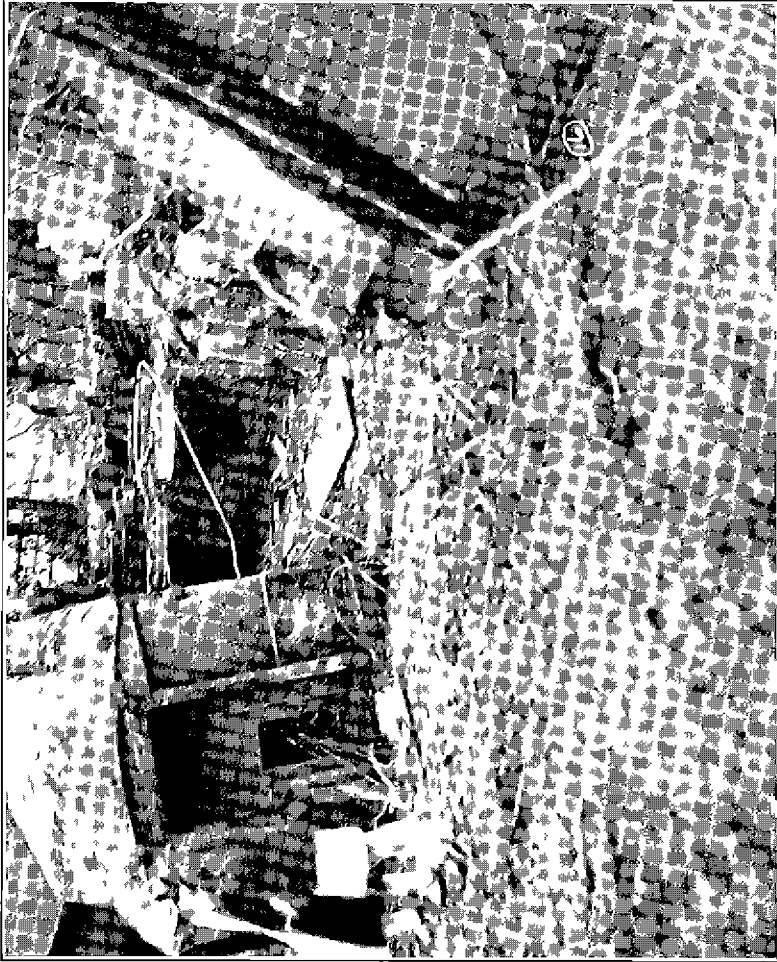
A series of photographs illustrate the appearance of different units of the train after the derailment. Figure No 2 is a partial view of the derailed engine, showing in the background two of its driving wheels. The end of the tender appears on the right of the cut resting on its side, the end of the mail car in upright position on the left. Figure No 3 is a closer view of the overturned engine. Its trailing axle is shown standing on end, partly submerged in water. Its leading truck was intact and occupied a place a few feet in front of the forward end of the engine. The side of the mail car is in partial view on the left of the cut. Figure No 4 shows the area bounded on two sides by the mail car and coach 409. In the foreground are shown the fragments of the forward truck frame of the tender. The forward axle of the frame, carrying with it the ends of the side rails and pedestal jaws, was detached from the rear portion of the frame. The rear portion of the frame, together with the equalizer bars and rear axle, occupied a place alongside the forward portion. The rear truck frame, intact, with the exception of a crack in the east side rail and slight bend of the same, was found a few feet to the right of this cut. It was standing on edge, nearly buried in the soft ground, as shown at the corner of the next cut, Figure No 5.

FIGURE 2.—Detached engine on its side. Ends of tender and mainmast in the foreground.

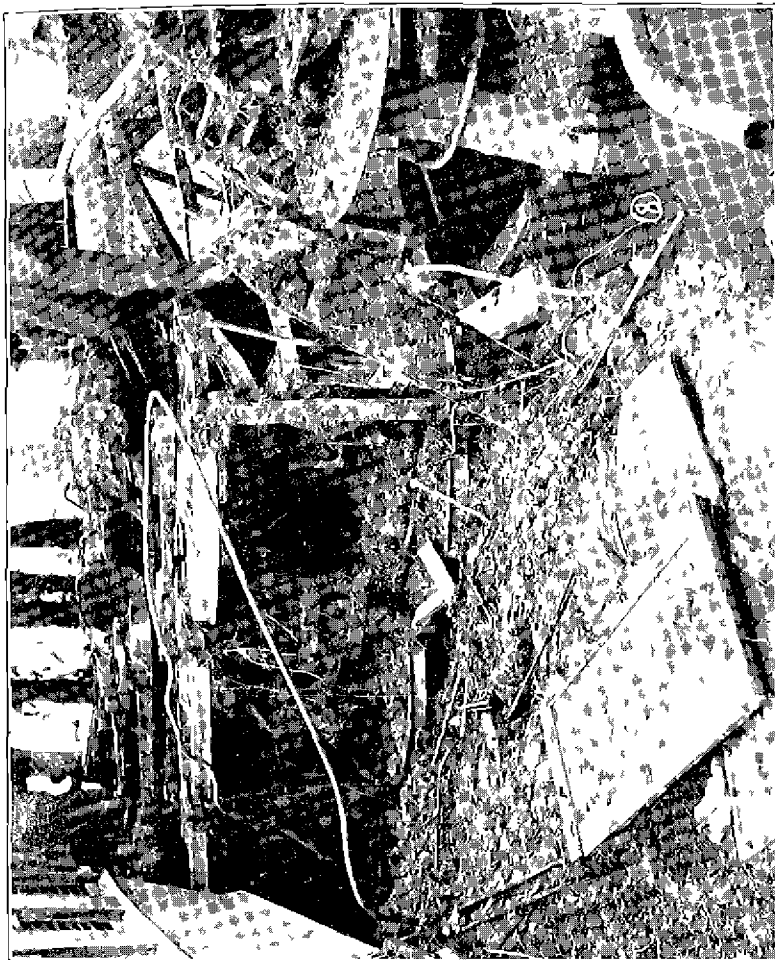
FIGURE 3 — Closer view of the derailed engine. Light axle on end partly submerged. Side of small car on left of cut.

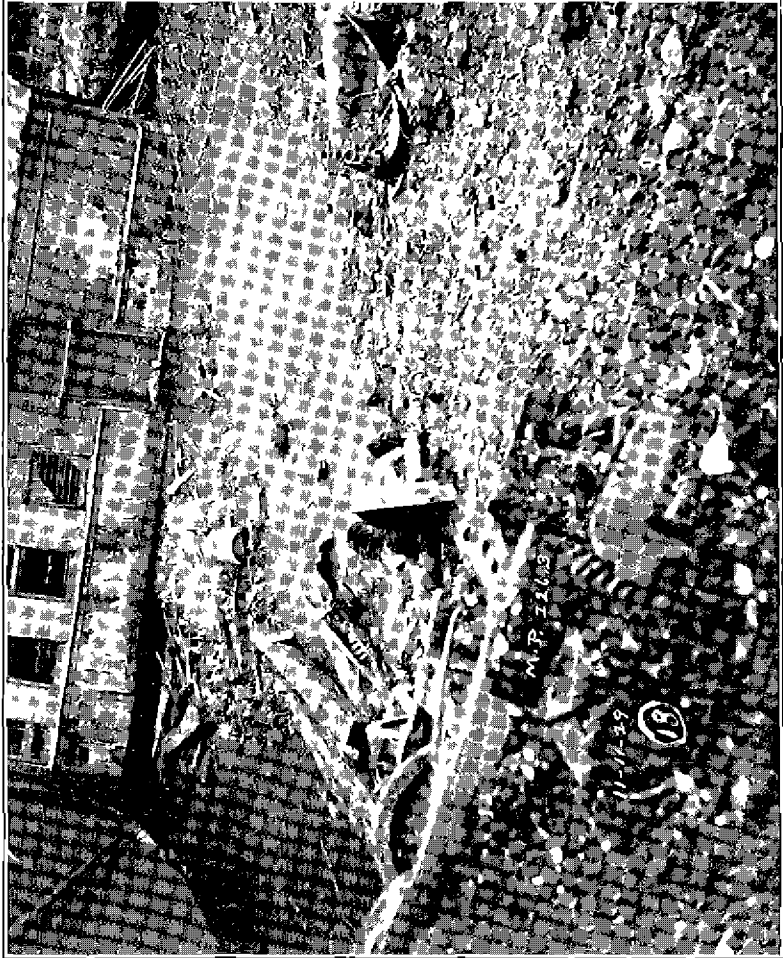
BUFILE 4—Angular space between car 409 and mail car. Fragments of forward tunnel frame in foreground. Forward axle near middle of car.

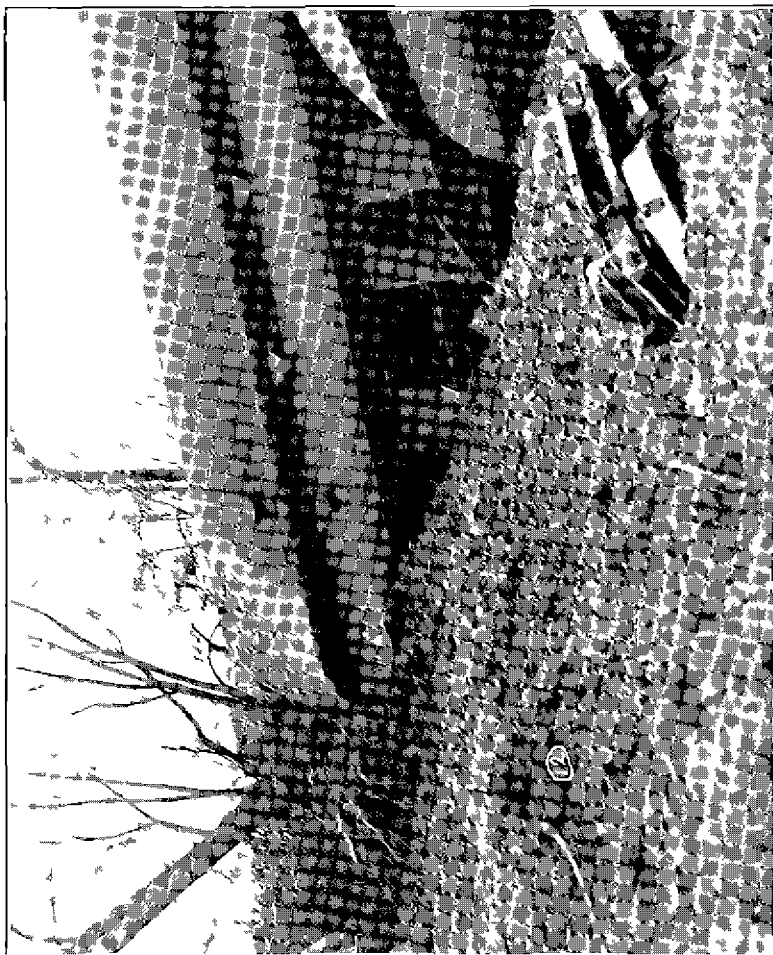
FIGURE 5—Rear tender truck nearly buried in soft ground. About 20 feet from fragments of forward truck frame

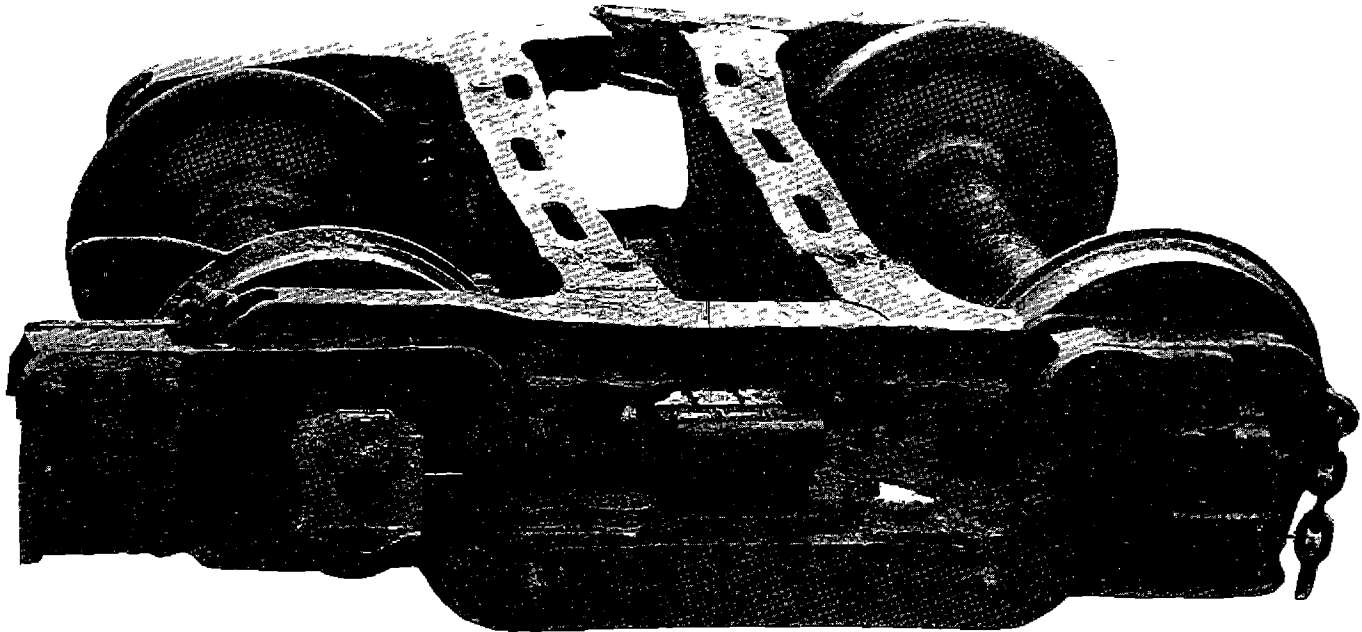
Figure No 6 shows the forward tender truck with its parts re-assembled, viewed from the east side. The frame was a steel cast-

The forward frame was fractured at two principal places. The east rail was fractured immediately forward of the seats of the helical springs and to the rear of the pedestal jaws. The fracture had its origin at the lower outside corner of the rail. This appeared to have been the first fracture which took place in the frame. It was immediately followed by the fracture of the west rail, the origin of which was at the lower side of the forward transom and abreast the forward wall of the same. The forward part of the west rail was torn from the transom, the rail itself also being separated between the junctions of the two transoms. At an early stage of rupture the forward and rear axles made a slight angle with each other, opening on the east side. Secondary fractures occurred as the rear portion of the frame was bent out of shape.

FIGURE 6—Forward tender truck Parts reassembled after the derailment View of right side

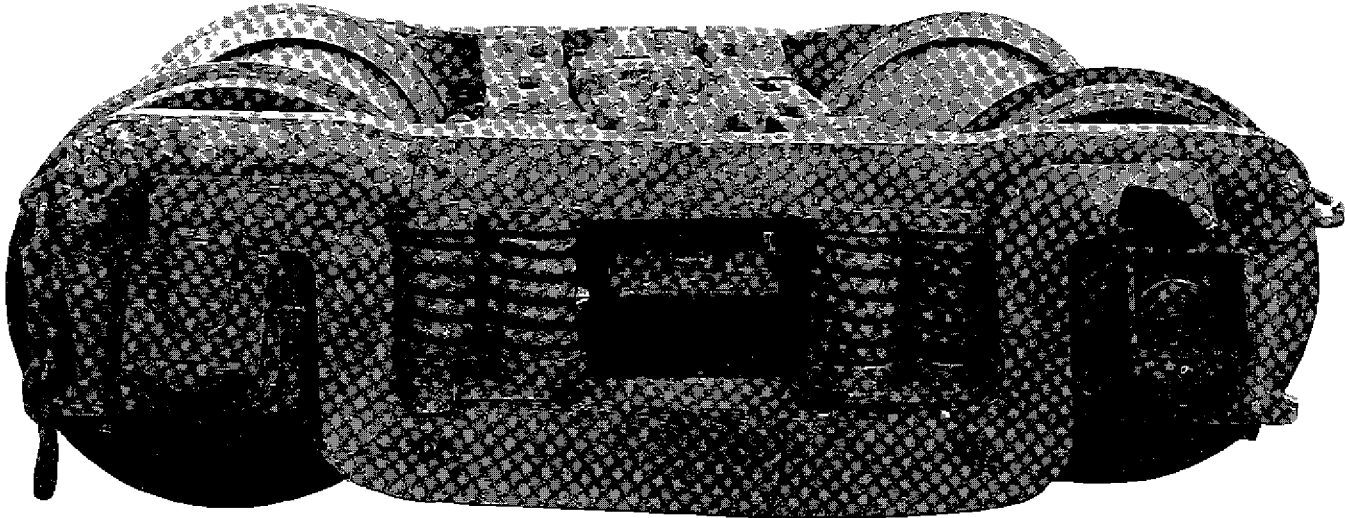
Figure No. 7 is a view of the rear truck of the tender, taken from the east side. A line of rupture occurred in this frame, at the same place as the original fracture in the forward frame except at the opposite end of the side rail. Three sides of the box-shaped cross section of the rail were separated. The truck was dismantled and the fourth side broken by means of a battering ram. It displayed toughness of metal. Each fracture exhibited by the two frames showed sound steel. The chemical composition of the metal of the forward frame, furnished by the Alexandria laboratory of the Southern Railway, was as follows:

FIGURE 7—Rear tender truck in the condition recovered after the derailment. Crack in side rail at rear of seats of helical springs.

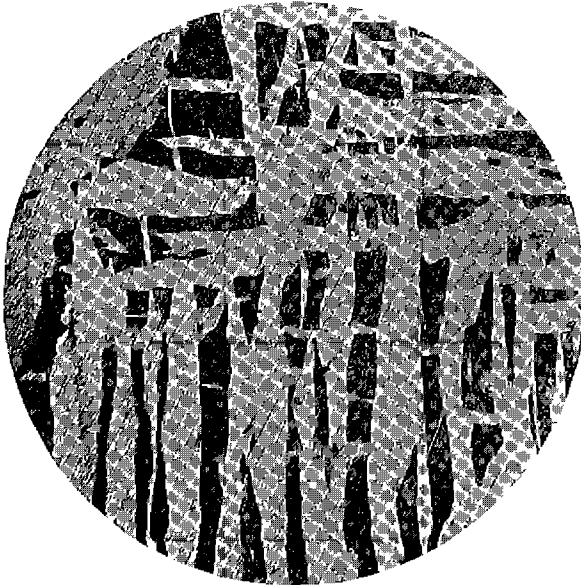
Figure No 8 is a photomicrograph of the structure of the metal, near the initial point of fracture of the rail, west side, at a magnification of 100 diameters

FIGURE 8.—Photomicrograph of structure of metal of forward truck frame Magnification 100 diameters

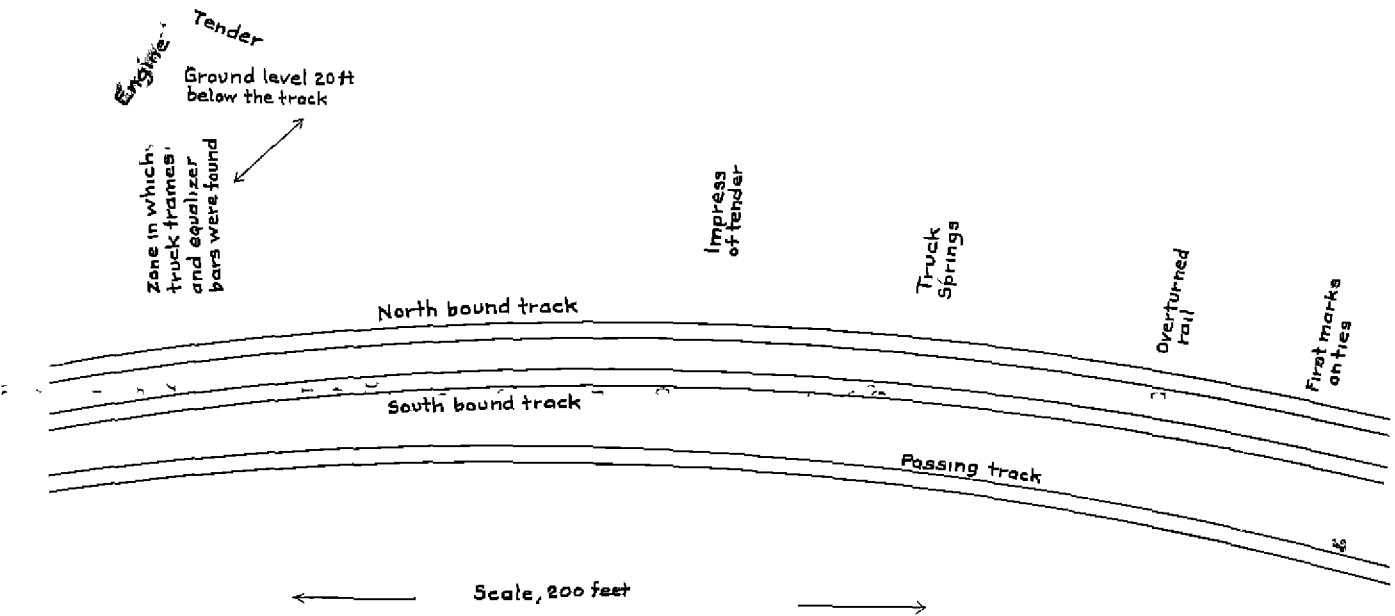
Figure No 9 is a simplified diagram of the tracks at the scene of the derailment, showing the positions of the overturned rail, where truck springs were found, the impress made by the tender on the embankment, and the places where the engine and tender came to rest after the derailment The distance from the overturned rail to the engine was about 335 feet horizontal, with a drop of 20 feet vertical The track was torn up from the overturned rail to a point abreast that which the engine reached Marks on the ties were found south of the overturned rail It has not been possible to establish a relation between these marks and the events which transpired during the early stages of the accident

FIGURE 9 —Diagram showing positions of engine, tender, truck frames and fragments with reference to location of overturned rail

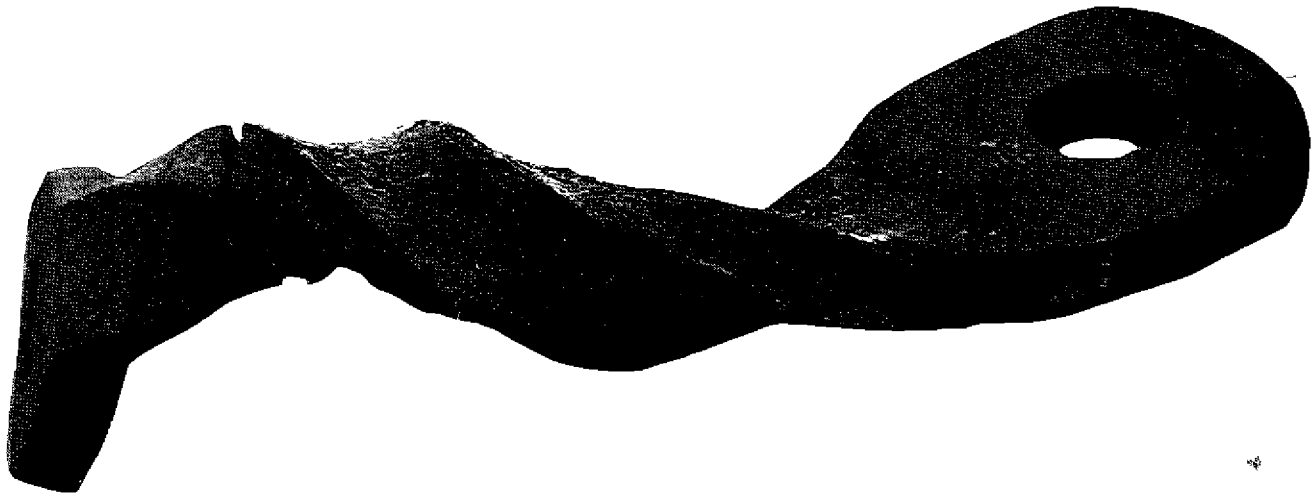
Figure No 10 illustrates the twisted and fractured drawbar which connected the engine with the tender. Its dimensions were $78\frac{3}{4}$ inches long, $5\frac{1}{2}$ inches wide, and 3 inches thick. It was twisted through an angle of nearly 360° before separation. The safety bar was likewise twisted but remained unbroken. No further evidence is needed to establish the remarkable fact that the engine rotated through an angle of 450° after it left the track and before it finally came to rest.

FIGURE 10—Drawbar which connected engine and tender, shown as recovered after the derailment Twisted and broken during the flight of the engine
