INTERSTATE COMMERCE COMMISSION

REPORT OF THE DIRECTOR OF THE BUREAU OF SAFETY IN RE
INVESTIGATION OF AN ACCIDENT WHICH OCCURRED ON THE
CINCINNATI, NEW ORLEANS & TEXAS PACIFIC RAILWAY,
SOUTHERN RAILWAY SYSTEM, AT HIGH BRIDGE, KY., ON
JANUARY 20, 1930.

February 28, 1930.

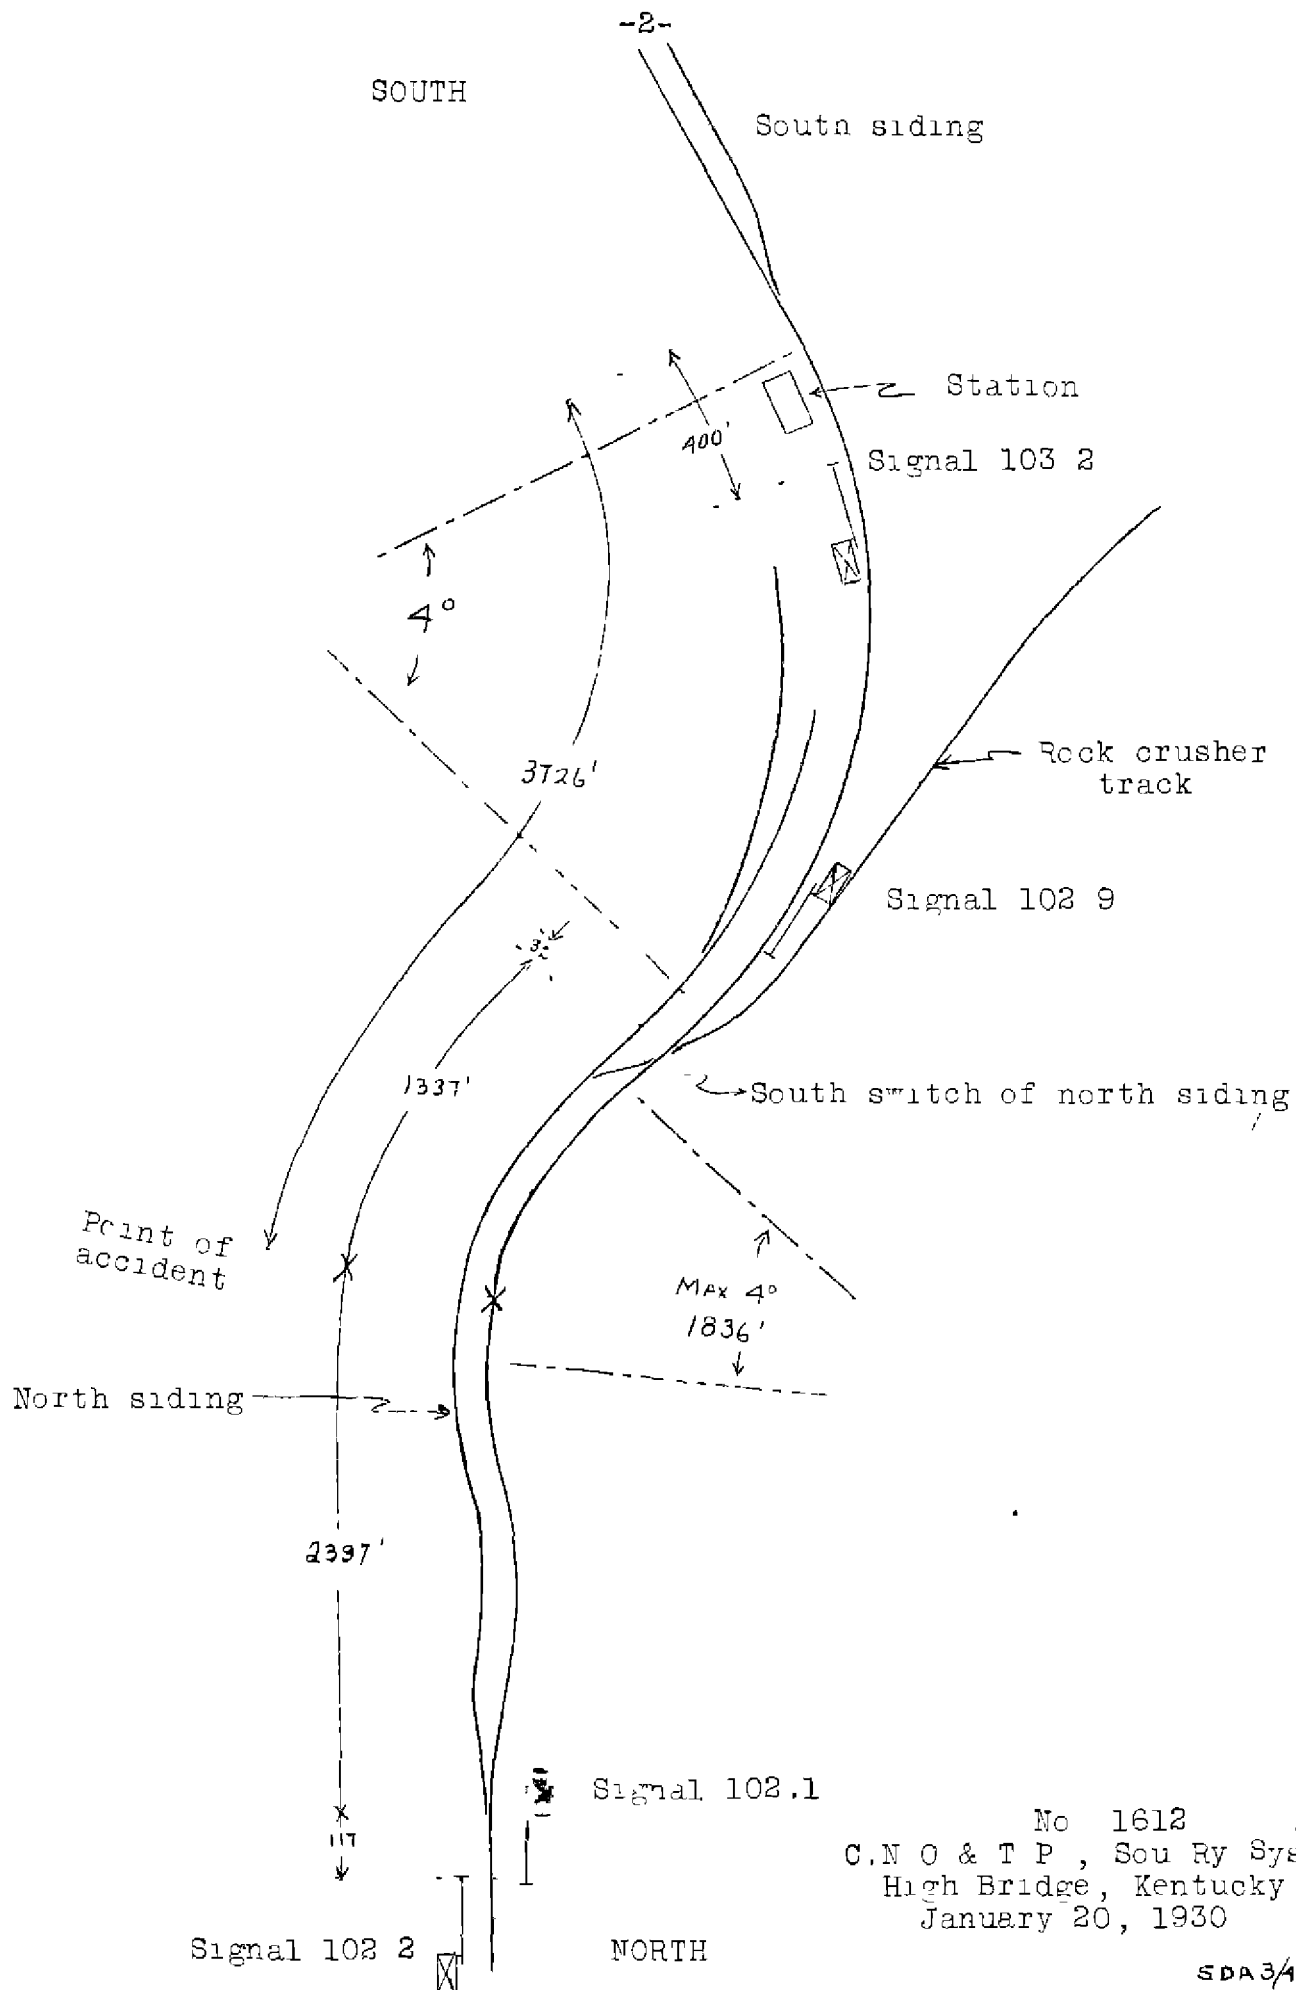
No 1612
 C.N O & T P , Sou Ry Sys
 High Bridge, Kentucky
 January 20, 1930

The signals involved are southbound permissive signal 102.1 and northbound absolute signal 103.2. Signal 102.1 is near the north switch of the north siding, and its control extends southward to signal 103.2. Signal 103.2 is located about 400 feet north of the north switch of the south siding, and its control extends to a point 1,351 feet north of signal 102.1. When a northbound train passes the latter point, signal 103.2 goes from the stop to the caution position, provided the track between the two points is not otherwise occupied, and when the train is 3,067 feet north of signal 102.1, it permits signal 103.2 to assume the clear position.
