INTERSTATE COMMERCE COMMISSION

REPORT OF THE DIRECTOR OF THE BUREAU OF SAFETY IN RE
INVESTIGATION OF AN ACCIDENT WHICH OCCURRED ON THE
CLEVELAND, CINCINNATI, CHICAGO & ST. LOUIS RAILWAY,
NEW YORK CENTRAL LINES, AT KANKAKEE, ILL., ON
SEPTEMBER 30, 1931

November 4, 1931.

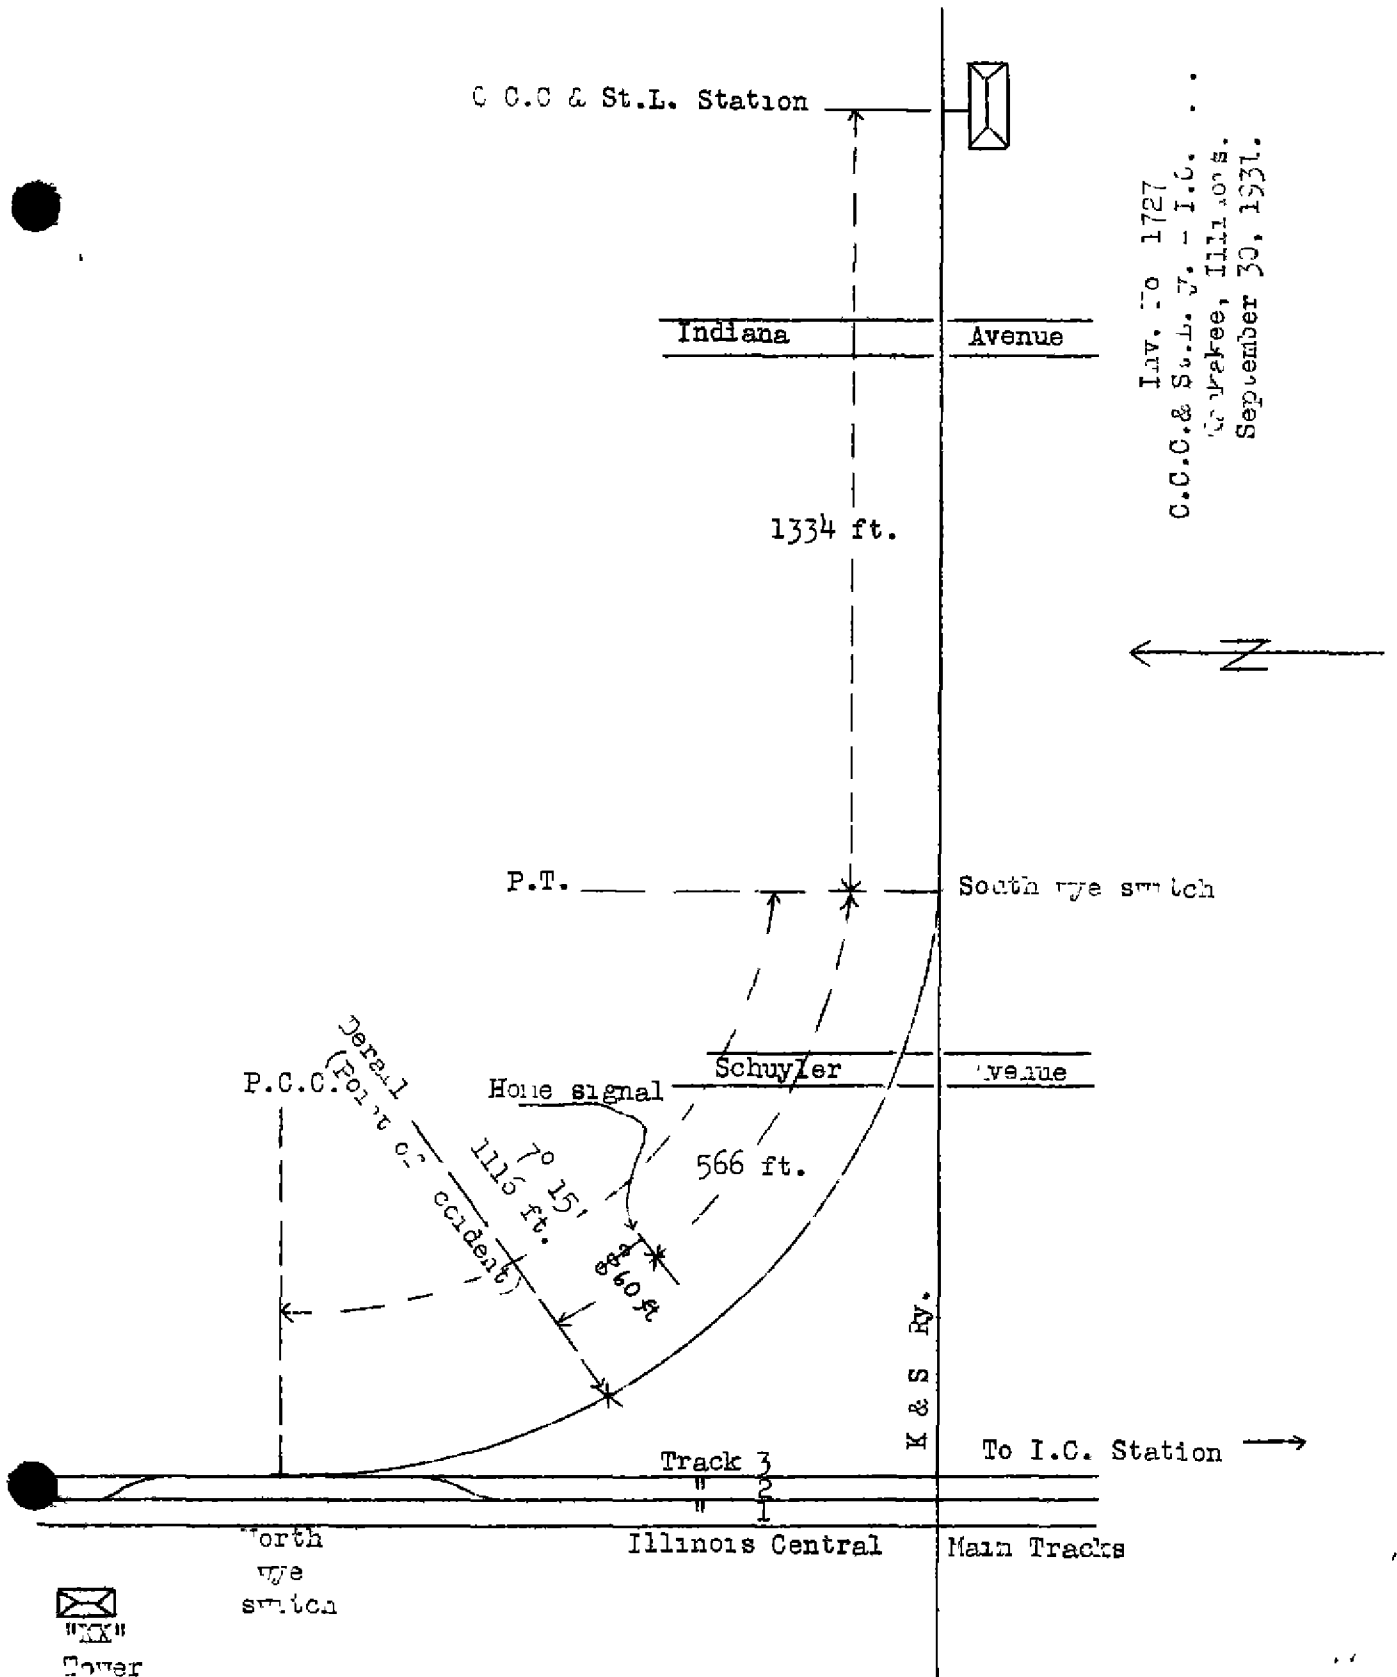
Inv. No 1727
 C.C.C. & St.L. Ry. - I.C.
 Chicago, Illinois.
 September 30, 1931.

This accident occurred at a derail located 1,960 feet north of the Big Four passenger station, on the Big Four wye; approaching this derail from the south, beginning at the passenger station, there are 1,334 feet of tangent track followed by a compound curve to the right 1,116 feet in length, with a maximum curvature of 8° . The derail is located on this curve approximately 626 feet from the south switch, the curvature at that point being $7^{\circ} 15'$.
