INTERSTATE COMMERCE COMMISSION.

REPORT OF THE CHIEF INSPECTOR OF SAFETY APPLIANCES REGARDING INVESTIGATION OF A DERAILMENT ON THE CLEVELAND, CINCINNATI, CHICAGO & ST. LOUIS RAILWAY, NEAR STOCKWELL, IND., ON JANUARY 7, 1913, ACCOMPANIED BY REPORT OF THE ENGINEER-PHYSICIST OF THE BUREAU OF STANDARDS REGARDING HIS INVESTIGATION OF A BROKEN TIRE WHICH CAUSED THIS ACCIDENT.

SEPTEMBER 24, 1913.

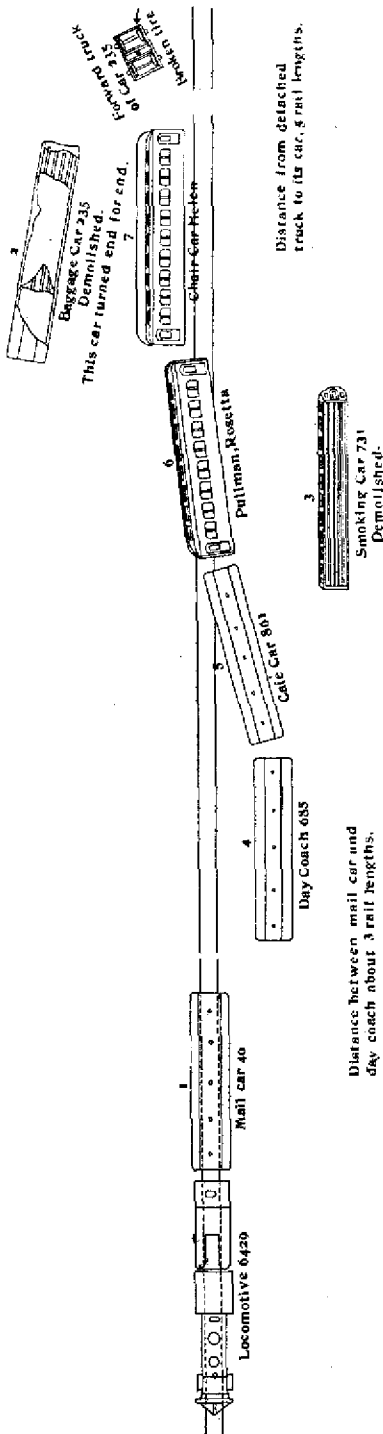
Illustration No. 1 shows the relative positions of the derailed cars after the accident. The locomotive and mail car remained on the track and were not damaged; the baggage car was derailed on the north side of the track and was practically demolished, as is shown in illustration No. 2. The smoking car was derailed on the south side of the track and was badly crushed; the passenger who was killed and most of those injured were in this car. The coach was also derailed on the south side of the track, but was not so badly damaged. The other three cars were derailed but suffered comparatively slight damage. All the cars in this train were of wooden construction except the second car from the rear end, which was of steel.

Six cars of the train were derailed, the locomotive and the mail car remaining on the track uninjured, the damage to the train and the track occurring behind them. The baggage car was derailed to the right side of the track, turned end for end and faced toward the rear, and came to rest in a demolished condition. Its forward truck was 5 rail lengths to the rear, also turned nearly end for end. The smoking car was derailed to the left side of the track and came to rest bottom side up badly demolished. Most of the injured people and the passenger who was killed were in this car. The day coach and café car were on the left side of the track, the Pullman car "Rosetta" was over the track, while the chair car "Helen" overhung the embankment on the right side. The relative positions of the cars when they came to rest are shown on the diagram (fig. No. 1).

No. 1.—Relative positions of cars after derailment.

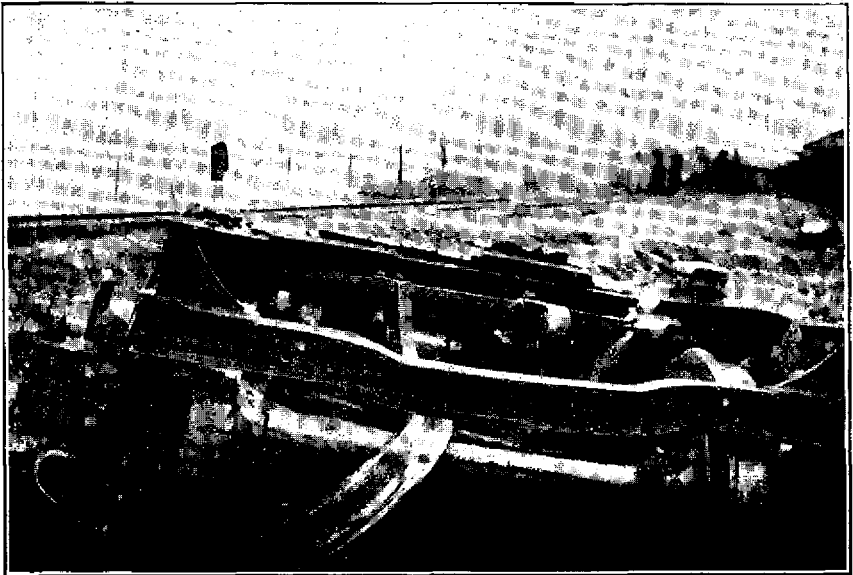
fractured tire is seen encircling the axle. This view is looking toward Lafayette in the direction the train was traveling. Figure No. 4 shows the axle with ruptured tire after removal from the truck, and one of the retaining rings, the latter much bent. The lip of the tire, which acted as a lock for the outer retaining ring, was generally broken from the body. The inner lip was not injured. This is one of the results of untiring which would be expected.

No. 3.—View taken looking toward the north, showing forward truck of baggage car located five rail lengths behind that car. Fractured tire can be seen encircling the axle.

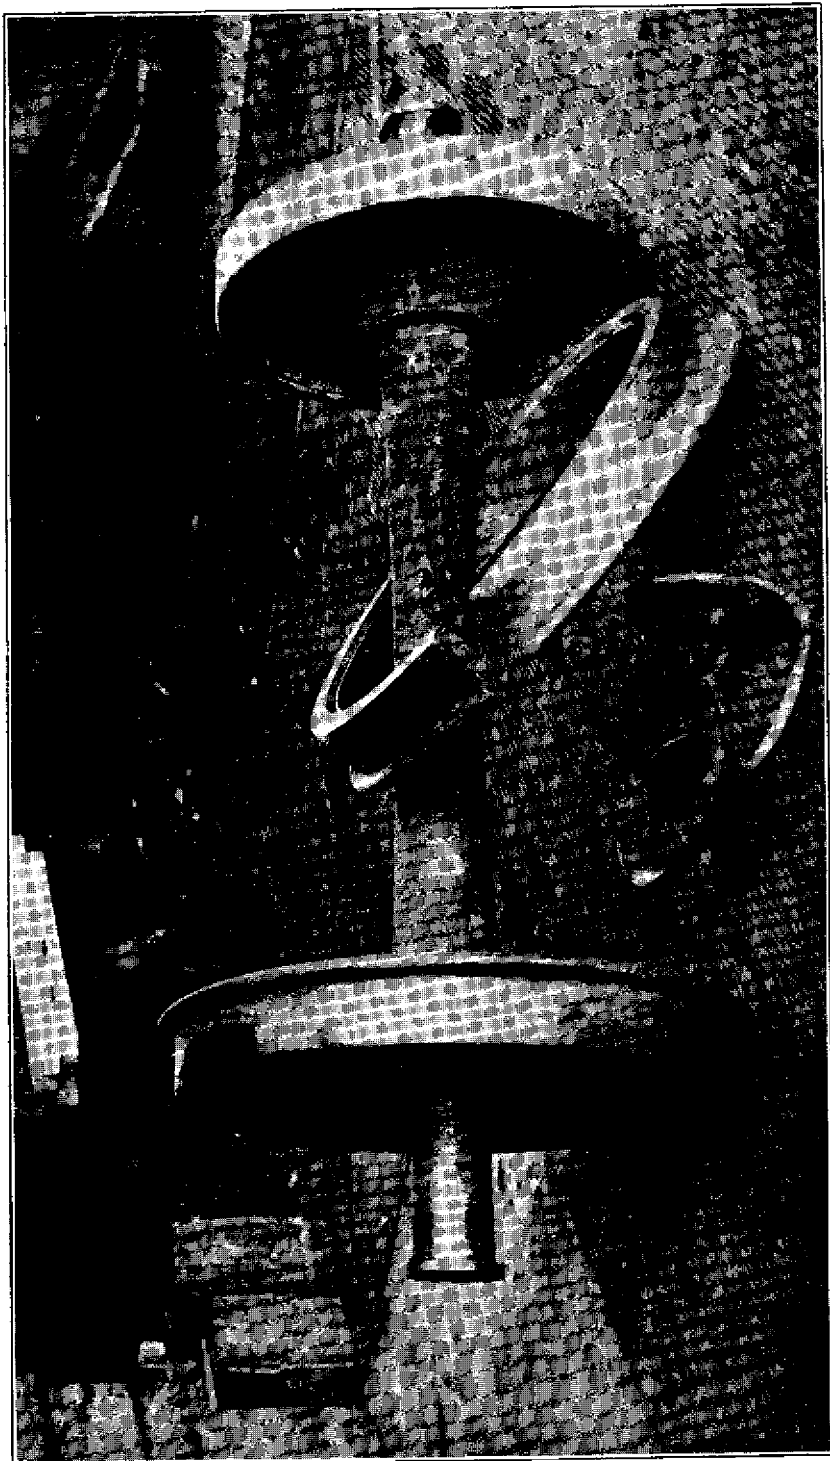
No. 4. -View taken in shops, showing intact wheel, axle, and fractured tire of forward truck of baggage car, together with bent retaining ring.

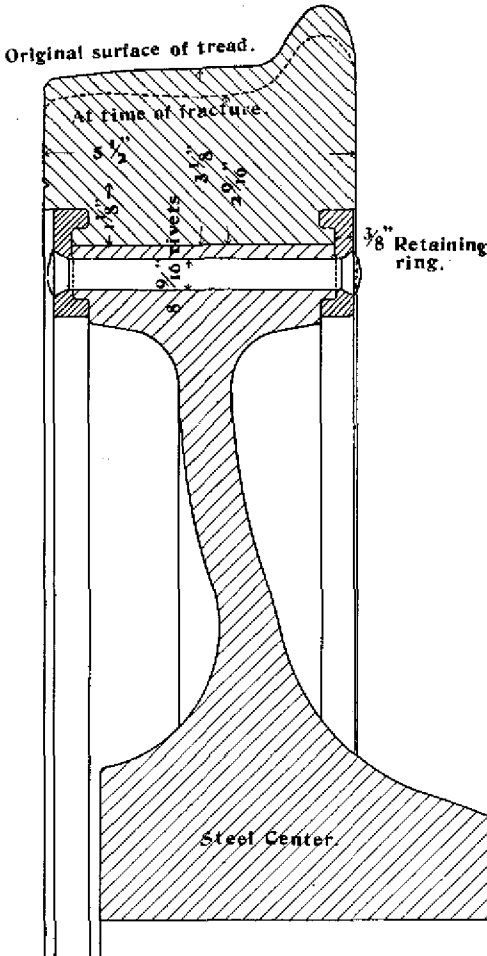
Figure No. 5 shows the cross section of the wheel center and tire with retaining rings and riveted connection. From the design of the wheel it is apparent that the retaining rings can act in two capacities—to hold fragments of a broken tire against outward centrifugal forces, and to restrain the tire against lateral thrust par-

Eight $\frac{9}{16}$ -inch rivets are provided in the construction of the wheel to hold the tire against such an emergency as arose when this tire fractured. The total sectional area of these eight rivets is a little

No. 5.--Cross section of tire and wheel center, showing details of construction of wheel.

less than 2 square inches. The two retaining rings, however, have a sectional area of about 60 square inches to resist an outward radial force taken either in tension on the body of the rings or shear of the inner lips.

That the retaining rings and rivets in the construction of the wheel did not have adequate strength, shrinkage resistance having been lost, to hold the fractured tire on its wheel center.

That adequate means should be employed to hold a tire of this type on its wheel center independent of shrinkage resistance.

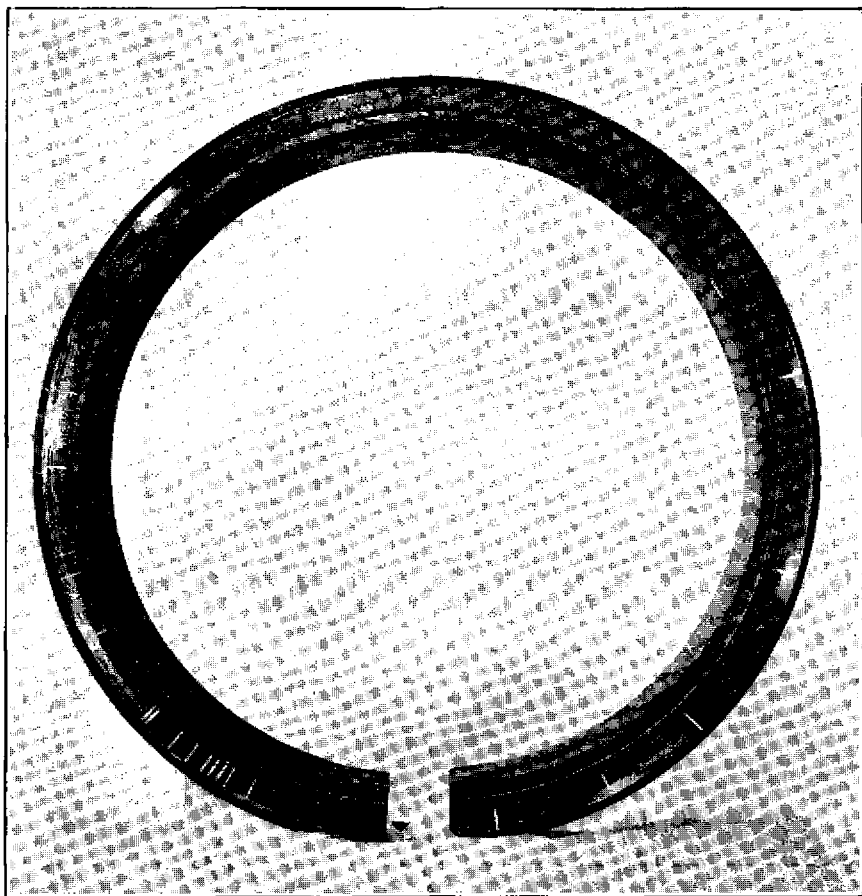
In the tread of the tire which caused this accident there were a number of thermal cracks, as will be noted in illustration No. 6, these cracks being described in Mr. Howard's report.

Figure No. 6 shows the outer end of the tire on which a number of cracks of pronounced size were visible. The location of those which measured one-half inch or more in length, 21 in number, is indicated by chalk marks. A further exhibit of these cracks is made by figures Nos. 7 and 8. The outer edge of the tread is shown in these figures, on which appear a number of the longer cracks between which are numerous small ones. The wider and longer cracks were conspicuous, admitting of discovery upon inspection of the tire. Such cracks in steel have grave significance. They lead to early ultimate failure, especially when the causes which occasioned their formation are aided and combined with independent straining forces. The shrinkage strains are always present in the cold tire, and they alone would have a tendency to complete the fracture of the tire when a thermal crack had reached a certain stage of development.

No. 6.—View showing fractured tire. Location of thermal cracks on outside of tire measuring one-half inch or more in length indicated by chalk marks.

That the fracture of the tire was occasioned by the presence of deep thermal cracks in the tread, one of which had separated the metal of the tire to a depth of one-half its thickness and had an area of over $1\frac{1}{2}$ square inches.

That these cracks were visible on the surface of the tread and the edge of the outer end of the tire.

That the presence of thermal cracks on the tread of a tire is sufficient cause for the removal of the wheel from service, which should be done.

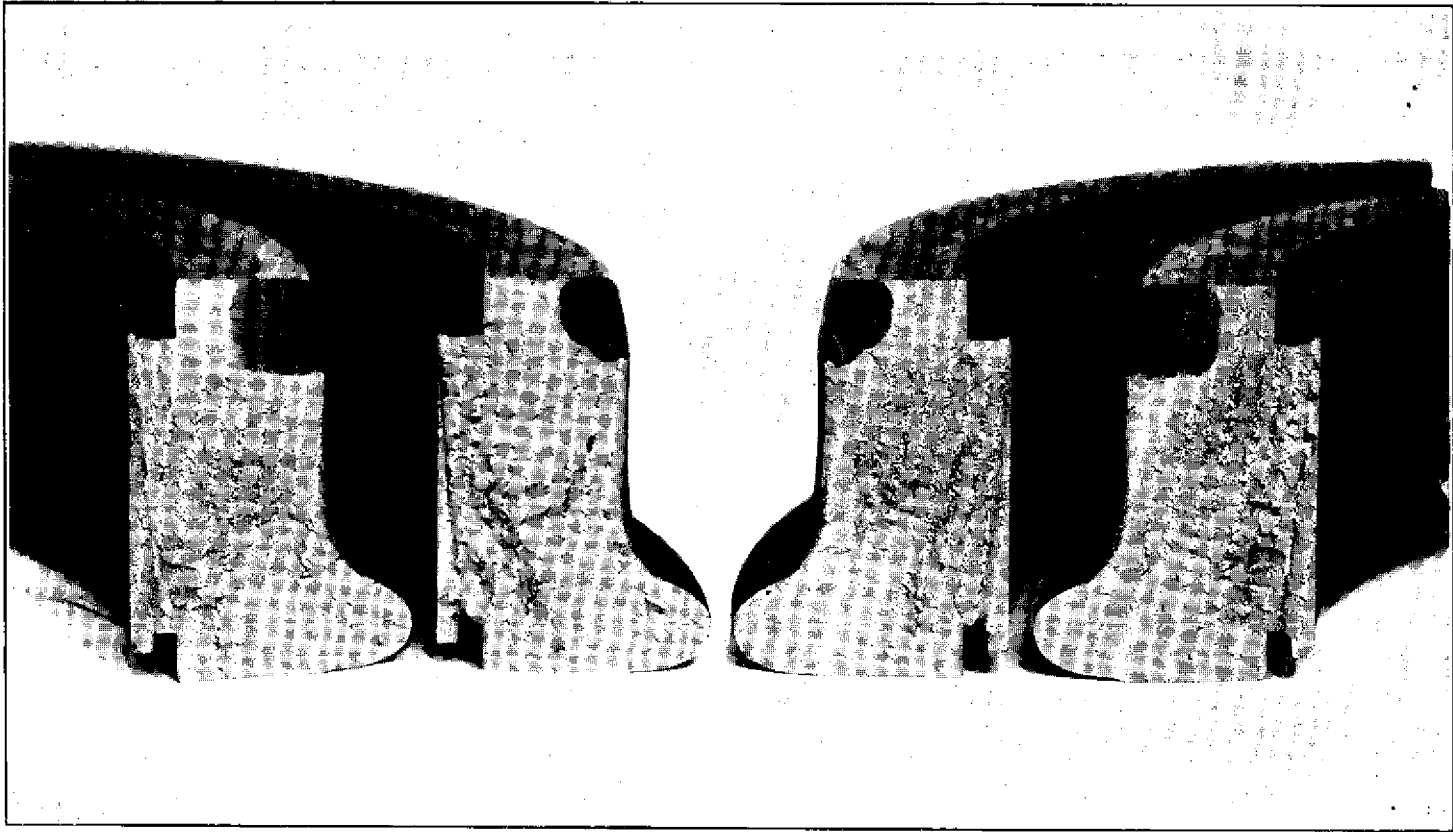
Sections measuring $1\frac{1}{8}$ inches by $\frac{7}{8}$ inch and $1\frac{1}{4}$ by $1\frac{1}{4}$ inches, respectively, which appear dark-colored on the figure, mark the extent of

No. 9.—View showing thermal cracks which developed in the tire while in service.

these thermal cracks. They had reached nearly half through the thickness of the tire. The gravity of the case is well illustrated in the discolored portions of these surfaces. A series of photographic prints of this kind could properly be placed before car inspectors for their information and guidance.

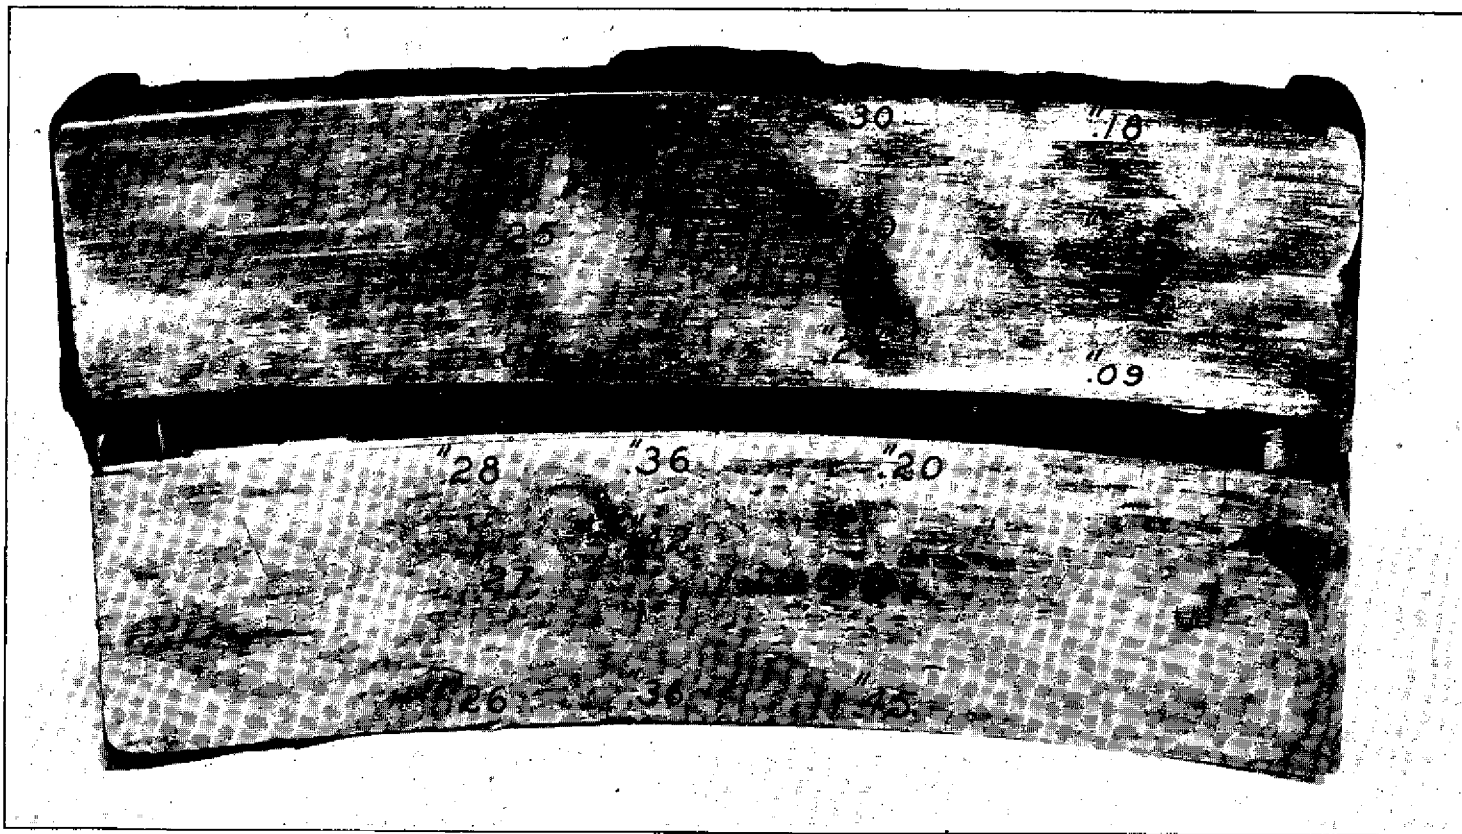
Shoe branded "V 7434" had thermal cracks extending across its face at intervals of 0.75 inch to 1.25 inches; that branded "G 3960"

No. 10.—View showing thermal cracks developed on the working faces of brake shoes. Figures appearing on the illustration state the depth of penetration of the cracks at the places indicated. The upper figure of illustration shows a cast-iron shoe with steel-strip backing. The lower figure shows a cast-iron shoe, steel-strip backing, with interlacing steel wires cast in the shoe near its working face.

at intervals of 1 inch each. The shoes were subsequently broken apart in several places by the blows of a sledge hammer and the depths of the cracks noted, which are entered on figure No. 10. The maximum depths were 0.40 inch and 0.45 inch, respectively. End views of the fractures are shown by figure No. 12. Thermal cracks are not confined to railway material, hence their development in tires, brake shoes, and rails do not present new or novel examples in constructive materials.

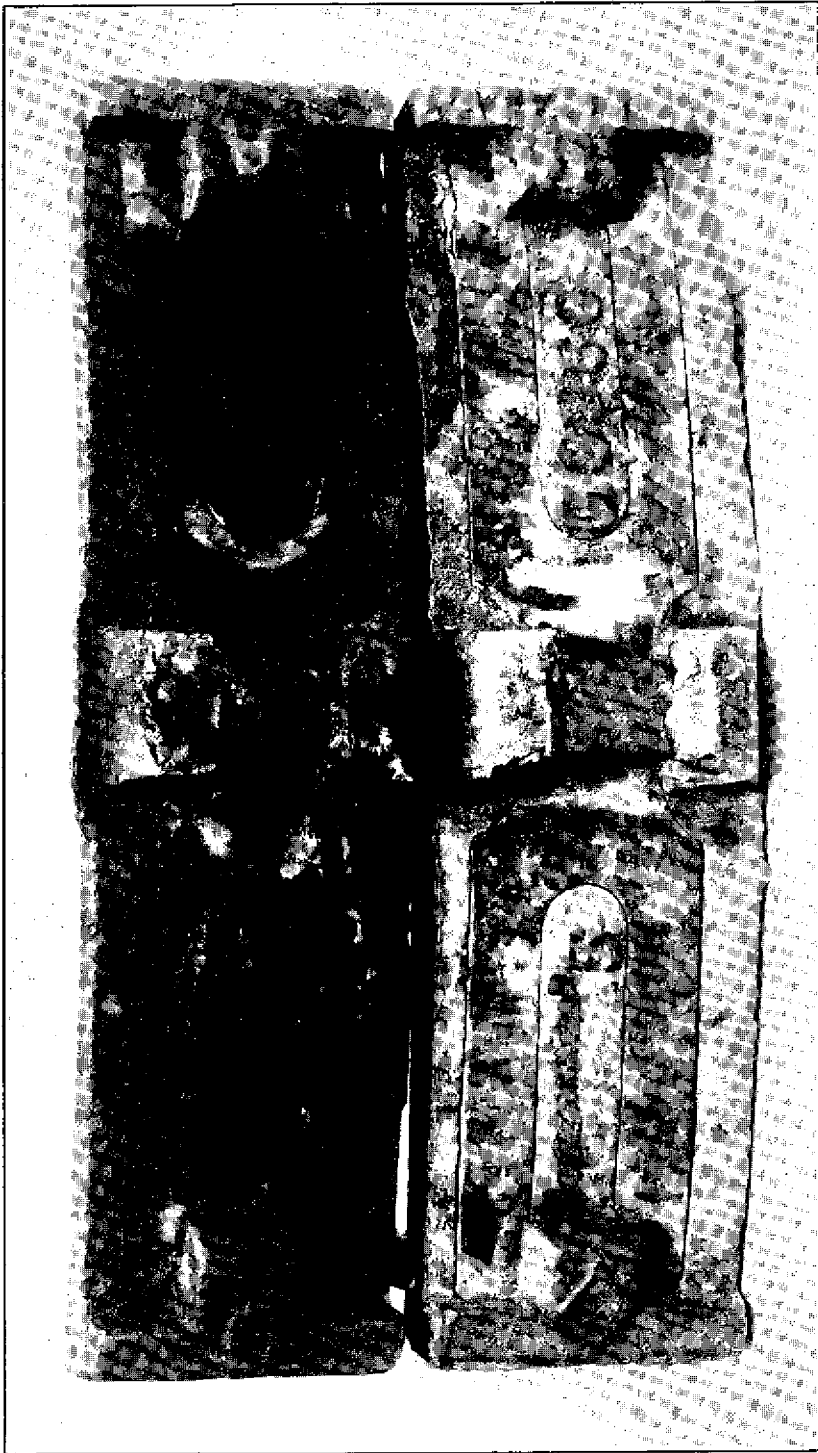
Thermal cracks in brake shoes are guarded against in manufacture by casting in place in the backs of the shoes strips of forged or rolled steel which hold the fragments together. The appearance of two shoes, each nearly new, is shown in figures Nos. 10, 11, and 12. One is a plain cast-iron shoe with steel-strip backing, the other has interlaced steel wire inserted, together with the steel-strip backing. As shown in the cuts they are described as follows:

No. 11. Back sides of brake shoes shown in illustration No. 10, showing steel strips which retain fragments of shoe in place after the development of diagonal cracks on the working faces.

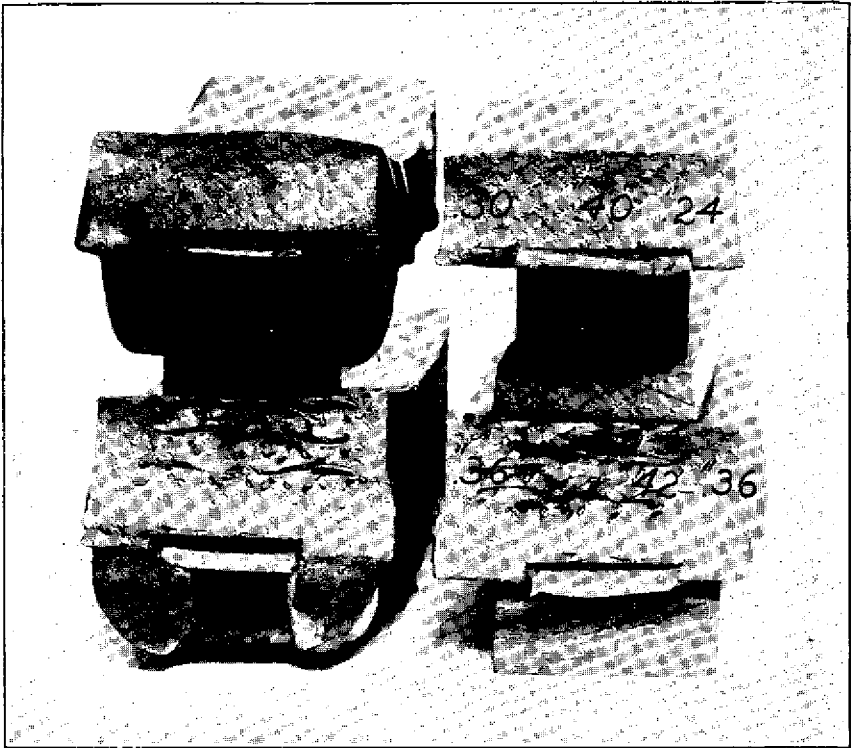
No. 12.—Fractured surfaces of brake shoes shown in illustrations Nos. 10 and 11. Depth of penetration of thermal cracks shown by figures appearing on the illustration.
