REPORT OF THE DIRECTOR OF THE BUREAU OF SAFETY IN RE
INVESTIGATION OF AN ACCIDENT WHICH OCCURRED AT A
CROSSOVER CONNECTING THE DAVENPORT, ROCK ISLAND &
NORTH-WESTERN RAILWAY WITH THE CHICAGO & NORTH
WESTERN RAILWAY AT CLINTON, IOWA, ON MAY 15, 1931.

July 2, 1931.

Inv. No. 1708
 Chicago & North Western
 and the
 Davenport, Rock Island & North Western
 Clinton, Iowa
 May 15, 1931

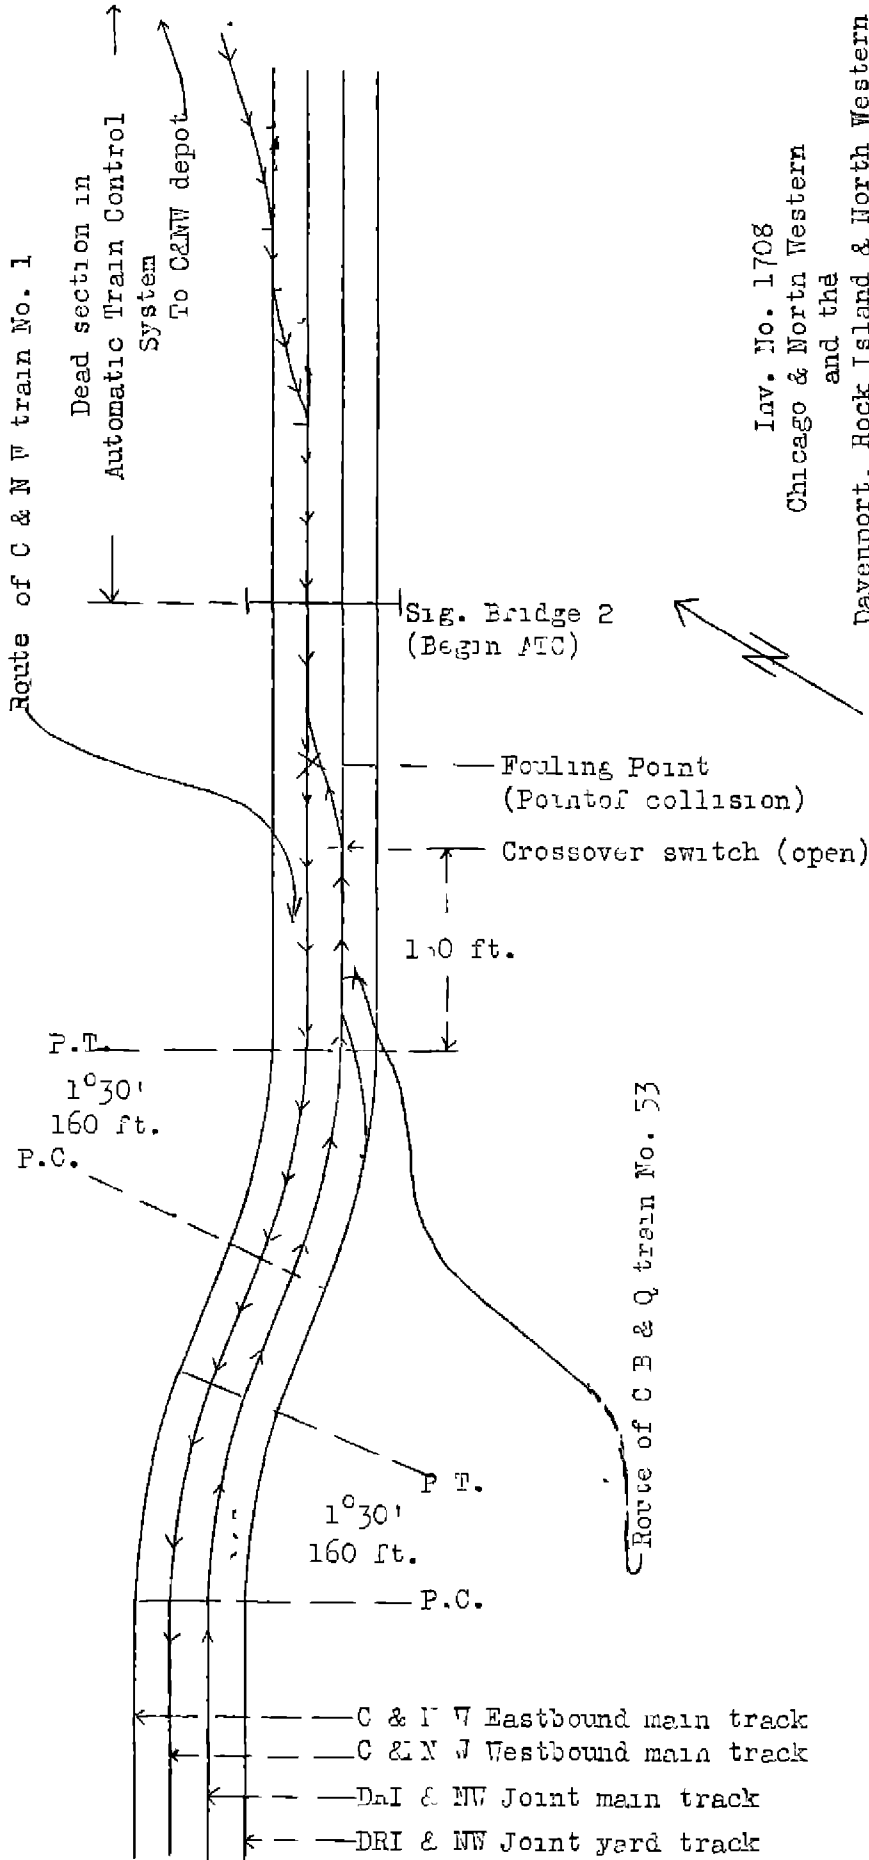
The direct cause of this accident was an open crossover switch.

The/switch of the crossover between the DRI&NWRy and the C&NWRy is connected to the automatic train-control system of the C&NWRy. As a result of this switch being open, westbound C&NWRy train No. 1, which was making a through movement on the C&NWRy, continued to receive a slow-speed cab signal indication, and the engineman was operating his train in obedience to this indication when the accident occurred. The view of the switch from the fireman's side of CB&QRR train No. 53, (DRI&NWRy train No. 4) moving eastward on the DRI&NWRy main track, was considerably obstructed by westbound C&NWRy train No. 1 moving around the curves in the opposite direction on the adjacent track, as well as by a switch indicator and another switchstand nearby. The engine crew of CB&QRR train No. 53 were on the alert, however, and saw the open facing-point crossover switch practically as soon as it was possible to have done so, with the result that the speed of their train was very considerably reduced prior to entering the crossover and colliding with the rear portion of C&NWRy train No. 1; there is no question but that the attention to duty and quick action of the CB&QRR engine crew prevented the results of this accident from being considerably more serious than was actually the case. After the accident the switch was found to be lined for the crossover and locked, but exactly when or by whom the switch was opened could not be ascertained. The last time the switch was known to have been used for a facing-point movement was about 11.35 a.m., when a CMStP&PRy

It appeared that there were four switchstands in service in this vicinity of the same type as that involved in the accident, and that all of these main line switches could be operated manually without unlocking, although considerable effort was required to do so. Subsequently it is understood that decision has been reached to substitute a rigid stand for those now in use. This elimination of main line stands which can be operated without unlocking is to be commended.
