DELAWARE, LACKAWANNA & WESTERN
RAILROAD NEAR EAST CORNING,
N. Y., JULY 4, 1912

REPORT OF CHIEF INSPECTOR OF
SAFETY APPLIANCES

REPORT OF THE CHIEF INSPECTOR OF SAFETY APPLIANCES OF THE INTERSTATE COMMERCE COMMISSION COVERING HIS INVESTIGATION OF AN ACCIDENT WHICH OCCURRED ON THE DELAWARE, LACKAWANNA & WESTERN RAILROAD NEAR EAST CORNING, N Y , ON JULY 4, 1912

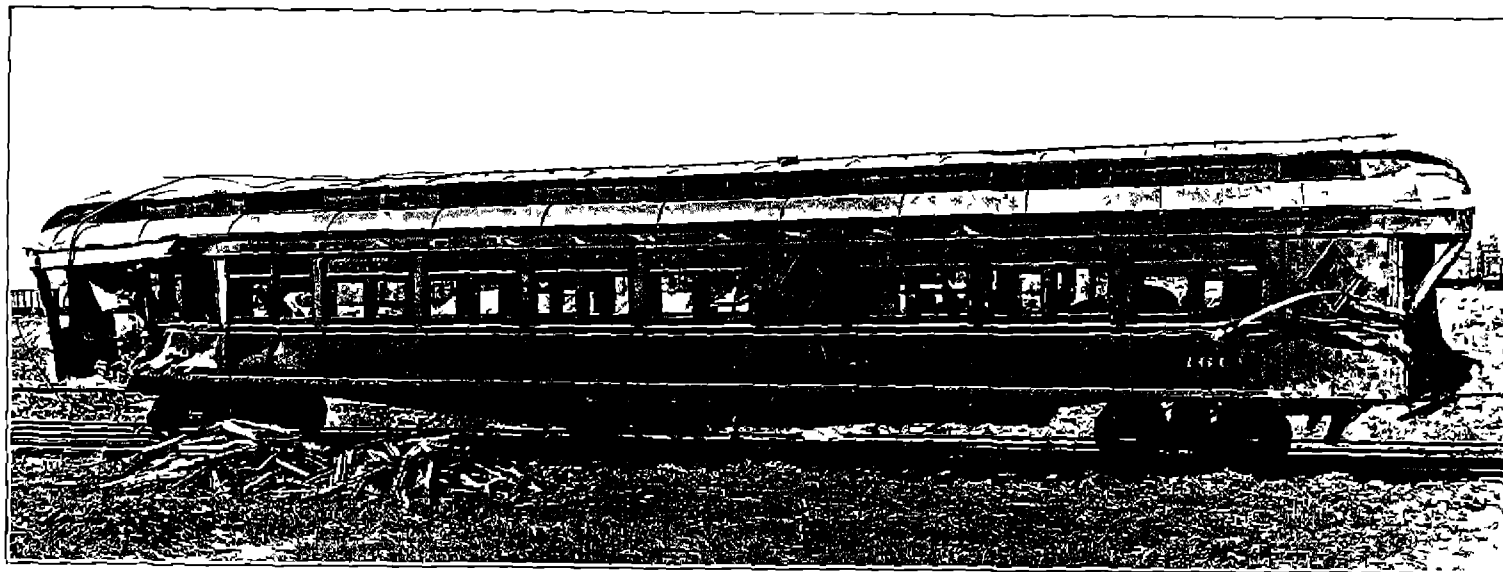
ILLUSTRATION NO 3 THE STEEL COACH AFTER REMOVAL FROM THE SCENE OF THE ACCIDENT SHOWING THE SIDE ON WHICH THE CAR RESTED AFTER THE COLLISION

The extent of the damage to the steel coach at its east and west ends, respectively, is shown in illustrations Nos 1 and 2, which are reproductions from photographs taken immediately after the accident Illustration No 3 shows the side on which the steel car rested after the accident, while illustration No 4 shows the opposite side Illustrations Nos 3 and 4 are reproductions of photographs taken after new trucks had been placed under the car and it had been removed from the scene of the accident This accident has again demonstrated the superiority of all-steel equipment In this connection attention is called to the following recommendation which was made in the report dealing with the accident which occurred on the Pennsylvania Railroad at Fort Wayne, Ind, on August 13, 1911

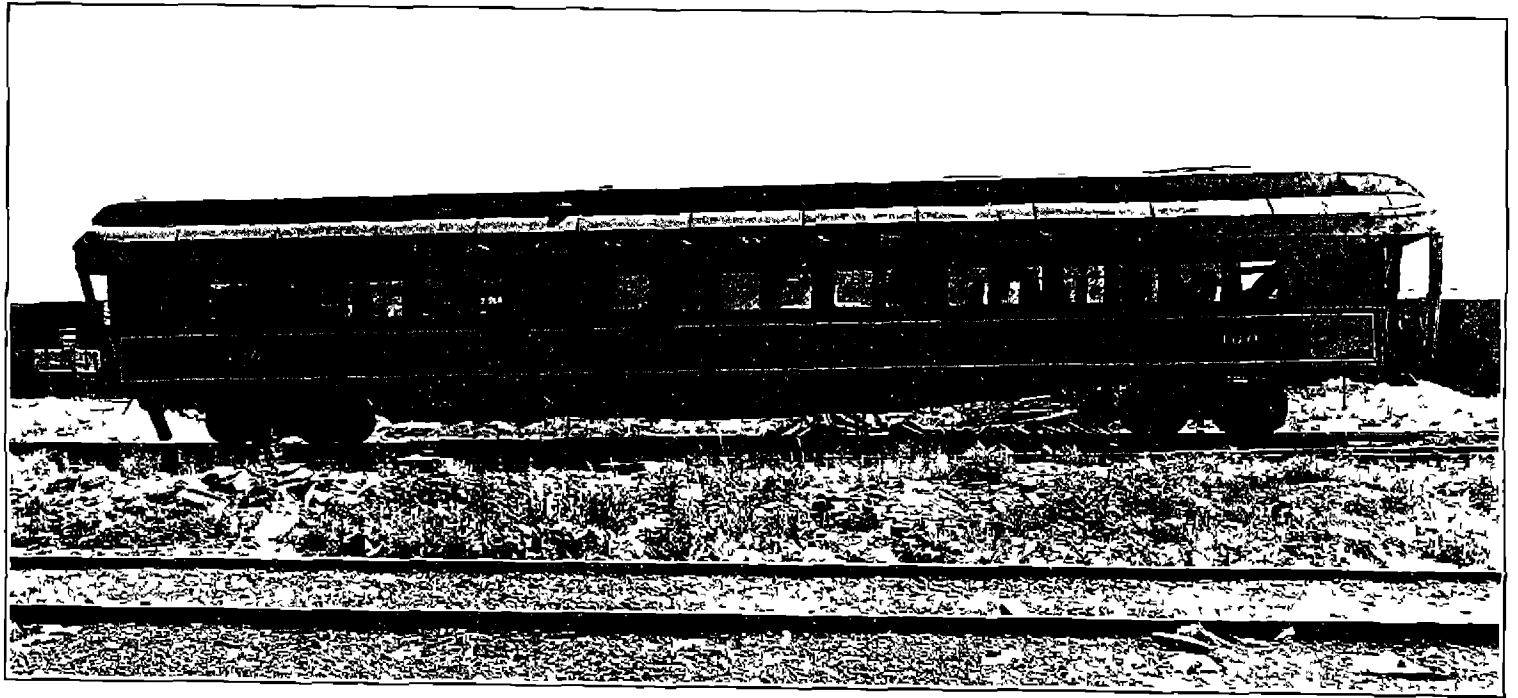
ILLUSTRATION NO. 4 VIEW OF OPPOSITE SIDE OF THE STEEL COACH
