INTERSTATE COMMERCE COMMISSION

IN RE INVESTIGATION OF AN ACCIDENT WHICH OCCURRED ON
THE DENVER & INTERURBAN RAILROAD, NEAR GLOBEVILLE,
COLO., ON SEPTEMBER 6, 1920

NOVEMBER 17, 1920

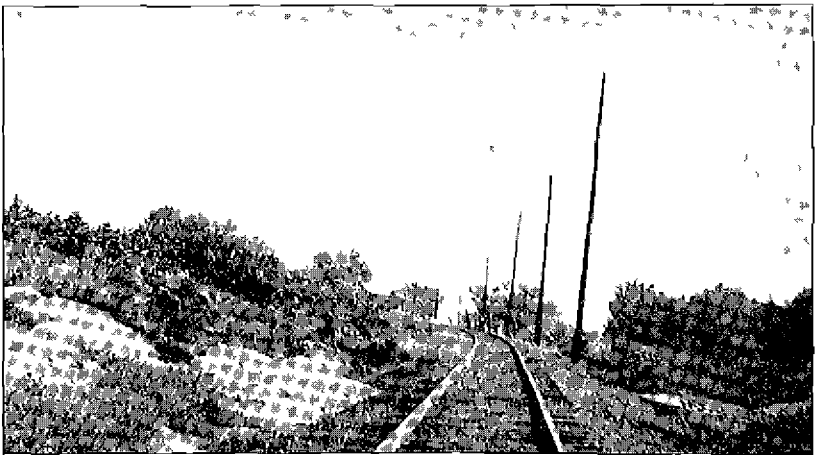
FIG. 1—View approaching point of accident from the south

approaching the point of accident from the south, taken from about the point where the motorman of the northbound train first saw the southbound train, the distance to the approximate point of accident where the people are shown standing on the track, is about 360 feet. Illustration No. 2 is a view approaching from the north, taken from the tangent track immediately north of the curve on which the accident occurred, while illustration No. 3 is taken from a point opposite the large tree shown on the right of the track in illustration No. 2, the man standing in the center of the track is at the approximate point of accident. The weather at the time of the accident was clear.

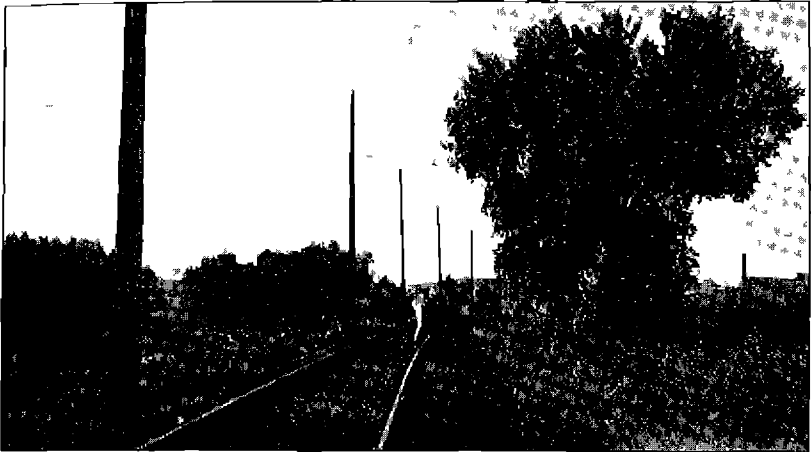
FIG 2—View approaching curve from the north

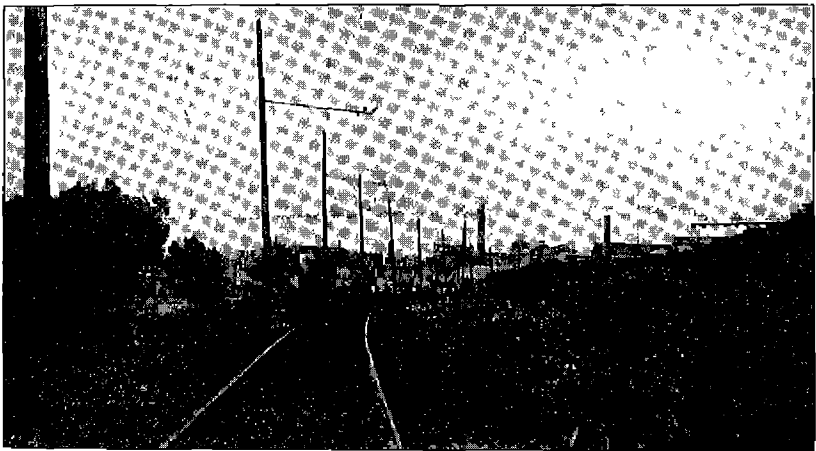
FIG 3—View of curve approaching from the north, taken opposite tree shown in Fig 2

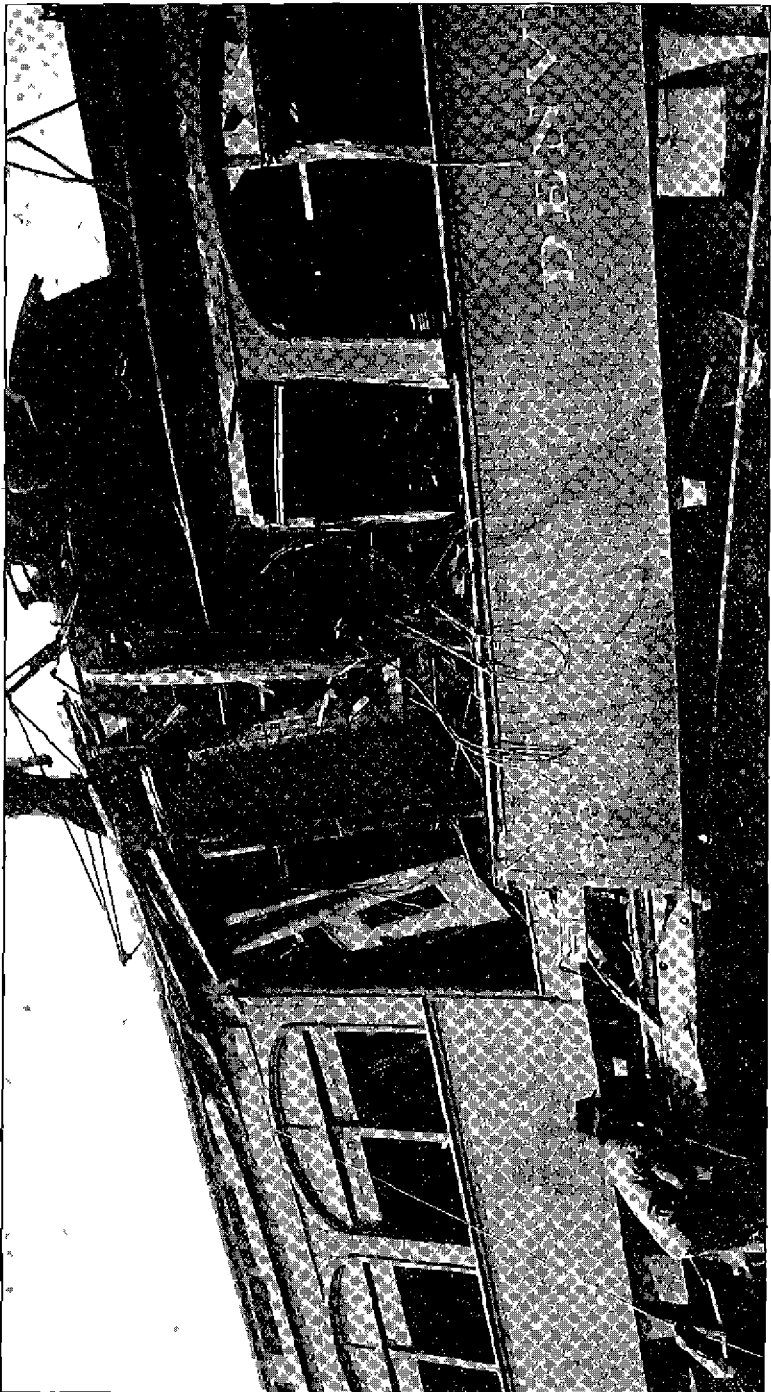
Fig 4 —View of motors 153 and 158 taken at point of accident

Motor 153, of train No 308, was telescoped a distance of about 15 feet by motor 158, of extra 158, all of those killed were riding in motor 153 Both of these motor cars were badly damaged Illustration No 4 shows these two cars before they had been removed from the scene of the accident The employees killed were the conductor of train No 308 and a section foreman
