INTERSTATE COMMERCE COMMISSION

REPORT OF THE DIRECTOR OF THE BUREAU OF SAFETY IN RE
INVESTIGATION OF AN ACCIDENT WHICH OCCURRED ON THE
DENVER & RIO GRANDE WESTERN RAILROAD AT ROPER, UTAH,
ON JUNE 22, 1931.

July 29, 1931

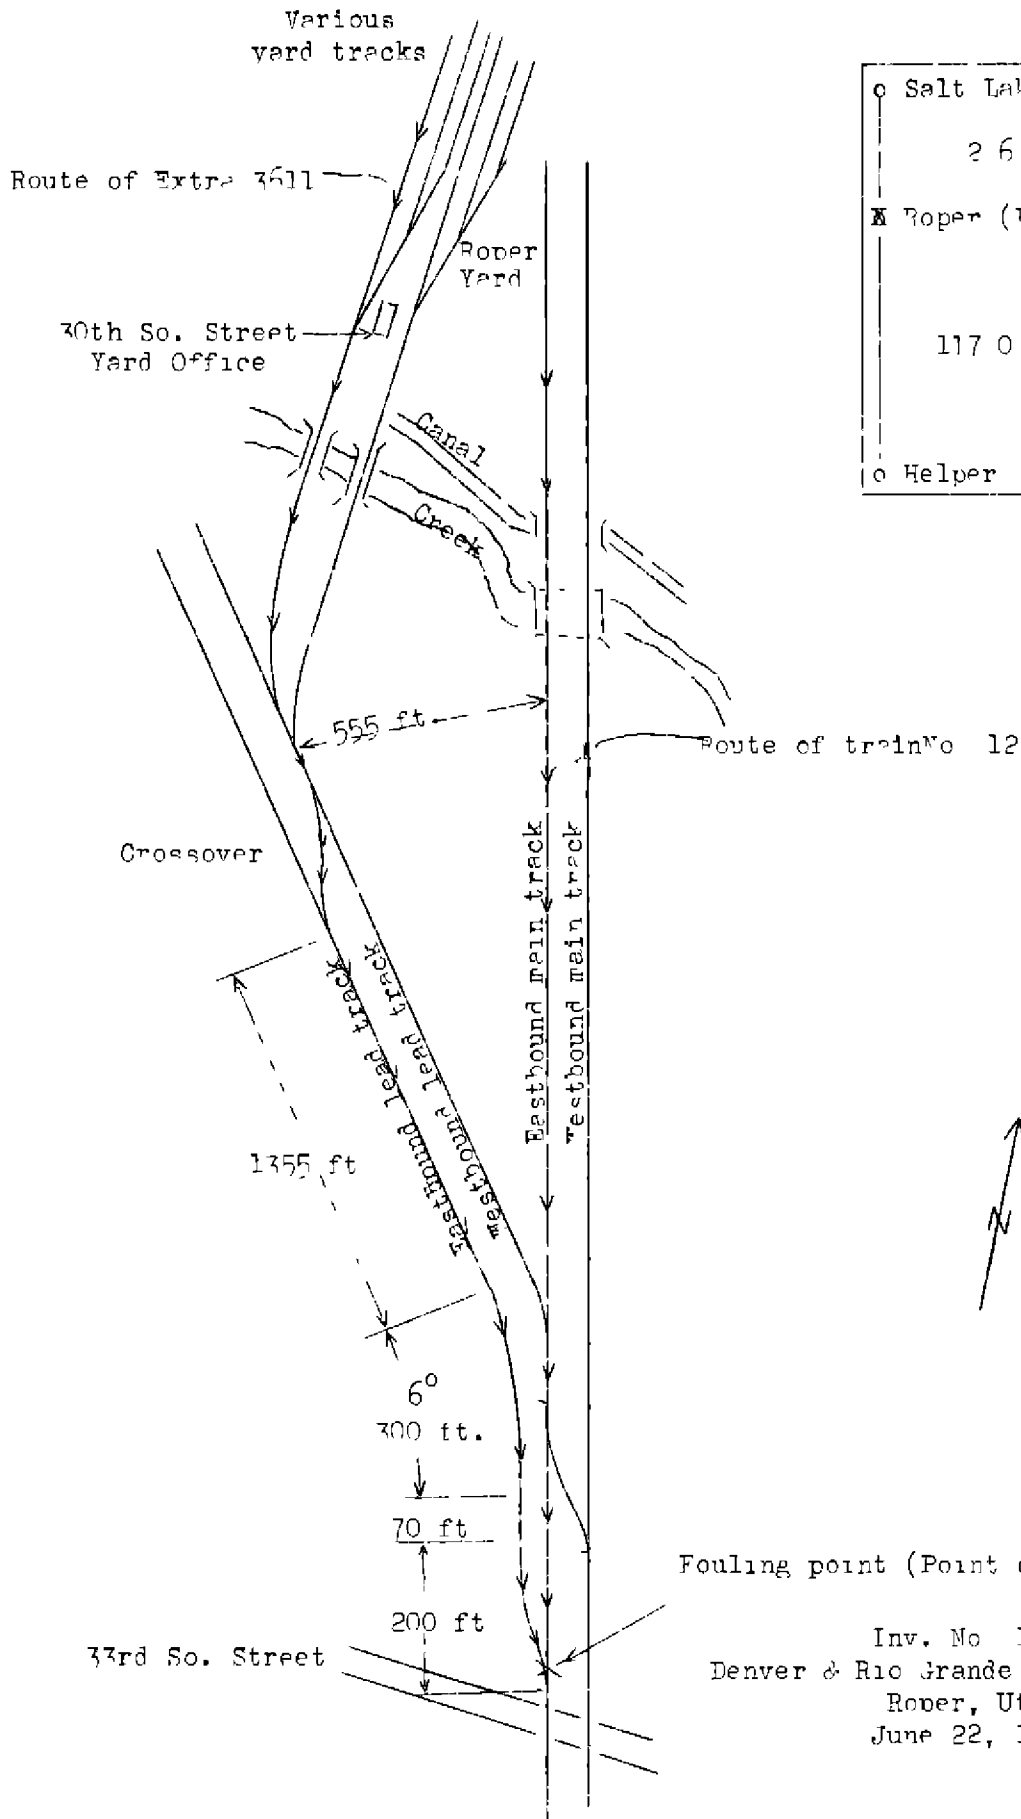
Inv. No 1712
 Denver & Rio Grande Western R R
 Roper, Utah
 June 22, 1931

Fouling point (Point of collision)
