INTERSTATE COMMERCE COMMISSION

REPORT OF THE DIRECTOR OF THE BUREAU OF SAFETY IN RE
INVESTIGATION OF AN ACCIDENT WHICH OCCURRED ON THE
DENVER AND SALT LAKE RAILWAY NEAR VOLCANO, COLO ,
ON AUGUST 12, 1929.

November 23, 1929.

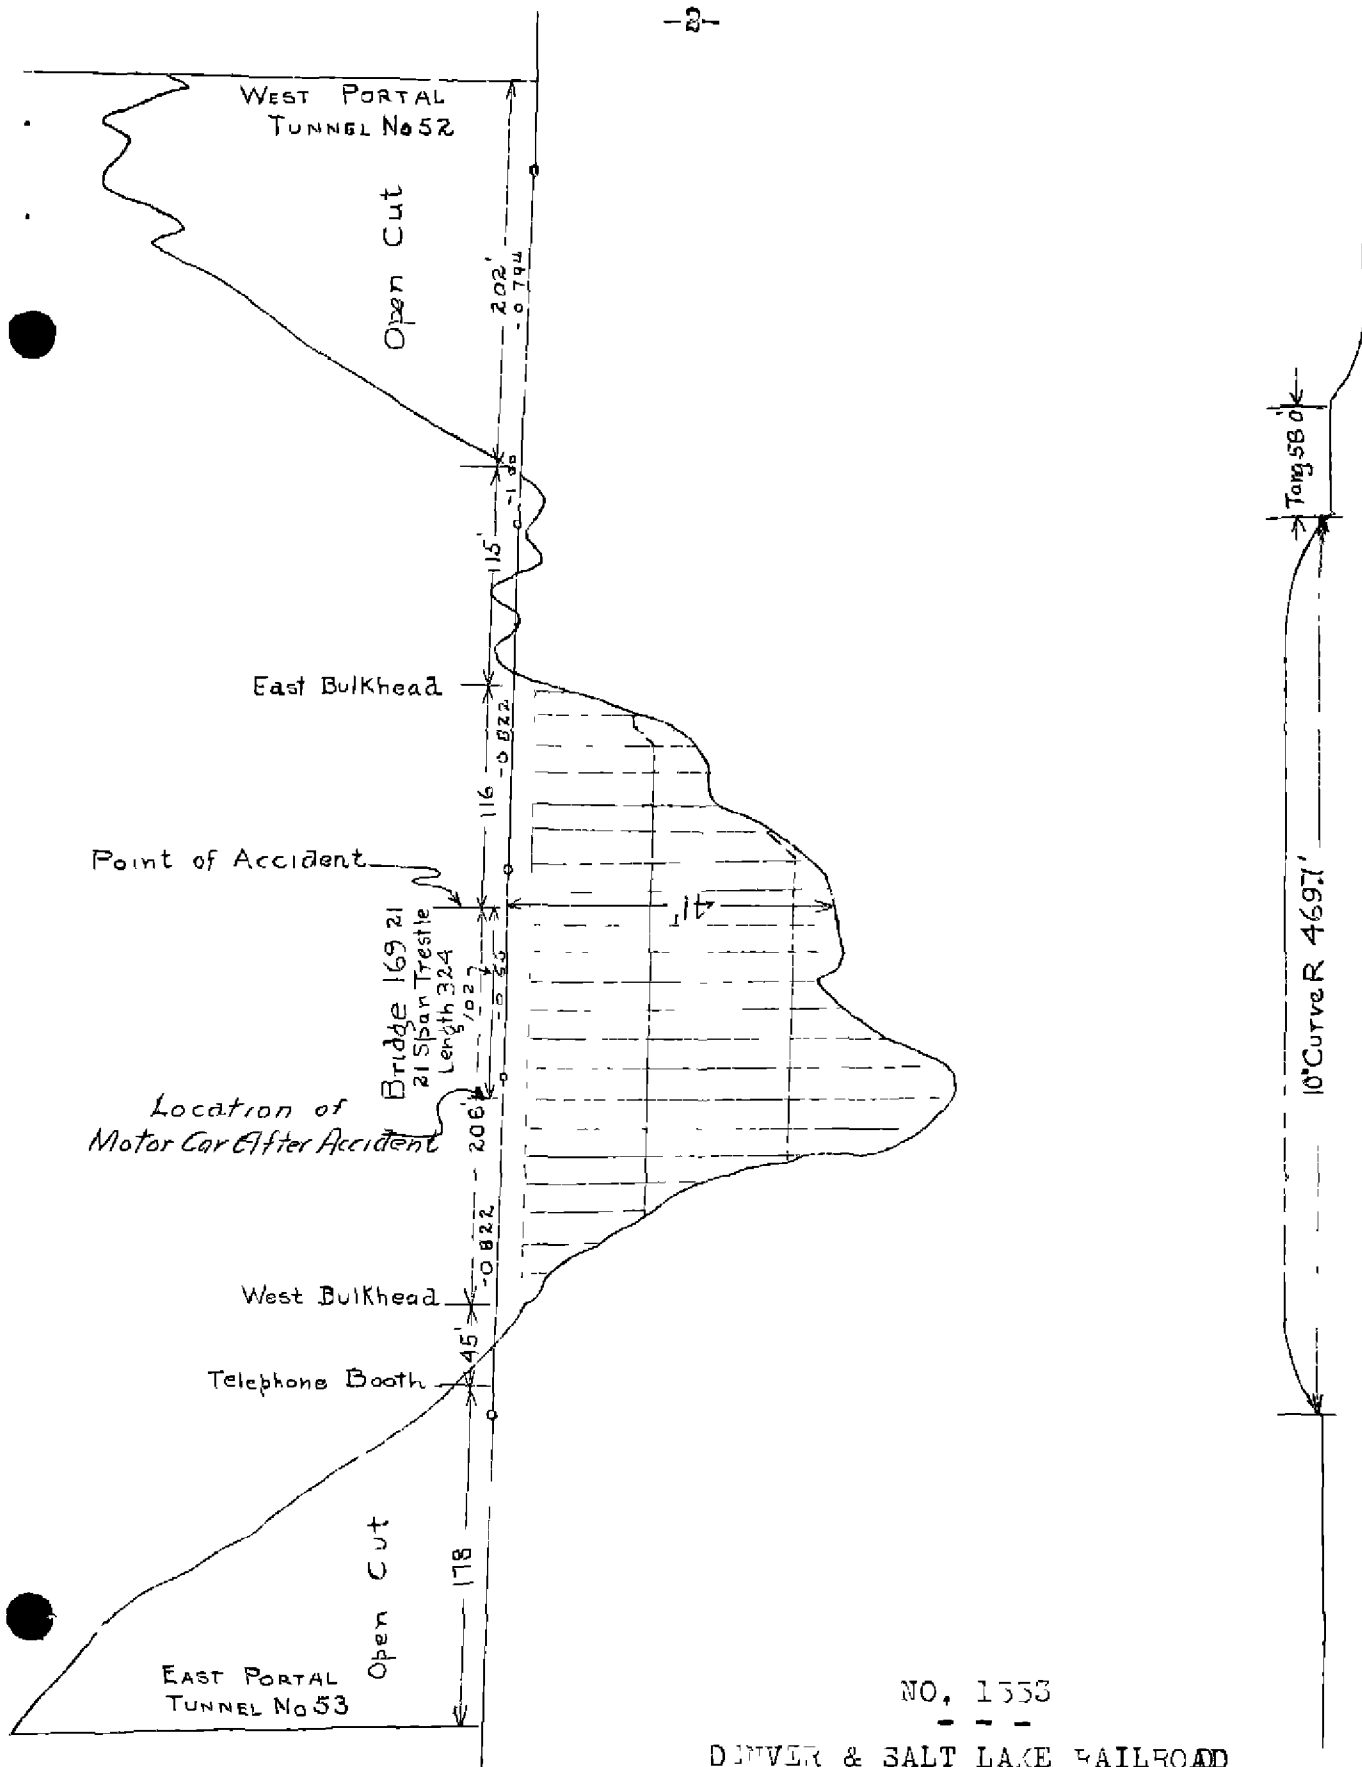
NO. 1553

Volcano, Colo.

Aug. 12, 1929.
