INTERSTATE COMMERCE COMMISSION

REPORT OF THE DIRECTOR OF THE BUREAU OF SAFETY IN RE INVESTIGATION OF AN ACCIDENT WHICH OCCURRED ON THE ERIE RAILROAD AT CLEVELAND, OHIO, ON OCTOBER 22, 1930.

December 20, 1930.

Inv. No. 167.
 Erie Railroad
 Cleveland, Ohio
 October 22, 1930

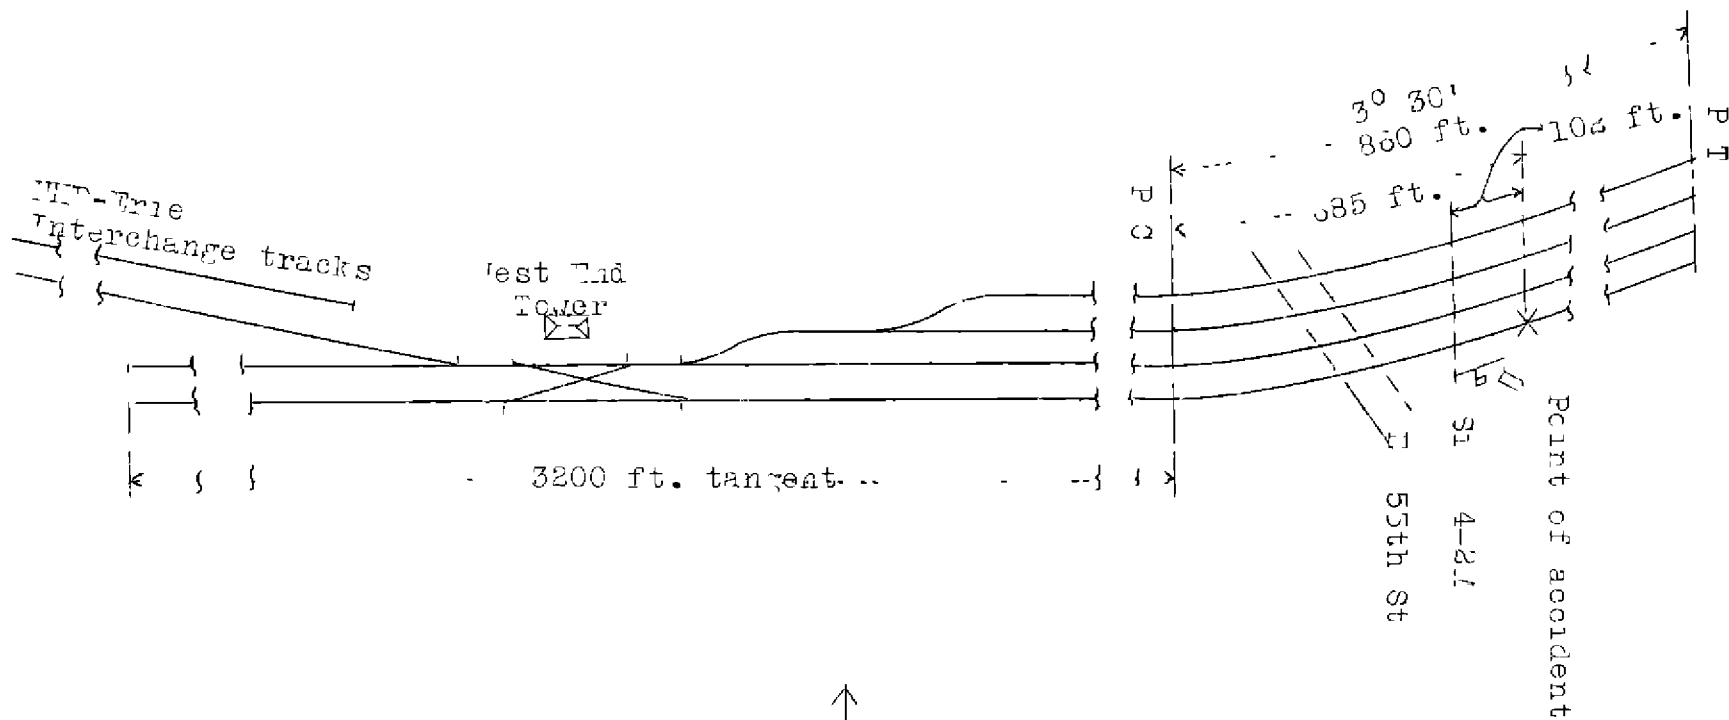
Signal 4-2M, located 102 feet west of the point of collision, is a two-arm, upper-quadrant signal, the top arm is an automatic block signal and operates in three

positions, night indications being red, yellow, and green, while the bottom arm is a train-order signal and operates in two positions, night indications being red and green. Signal 4-2M is located 3,760 feet east of where transfer trains of the New York, Chicago & St. Louis Railroad, hereinafter referred to as the Nickle Plate Road or NKP, enter upon the eastbound main track of the Erie Railroad west of West End tower, and is the first automatic block signal encountered by such transfer trains. A view of signal 4-2M can be had across the inside of the curve from the cab of an eastbound engine for a distance of 2,600 feet, however, owing to the three freight cars standing on the yard track at E. 55th Street, a view of the caboose standing at the point of accident could not be obtained until it was only 650 feet distant.
