## INTERSTATE COMMERCE COMMISSION

REPORT OF THE DIRECTOR OF THE BUREAU OF SAFETY IN RE  
INVESTIGATION OF AN ACCIDENT WHICH OCCURRED ON THE  
ERIE RAILROAD NEAR CORNING, N. Y., ON JULY 11, 1929.

October 21, 1929

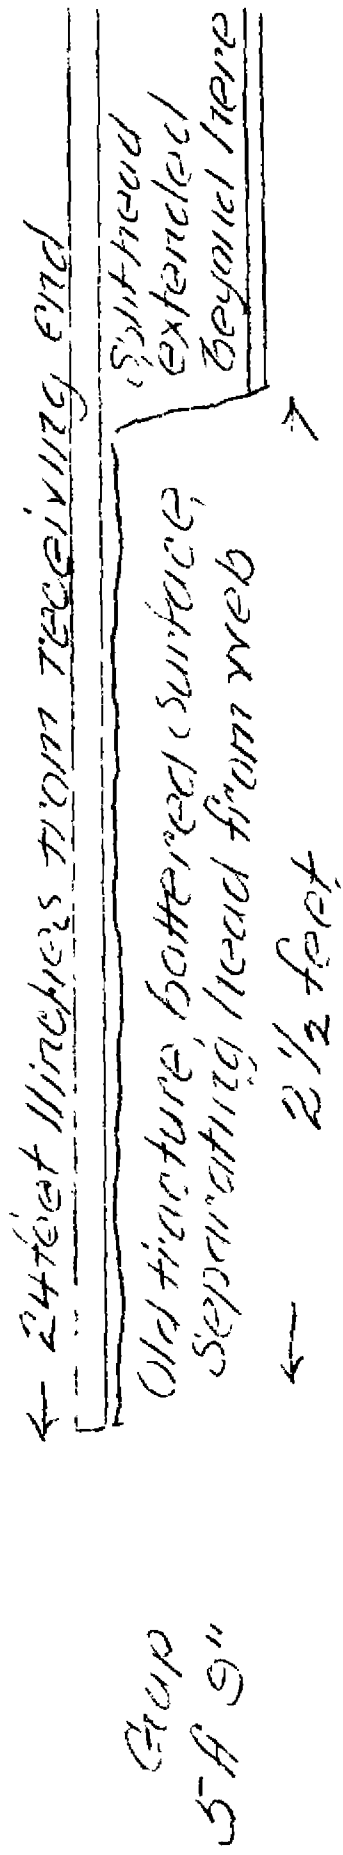
No doubt the fragments representing the 5 feet 9 inches gap contained split head fractures over their entire lengths. The estimated aggregated length of the split head fracture at the time of the accident was not less than ten feet.

Two feet and 7 inches of the leaving end of the long fragment displayed a fracture under the split head, separating it from the web. The surface of the fracture was worn and battered, indicating that it existed prior to the time of the accident. The split head fracture originating a short distance below the running surface of the head, had extended downward through the depth of the head, bifurcated and reached the surface at the fillets of the web, and thus completely separated the head from the web. This no doubt represented the condition of the rail when the train which was derailed entered upon it. The split head fracture had reached the surface at the fillet of the web of the 28-inch fragment, leading to the belief that over a considerable part or the whole of the length of ten feet the fracture had been in sight prior to the accident.

Total length of split head estimated over 10 feet

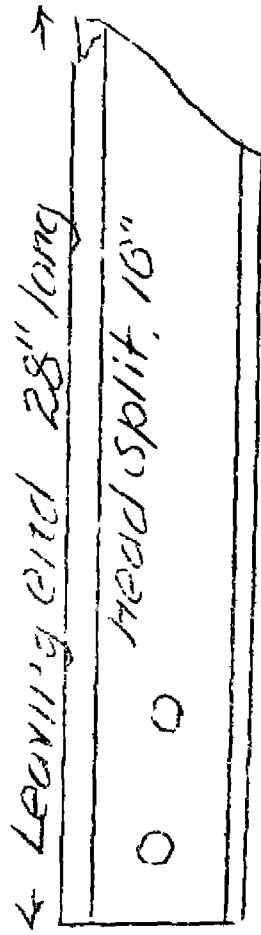
Gap 5' 9"

Fragments not recovered

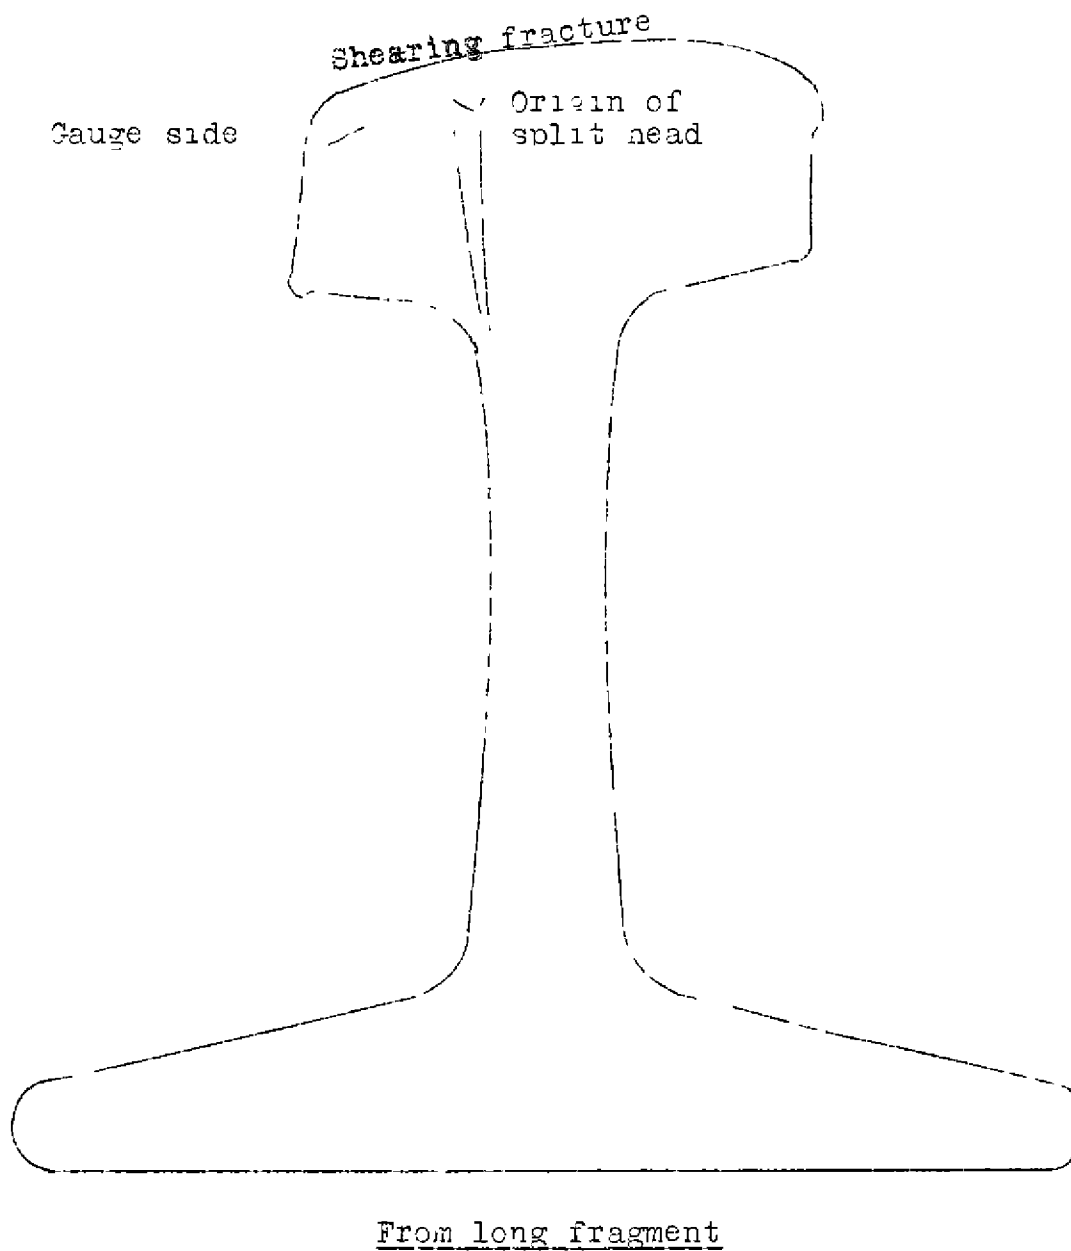
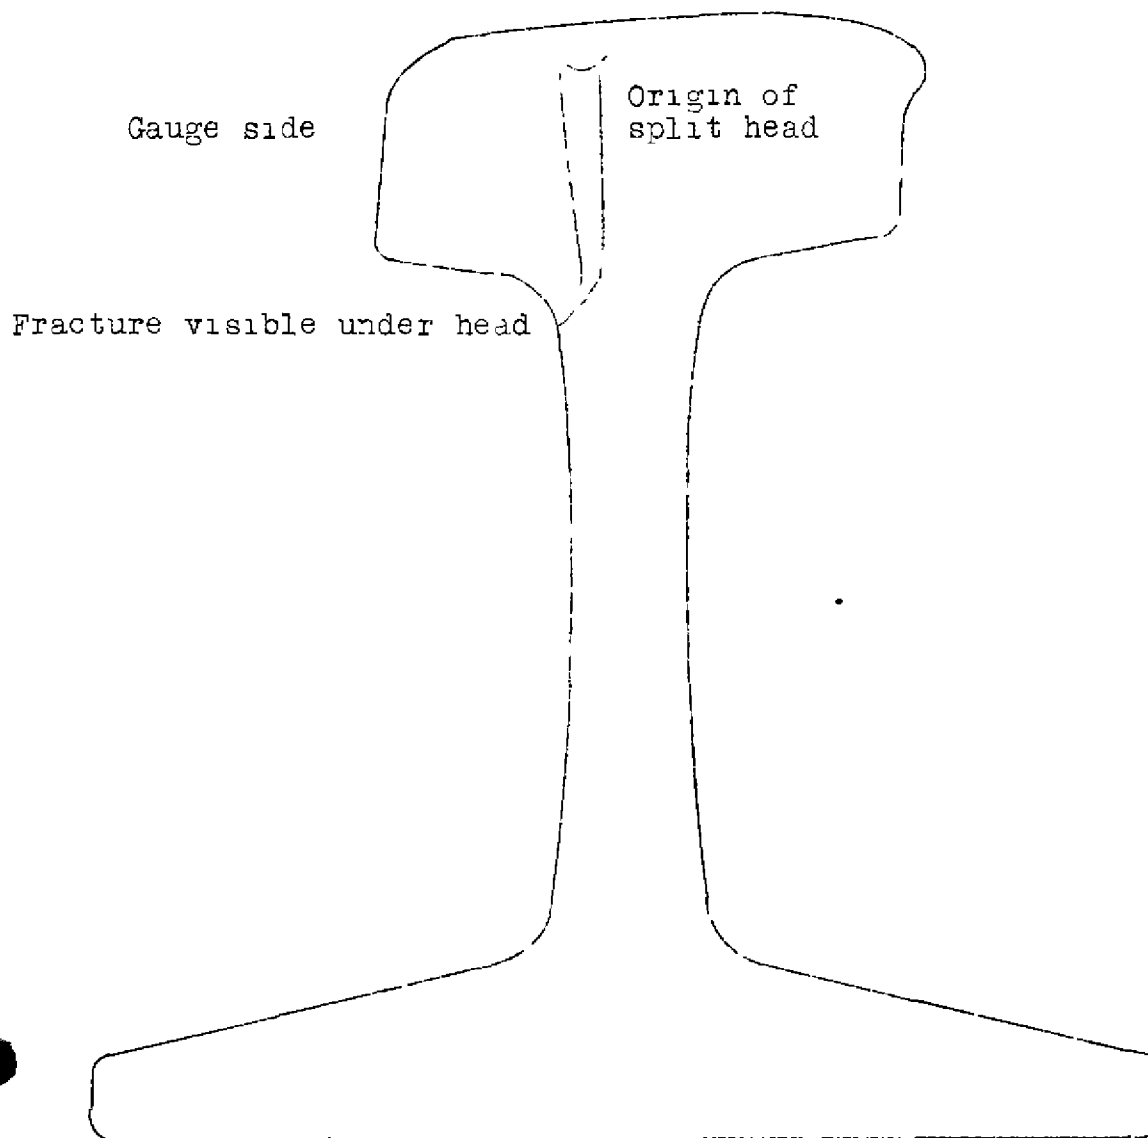
From short fragment.

The dimensions of the split head fracture, as exhibited a few inches beyond the receiving end of the 28-inch fragment, were in width, at the top, two-tenths of an inch, and having a depth of one and four-tenths of an inch. These fractures are widest at the top tapering to zero at the bottom. They originate at the top and as they extend are necessarily of zero width at the bottom.

The longitudinal fracture of this rail began about a quarter of an inch below the running surface, but from its point of inception oblique shearing fractures formed which passed upward. About fifteen-hundredths of an inch of unfractured metal remained above the shearing fractures. The metal immediately below the running surface of a rail shows flattening of the grain of the steel, due to the lateral flow of the metal under the wheel pressures. When this lateral flow of metal encounters a longitudinal streak or acicular seam in the upper part of the head an opportunity is presented for the inception of a split head fracture.
