INTERSTATE COMMERCE COMMISSION

REPORT OF THE DIRECTOR OF THE BUREAU OF SAFETY IN RE INVESTIGATION OF AN ACCIDENT WHICH OCCURRED ON THE ERIE RAILROAD AT FREEDOM, OHIO, ON MARCH 4, 1930.

March 26, 1930.

Inv.No.1625
 Erie Railroad
 Freedom, Ohio
 March 4, 1930

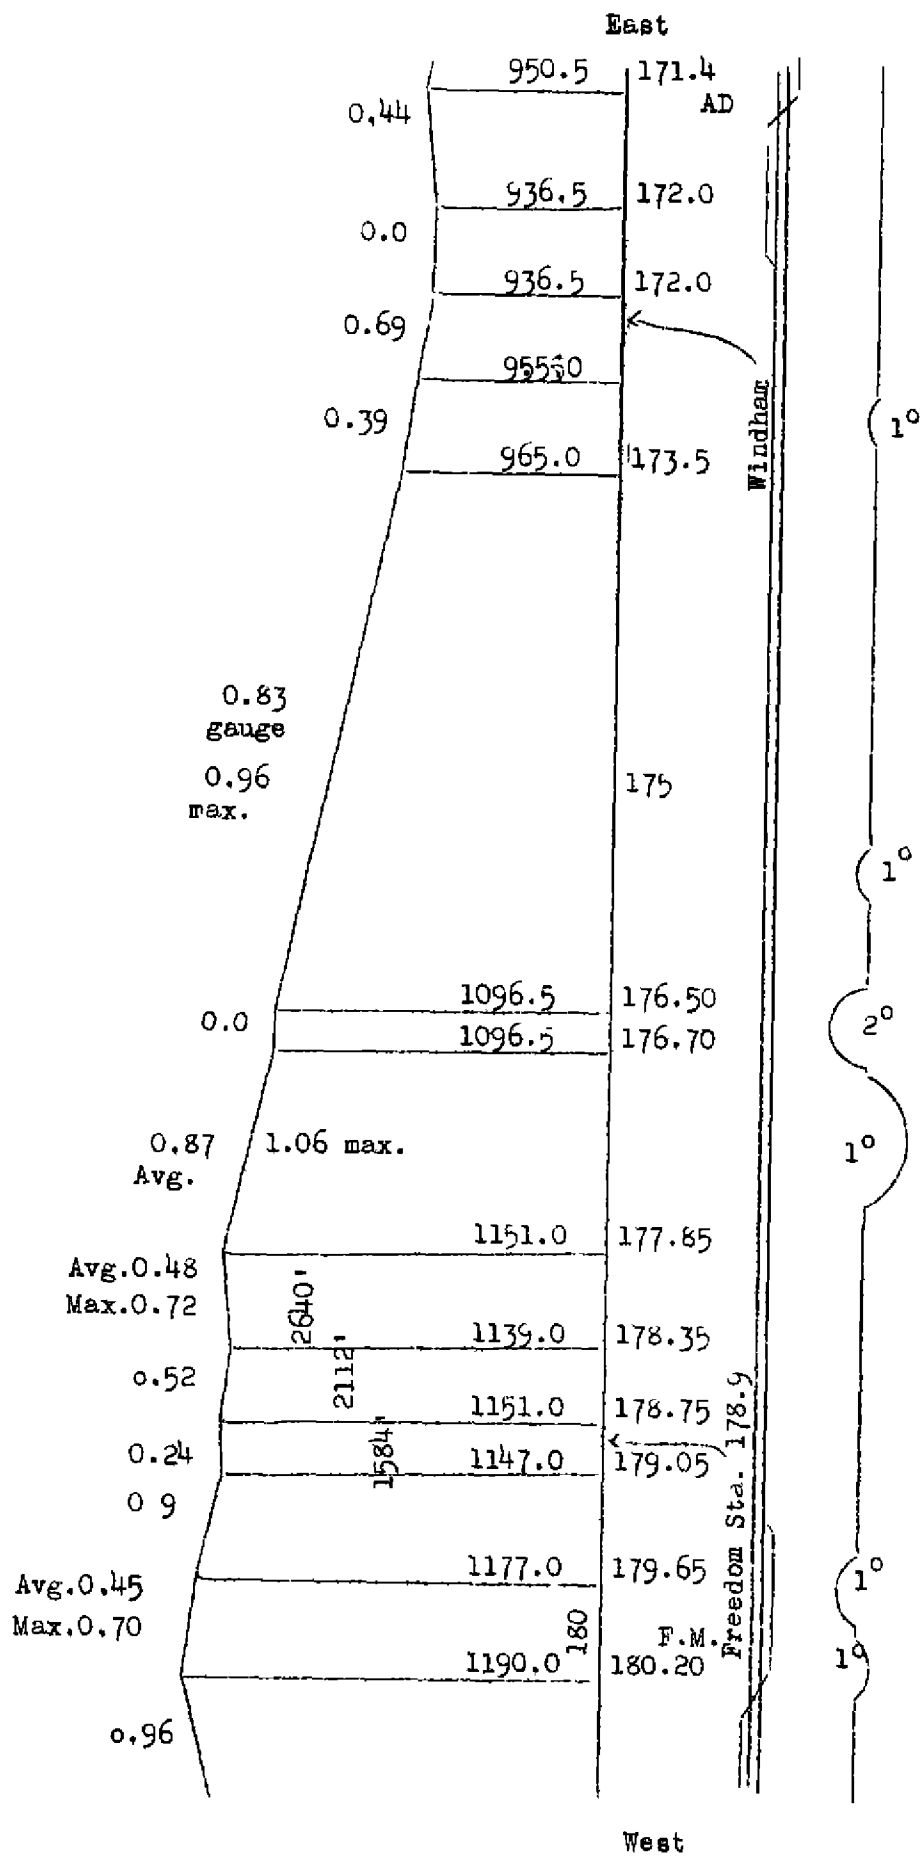
This accident occurred on the Second District of the Mahoning Division, extending between Meadville, Pa., and Kent, Ohio, a distance of 89 miles, in the vicinity of the point of accident this is a double-track line over which trains are operated by time-table, train orders, and an automatic block-signal system. Freedom is located 76 4 miles west of Meadville and the accident occurred in the vicinity of the station at Freedom; approaching from the east, the track is tangent for about 2 miles, the station at Freedom being located on this tangent at a point about 1.4 miles from its eastern end. The grade for west-bound trains is generally ascending for several miles, the maximum gradient being 1.06 per cent; however, there is an occasional stretch of either level or descending grade, the longest of these being 2,640 feet of descending grade with an average gradient of 0.48 per cent and a maximum gradient of 0.72 per cent, west of this point there are 2,112 feet of 0.52 per cent ascending grade and 1,584 feet of 0.24 per cent descending grade, following which the track ascends to the summit of the grade, a distance of 6,072 feet. The station at Freedom is located practically midway of the above-mentioned 0.24 per cent descending grade.

At the time of the accident the forward portion of the westbound freight train involved in this accident was moving on the 0.24 per cent descending grade, the middle portion of the train was negotiating the 0.52 per cent ascending grade, while the rear portion of the train, including the caboose and helper engine, was on the descending grade with an average gradient of 0.48 per cent
