INTERSTATE COMMERCE COMMISSION

REPORT OF THE DIRECTOR OF THE BUREAU OF SAFETY IN RE
INVESTIGATION OF AN ACCIDENT WHICH OCCURRED ON
THE FLORIDA EAST COAST RAILWAY NEAR BUNNELL,
FLA., ON MAY 3, 1930.

June 14, 1930.

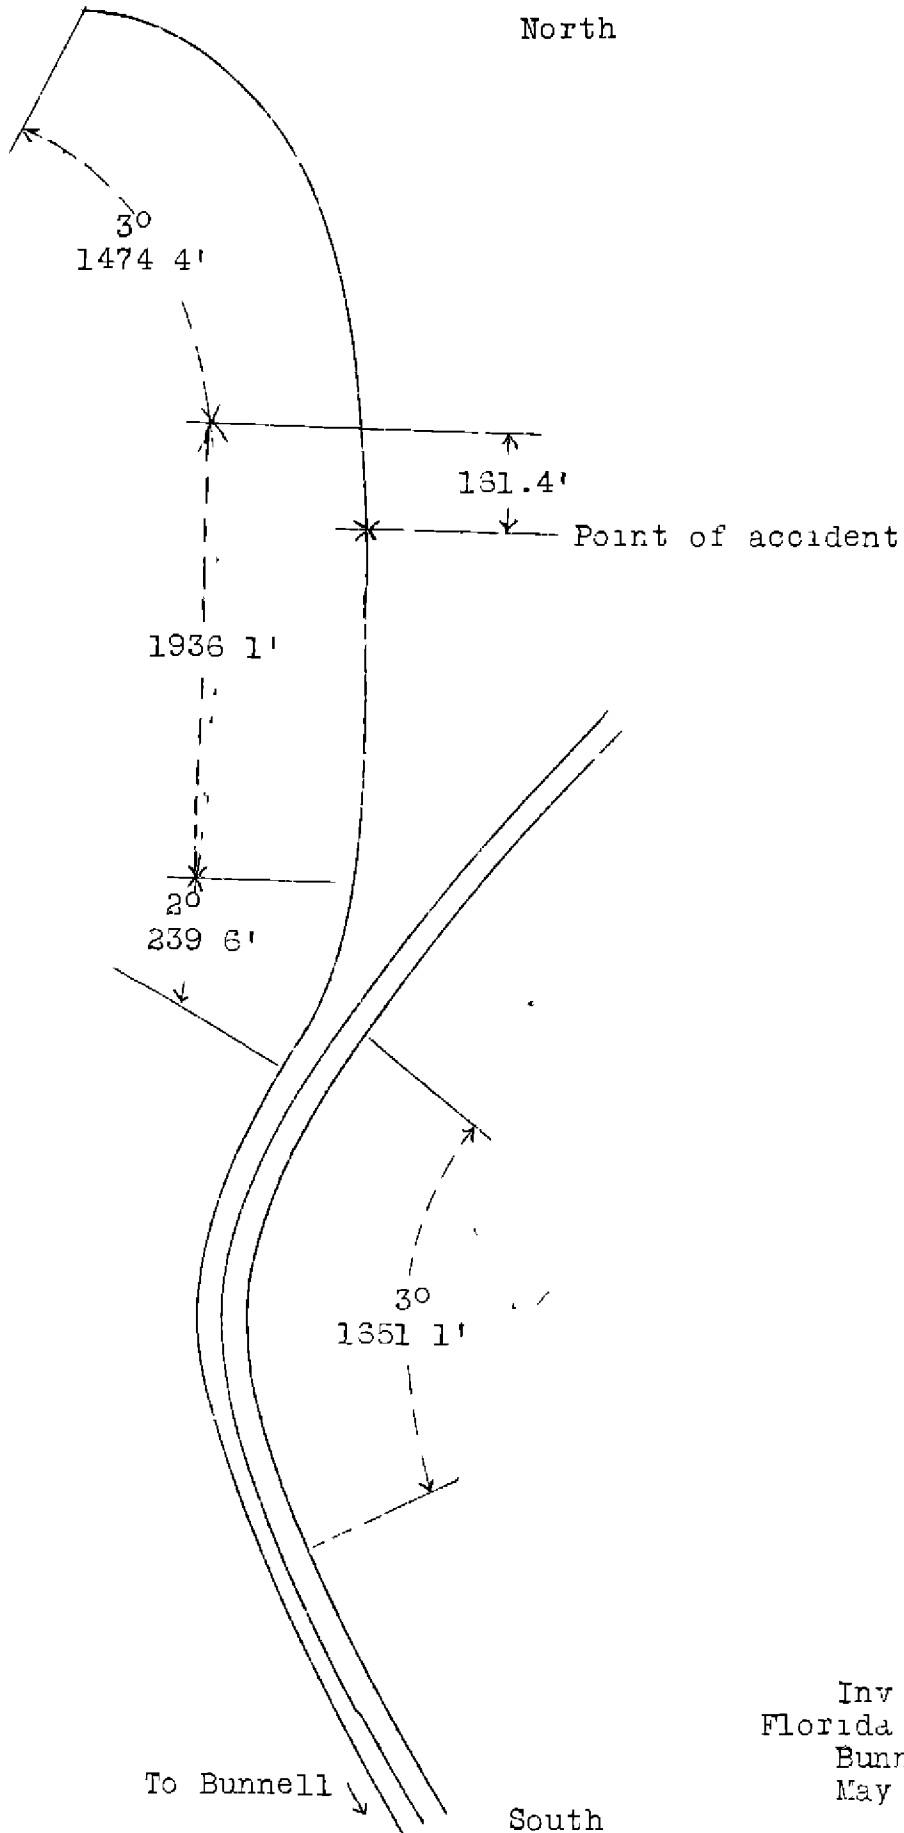
Inv No 1635
Florida East Coast Ry
Bunnell, Fla
May 3, 1930.

Due to trees located on the right or inside of the 3° curve north of the point of accident, the view is restricted to 1,800 feet for a southbound train until the train has reached a point about half way around the curve, where a view can then be had for about three-fourths of a mile.
