INTERSTATE COMMERCE COMMISSION

REPORT OF THE DIRECTOR OF THE BUREAU OF SAFETY IN RE INVESTIGATION OF AN ACCIDENT WHICH OCCURRED ON THE FLORIDA EAST COAST RAILWAY NEAR WABASSO, FLA., ON NO- VEMBER 14, 1924

DECEMBER 23, 1924

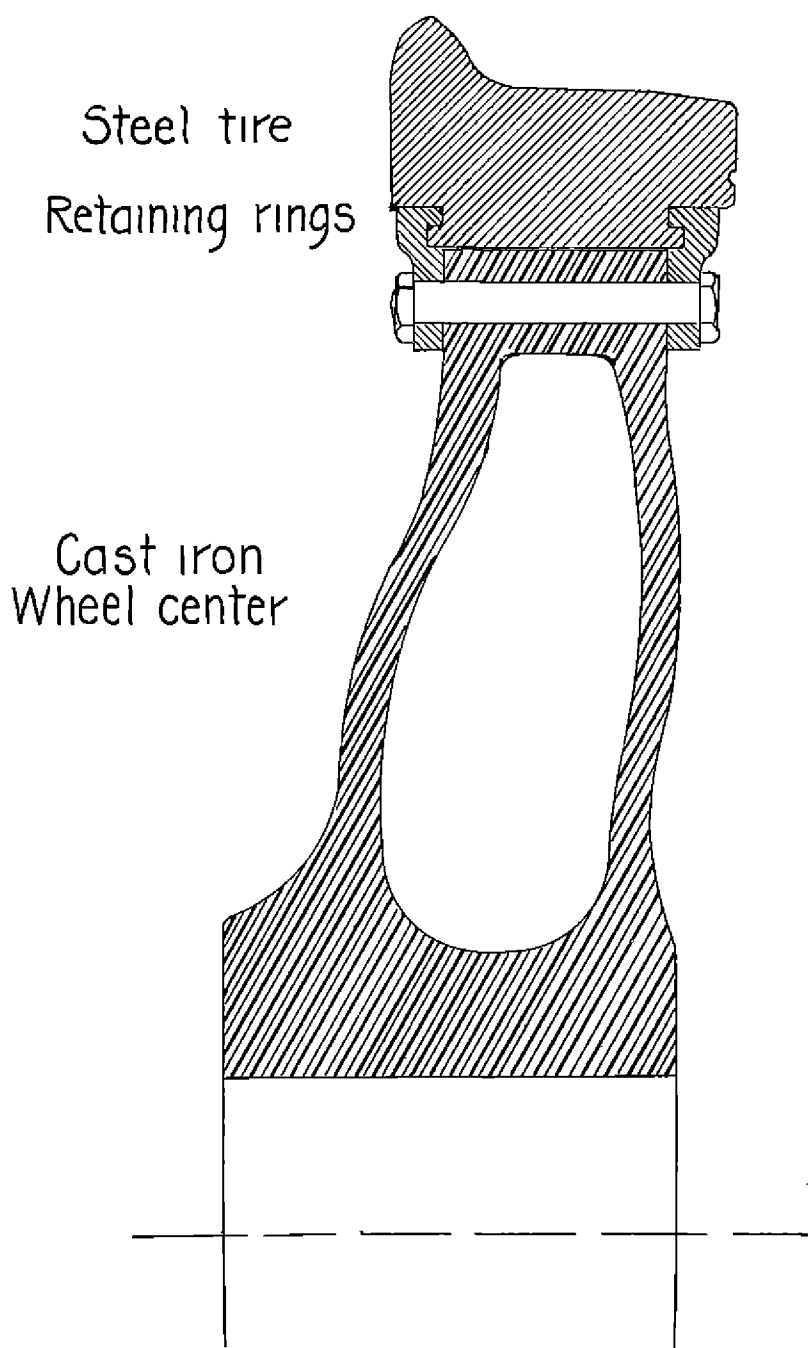
It appears that the original wheel centers remained on each axle. They were of cast iron, said to have been made by Knupp, and branded "Patented October 28, 1886." Figure No. 2 illustrates the construction of these wheels. They consisted of a double plate cast-iron center, upon which a steel tire was shrunk, the tire being further secured by two retaining rings, with 10 five-eighths-inch through bolts. The inner and outer plates were connected at intervals by webs, the sketch of the wheel showing only the plates in cross-section.

The examination of the failed wheel which was subsequently made showed the outside diameter of the cast-iron center to be much smaller than the inside diameter of the tire. There was a clearance amounting to some three thirty-seconds of an inch. Through lack of rotundity of the tire a more exact measurement of this clearance was not determined.

The rim of the cast-iron center showed wear. A slight shoulder had been formed at its inner edge. This was evidence that some looseness between the tire and the cast-iron center existed before the derailment occurred, furthermore, that the clearance between them must have been filled by a liner.

Between this tire and its center was found a sheetmetal liner, occupying the clearance which otherwise would have existed between them two diameters. The liner was made up of three pieces, each covering one-third the circumference of the center, and was 3 inches wide by $3\frac{1}{2}$ hundredths inch in thickness. It was evident that such

a liner had been used under the tire of the wheel which failed, the abrasive action of which, with a somewhat loose fit, would account for the slight shoulder displayed on the rim of the cast-iron center.

FIGURE No 2—Showing construction of wheel which failed

While adequate shrinkage fits can doubtless be acquired in the use of liners, their employment causes an uncertainty in the machining operations, desirable to avoid. Liners in a wheel of this type are not to be classed with shims in driving wheel tires which are accessible and where opportunity to tighten them is present.
