INTERSTATE COMMERCE COMMISSION

REPORT OF THE DIRECTOR OF THE BUREAU OF SAFETY IN RE
INVESTIGATION OF AN ACCIDENT WHICH OCCURRED ON
THE GRAND TRUNK RAILWAY SYSTEM AT BELSAY, MICH.,
ON MAY 28, 1930.

June 25, 1930.

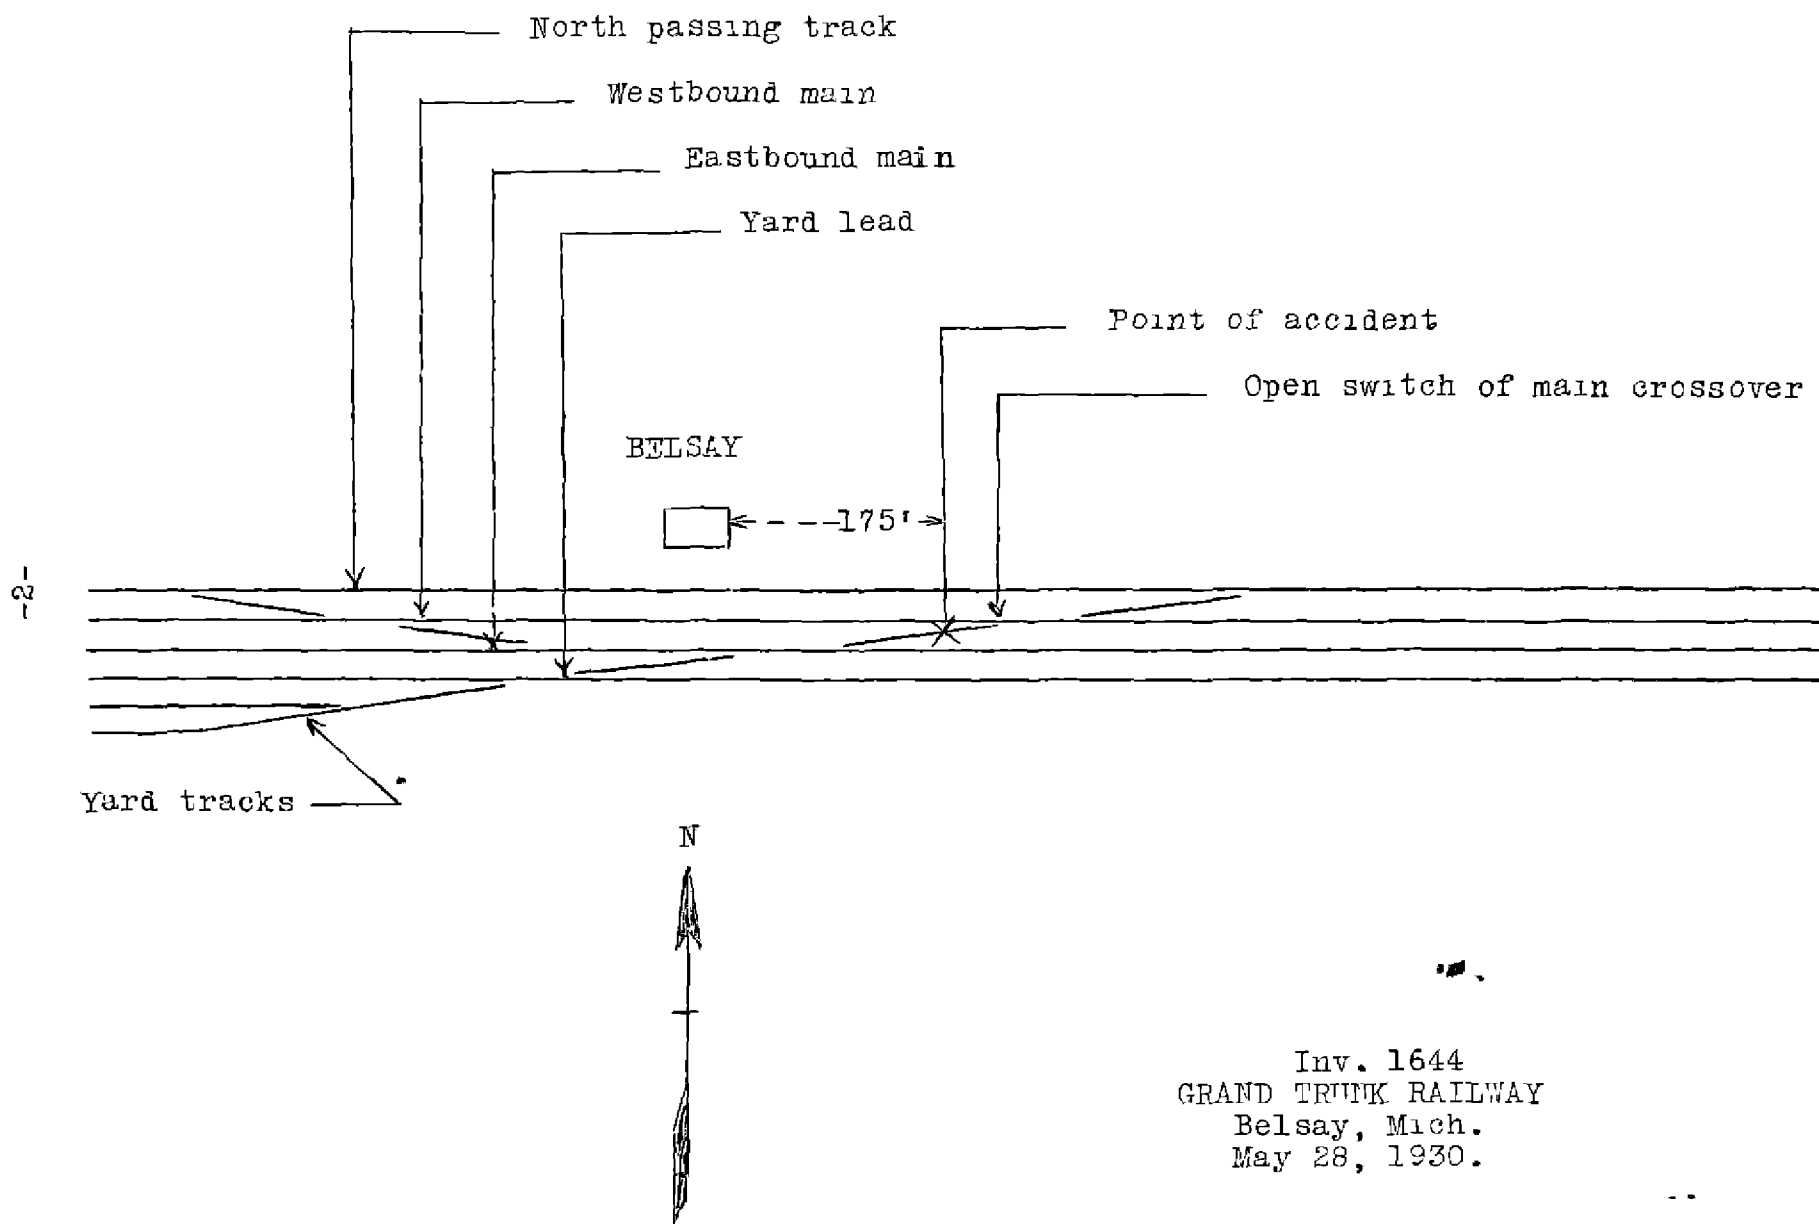
The east switch of the crossover involved in this accident is a facing-point switch for westbound trains and is of the ground-throw type. The switch-stand is located between the westbound main track and the north passing track. The switch has an oval, 6 x 10 inch, red banner, which shows only when set for diverging movements. The lamp has a 4 1/4 inch lens showing green for straight movements and red for diverging movements. Approaching from the east the

lamp and stand of this switch when set for a diverging movement are in line with the east switchstand of this crossover located 229 feet 8 inches to the east, and the view is also interfered with by the west switchstand of another crossover which has a 10 inch round banner, standing slightly higher and located 27 feet 8 inches east thereof. There were four other crossovers in this vicinity, connecting passing tracks with main tracks.

In approaching these switches from the east on the westbound main track, it was found that with all the other switches set in normal position and the east switch of the crossover between main tracks open, a portion of the red banner could be distinguished in cloudy weather for a distance of approximately 800 feet from the engineman's side of the engine cab, but a clear view of the banner could not be had until a point about 100 feet east of the switch had been reached. It could be definitely determined that the points were open at a distance of 380 feet.

It is recommended that the switchstands in the vicinity of the point of accident be so arranged that the lamp lenses and switch targets will be plainly visible from approaching trains.
