INTERSTATE COMMERCE COMMISSION

REPORT OF THE DIRECTOR OF THE BUREAU OF SAFETY IN RE INVESTIGATION OF AN ACCIDENT WHICH OCCURRED ON THE GRAND TRUNK WESTERN RAILWAY NEAR DURAND, MICH., ON JUNE 5, 1923

JULY 7 1923

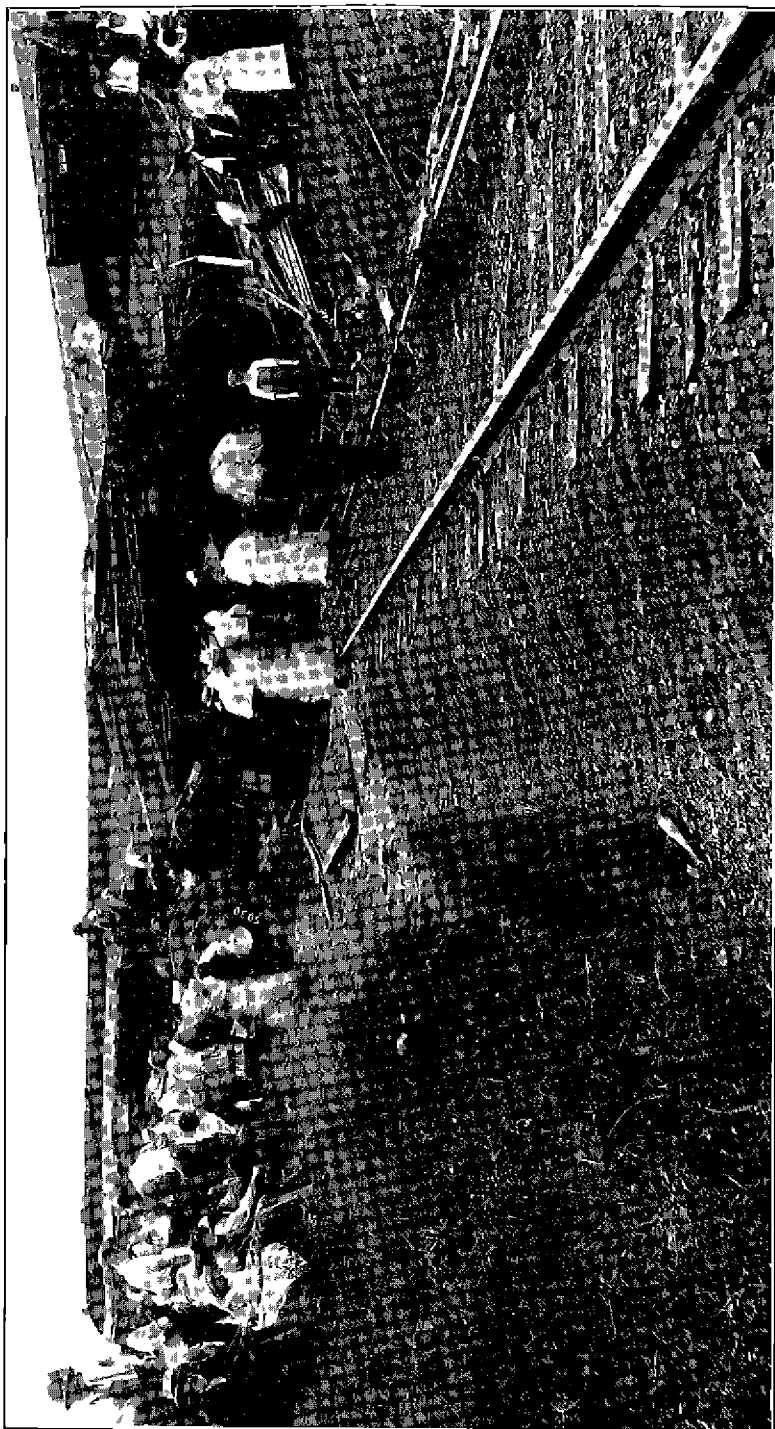
Engine 5030 was derailed to the right and came to rest on its right side, parallel to the track, badly damaged 362 feet from the initial point of derailment, while the tender was on the opposite side of the track. The first two cars were destroyed, while the third car was derailed to the left coming to rest leaning to the right with its head end resting on the embankment all except two of the remaining cars were derailed but remained upright. Illustration No. 1 is a general view of the wreckage, looking west. The employees killed were the engineman and fireman.

FIG No 1 —General view of wreckage looking west

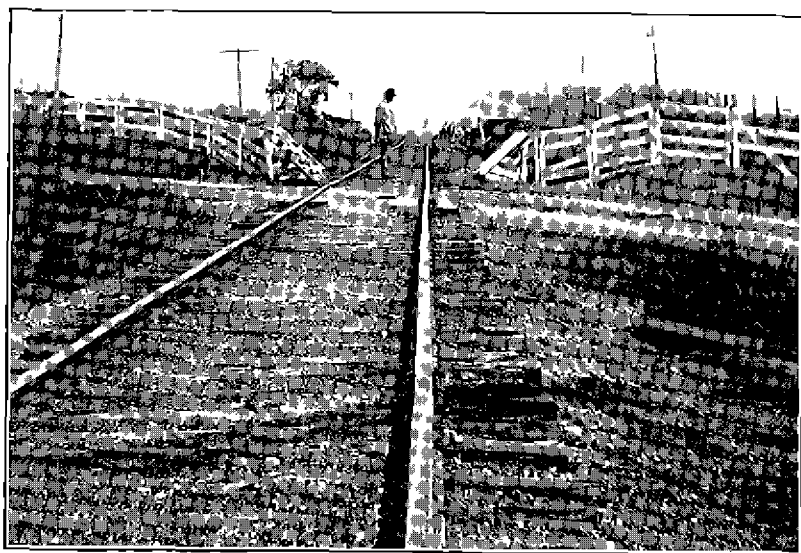
The track was poorly maintained and generally in poor condition. At a point 112 feet west of the point of accident two rails on the south side of the track were found to be spread, owing to soft and defective ties, and had been reinforced with tie-plates braced against the outsides of the rails and spiked to the ties. This condition is shown by illustration No. 2. The gauge as a whole however, was reasonably good. The ties were badly rail cut, while many of them were broken and decayed as many as 20 consecutive ties were found, many of them cut 3 inches deep, and including 4 consecutive broken ties under one rail while within half a mile

FIG No 2 -Right rail spread just west of point of accident

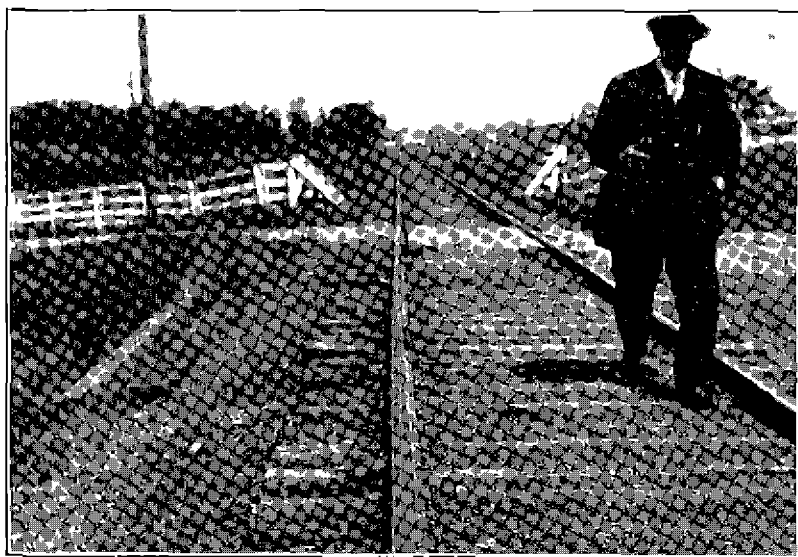
FIG No 3—Spread rail braced with tie plates

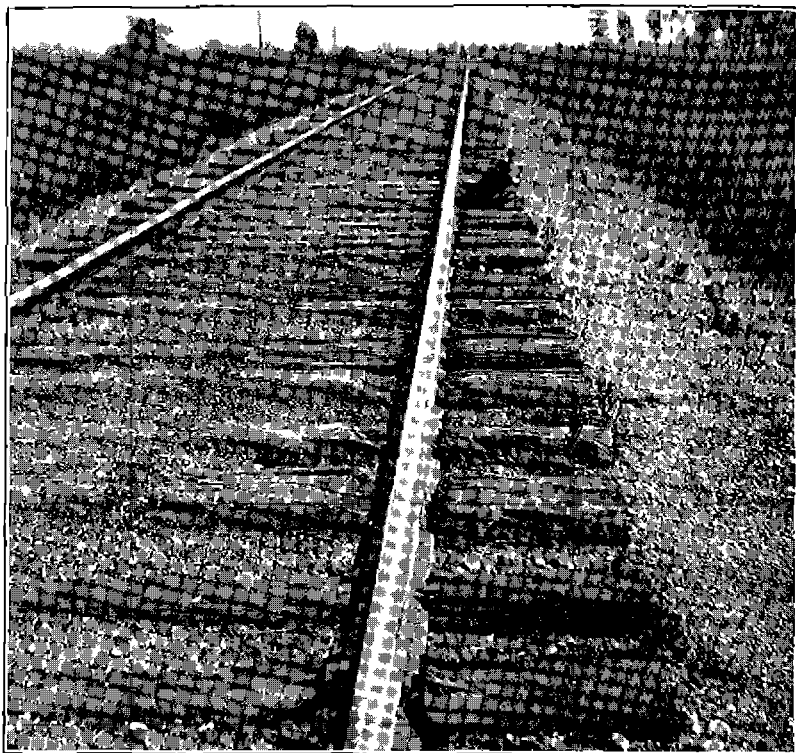
west of the point of accident there were found 143 broken and decayed ties in a 30-rail section, these defective ties not being uniformly distributed, as many as 12 being found in one rail section. Illustrations Nos 4 and 5 show decayed and badly cut ties, respectively, some distance west of point of accident. The track was somewhat rough, due to numerous low joints having been shimmed up, nine ties being shimmed up near one rail joint, the shims varying from $\frac{1}{2}$ to $1\frac{1}{4}$ inches in thickness, many loose spikes were also found. The rails were rolled and first laid in 1901, then taken up,

FIG. No. 4—Ties badly decayed and rail cut

In view of the condition of this track, the speed of trains should have been restricted, by slow orders or otherwise, to safe limits. The operating officers of this railway are responsible for permitting these conditions to exist and for allowing trains to be operated at speeds which were excessive in view of the existing track conditions. Steps should be taken immediately to restrict speeds within safe limits and to place this track in proper condition for the operation of trains over it.

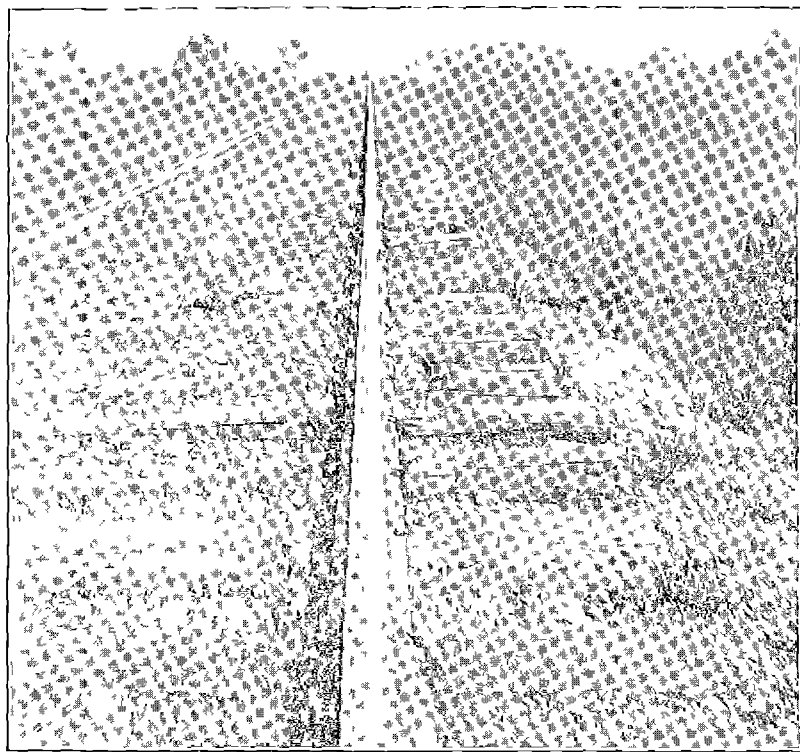
FIG. NO. 5.—Ties which were badly rail-cut used when rails were being moved to new bed.
